Technical Service Bulletin

GROUP AUTOMATIC TRANSMISSION	NUMBER 26-AT-002H
DATE FEBRUARY 2026	MODEL(S) SANTA FE (TMA) TUCSON (NX4A)

SUBJECT: ELECTRIC OIL PUMP REPLACEMENT - DTC U028700

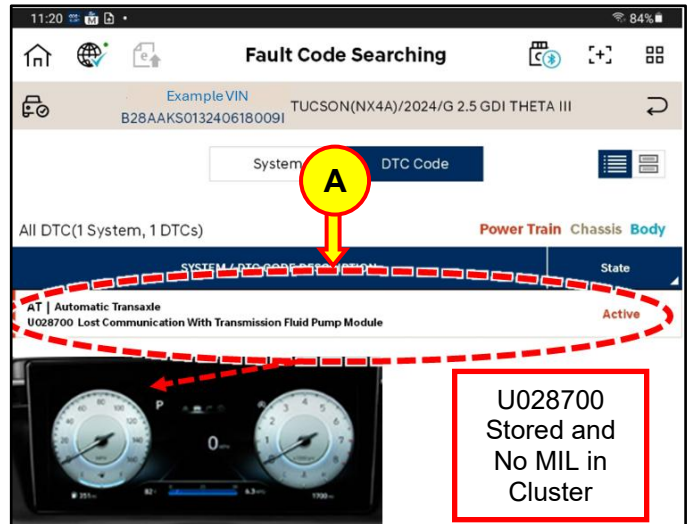
- If DTC U028700 is set in “**Active**” status (A), **proceed to step 2**.
- If DTC U028700 is **NOT** in “**Active**” status, or another DTC is found, this TSB does **NOT** apply. Follow the normal diagnostic process.
