## Technical Service Bulletin

<b>GROUP</b>	<b>NUMBER</b>
<b>CAMPAIGN</b>	<b>26-01-017G</b>
<b>DATE</b>	<b>MODEL(S)</b>
<b>FEBRUARY 2026</b>	<b>GV70 (JK1A)</b>

**SUBJECT:** DCU SOFTWARE UPDATE  
(LIMITED COVERAGE CAMPAIGN L03G)

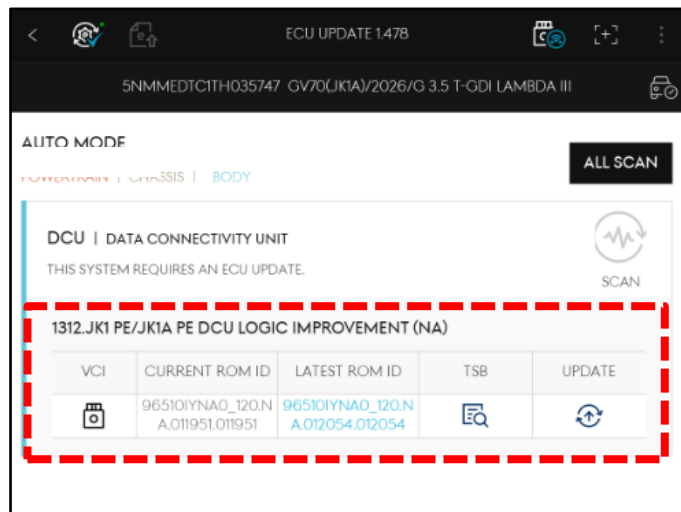
**Description:** Certain GV70 (JK1A) vehicles may exhibit a Data Communication Unit (DCU) software error due to the internal timer initialization logic not being implemented. The DCU module may shut down telematics services after one year. This bulletin provides instructions to perform a software update for the DCU module.

2. Perform the ECU update in **Auto Mode**.

- Verify the ROM ID by selecting the **DCU** system to scan the vehicle's current ROM ID.

If the update fails, remove the power connector from the in-cabin fuse box for at least **5 seconds**. Reassemble and retry the update.
