SIM 65 02 26

DIRECTIONAL ARROWS INCORRECT IN AR VIEW – HU-H6

2026-02-17

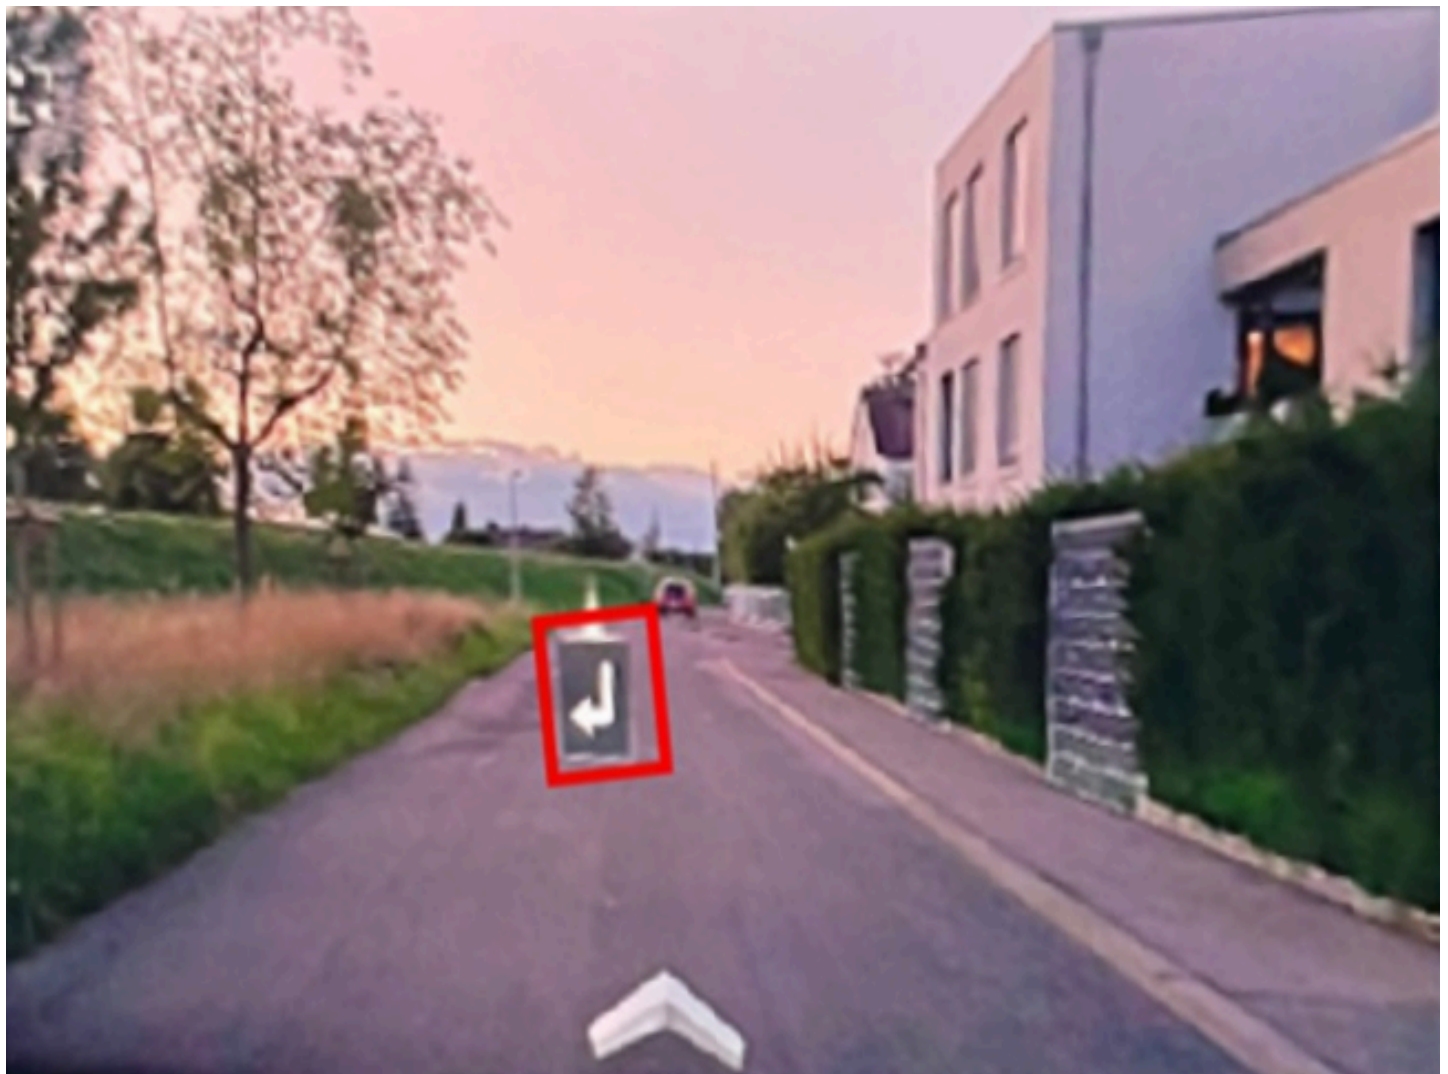
In Augmented View, the arrows are rotated by 180° (shown inverted below) when displayed on the MINI Interaction Unit (MIU).

Unfavorable software in the Headunit 6 (HU-H6).

Program the HU-H6.
