Water ingress at sliding sunroof

Topic number	LI77.20-P-073486
Version	2
Function group	77.20 - Electric sliding roof
Date	2/24/26
Validity	Type 463 as of model year 2019 (as of code XZ8) and sliding sunroof (code F15) type 465 with SA code 414
Reason for change	Expanded to include BR465 and adaptation of remedies

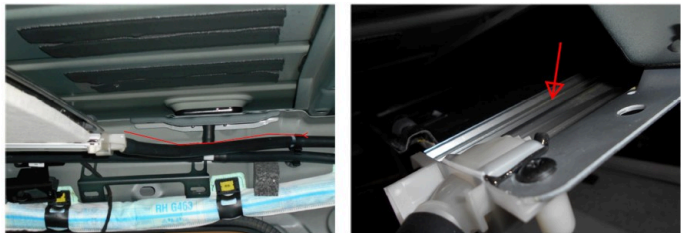
1. Incorrectly routed drain hoses: Water may accumulate in the rear area of the sliding sunroof frame (see picture #1). For example, the rear drain hoses may have been routed without sufficient slope, which consequently leads to the drains overflowing. Water can enter the vehicle interior through the headliner.
2. Sliding sunroof adjustment: An improper positioning of the tilting/sliding roof within the roof frame may, under certain circumstances, lead to increased water ingress through the seal between the sliding sunroof frame and the roof. However, one drop is permissible here.
3. Material degradation: Over time, the seal of the tilting/sliding roof may experience age-related changes in its elasticity, which could potentially affect its watertightness.

Picture 1 - Description of problem

- Route the left rear and right rear drain hoses of the sliding sunroof frame from the upper clip-on point to the lower clip-on point.
- This must be carried out for both fastening points at the C-pillar and D-pillar. Carry out this step on both the left and right side of the vehicle.
- Then move the water drain hoses of the roof luggage rack mounts from the lower clip-on point to the upper clip-on point (see Pictures 2 and 3, Video 1).
- Reinstall the roof lining.

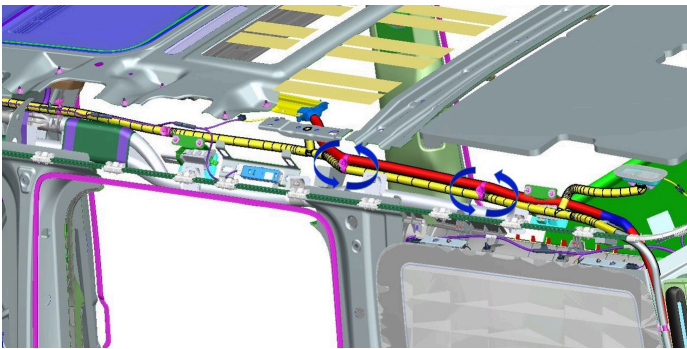
Picture 2 - Rework instruction for left side
Picture 3 - Swap hoses right vehicle side.JPG

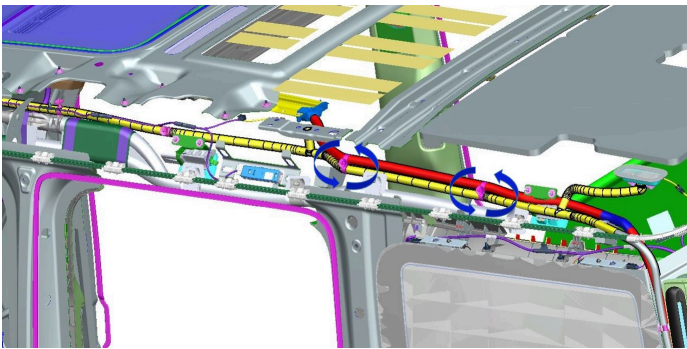
Picture 3 - Rework instruction for right side
