INSTRUCTION TO SERVICE

ITS61456		02/12/26
SECTION:	460-Windows	
SUBJECT:	Realign windshield support plate	
ISSUE:	Vertical stress crack on windshields	
SUMMARY:	Rework windshield frame per this ITS

ITS61456

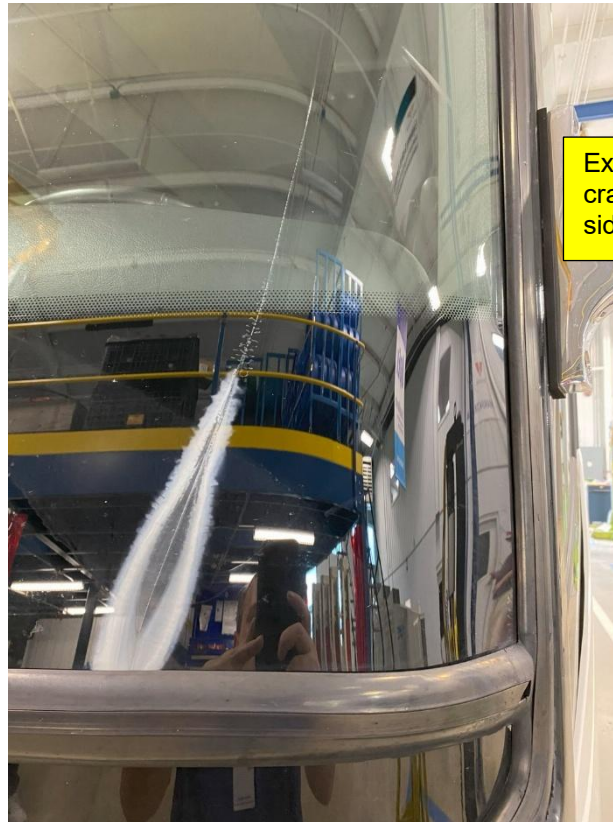
Example of a vertical stress crack located on the LH (driver side) windshield.

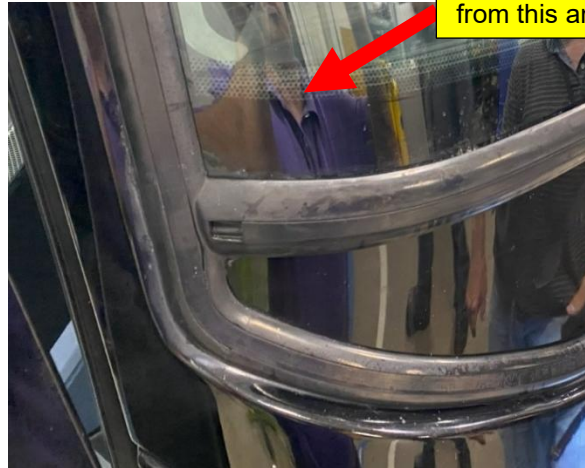
The aft edges of the center and side plates are aligned that indicates that the small side plate is not engaged correctly inside the rubber seal. **Repair is required.**

3. If windshield was recently replaced due to vertical stress crack, and the new windshield has no cracks now, then the frame repair can be done from inside, without removing the windshield. Inspect side plate alignment from outside: if the aft edges of the center and side plates are aligned then repair is required. Refer to Figure 1 below.

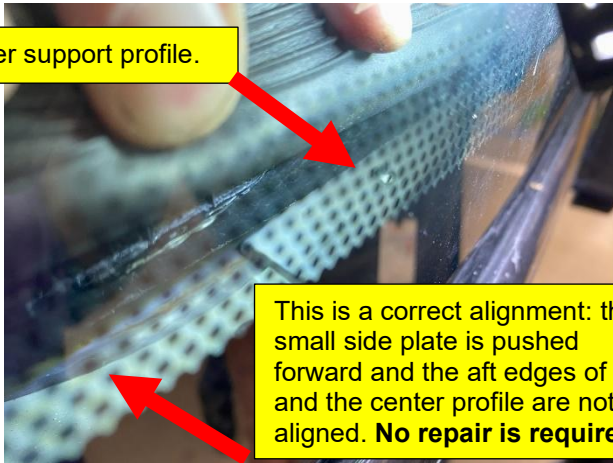
This is a correct alignment: the small side plate is pushed forward and the aft edges of this and the center profile are not aligned. **No repair is required.**

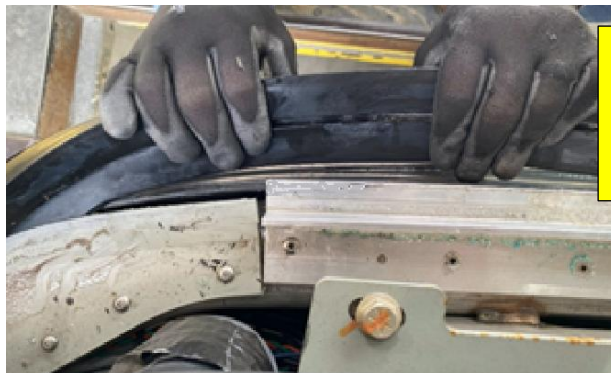
Figure 1: Side plate alignment inspection

Example of an **incorrect** side plate installation at the LH (street side): the forward edges of the center and side plates must be aligned to adequately support the windshield.
