GROUP	MODEL
Voluntary Emissions Service Campaign	2022-2023MY Multiple Models Listed (HEV, PHEV)
NUMBER	DATE
SC325 (Rev 1, 02/19/2025)	February 2025

AEWP INSPECTION AND REPLACEMENT (SC325)

This bulletin provides information to inspect and, if necessary, replace the Auxiliary Electric Water Pump (AEWP), control harness wiring, and/or engine room junction box for coolant intrusion and/or corrosion on certain 2022-2023MY Kia Hybrid and Plug-in Hybrid vehicles listed in the table below. The AEWP in the subject vehicles may crack internally and allow coolant to intrude into the AEWP circuitry. If coolant enters the AEWP circuitry, the Check Engine Light (CEL) may be illuminated with one or more DTCs listed on page 2. If the vehicle continues to be driven in this condition, the Active Air Flap (AAF) warning message can also activate, and coolant may eventually migrate through the wiring harness to the engine room junction block. This may result in a reduction of motive power and may cause the vehicle to release air pollutants which exceeds Federal and California standards. These standards were established to protect the public health and welfare from the dangers of air pollution. Follow

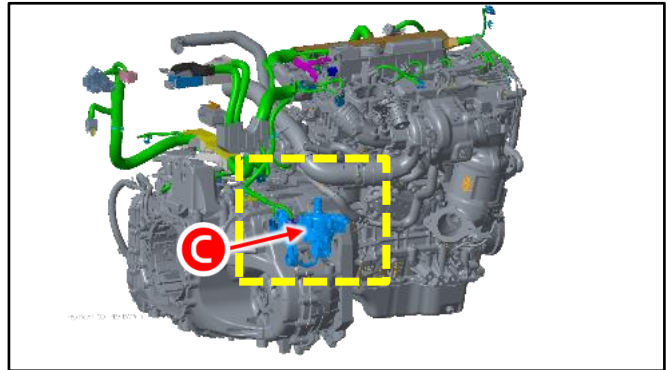
5. Locate AEWP and disconnect the control harness connector (C).
6. Inspect the AEWP connector (C) for moisture and/or coolant residue.

Are moisture and/or coolant residue present in the connector?

- **NO, moisture and coolant residue were NOT found (OK)**, then replace the following parts to close this campaign:
 - 1) AEWP assembly (Page 5)

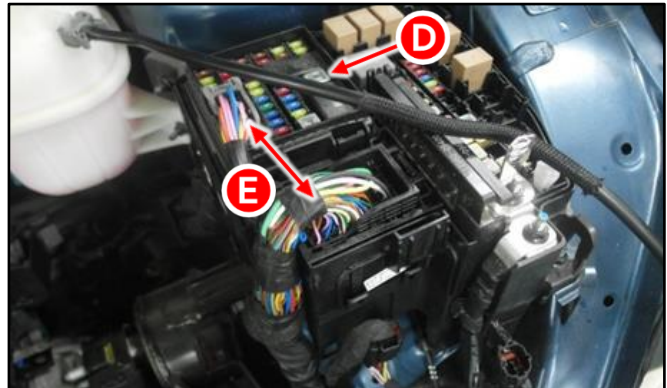
7. Lower the vehicle and locate the Process Control Block (PCB) - Fuse/Junction box (D).
8. Disconnect the control harness connectors (E) and inspect the connector for moisture.

Is coolant residue present in the connector?

- **NO, moisture and coolant residue were NOT found (OK)**, then replace the following parts to close this campaign:

- 1) AEWP assembly (Page 5)
- 2) Control Harness wiring (Page 6)

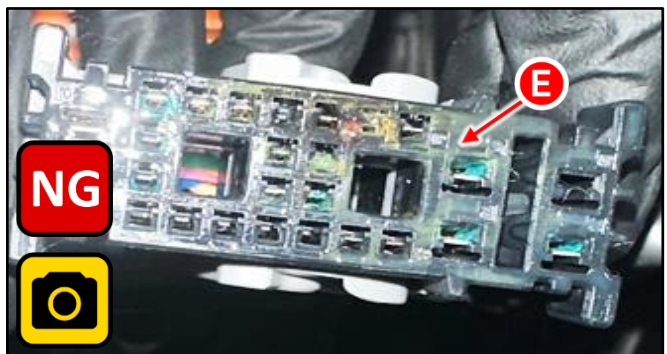
- **YES, moisture and/or coolant residue WERE found (NG)**, take a picture of the inspection area using KDS warranty attachment picture function to secure proper documentation and warranty compliance, then replace the following parts to close this campaign:

- 1) AEWP assembly (Page 5)
- 2) Control Harness wiring (Page 6)
- 3) Engine Room PCB Block (Page 5)
