SIB 17 01 24

COOLANT LEAK AT CHANGEOVER VALVE

2026-02-25

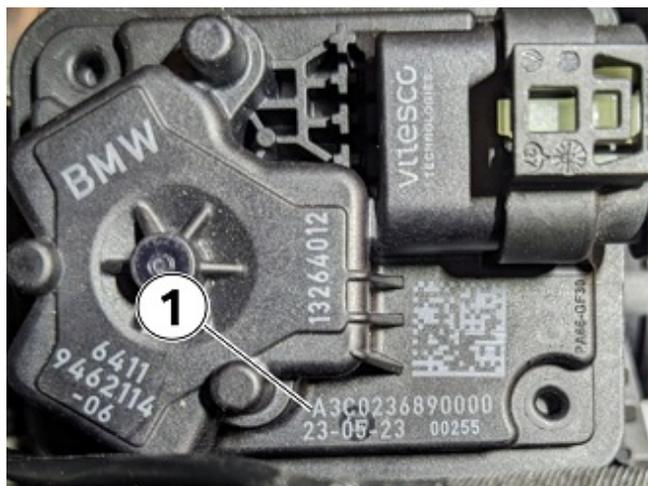
Check the production date of the remaining changeover valves (1). Improved valves were produced 18.1.2024 (January 18, 2024) and later.

Replace any* changeover valves PN 64 11 9 462 114) with a production date older than 5.1.2024 (January 5, 2024).
