SIB 31 03 26

NOISE COMPLAINT FROM FRONT AXLE WHILE DRIVING OVER ROUGH ROAD SURFACE
2026-02-23

E-Series	Model Description	Production Date
G05	X5 Sports Activity Vehicle	
G06	X6 Sports Activity Coupe	
G07	X7 Sports Activity Vehicle

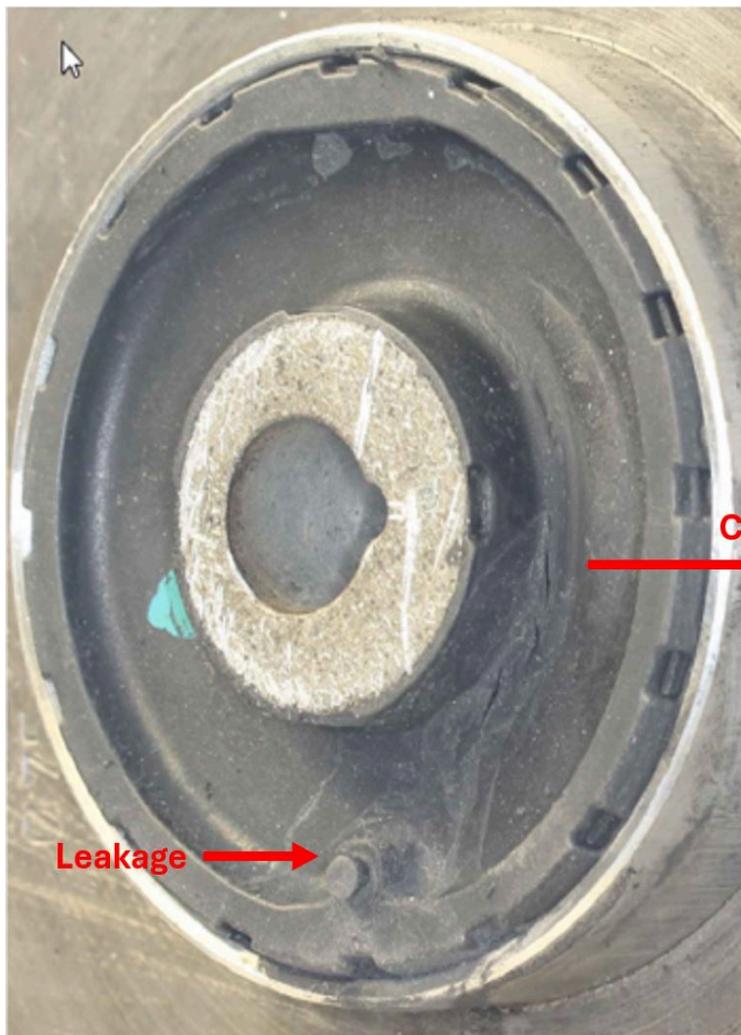
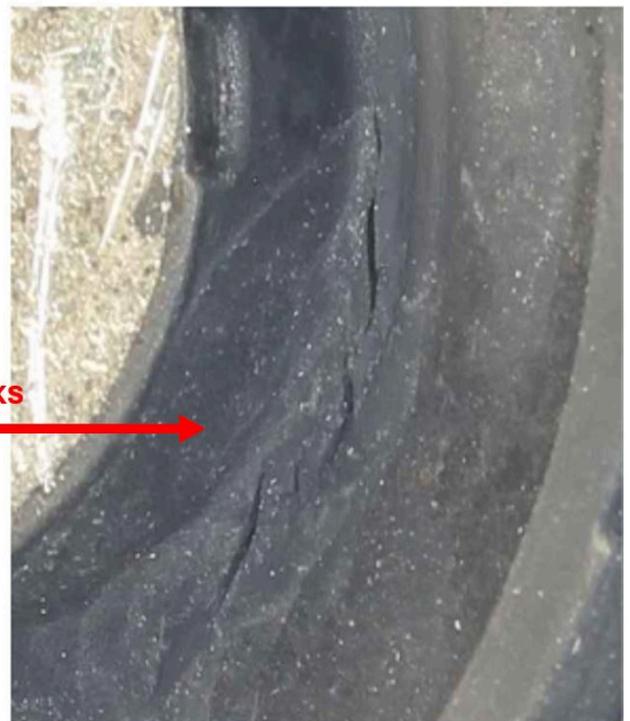
A customer may state that there is a “rattling” type of noise heard from the front axle while slow speed driving between 15 – 25 mph over rough road surfaces.

Various external influences can cause premature aging of the tension strut hydro-mount elastomer; which can lead to cracks in the material, and leakage.

Replace **both** tension struts with tension struts containing rubber conventional mounts using part numbers:
 31 10 8 864 693 Left
 31 10 8 864 694 Right

In the event of at least one defective tension strut rubber hydro-mount, replace **both** the left and right tension struts with the improved conventional rubber mounts per REP31 12 050.

A mixed installation of both variants is not allowed.
