## Rearview Camera Noise Optimization

Topic number	LI54.71-P-080180
Version	2
Function group	54.71 - Camera and radar-assisted assistance systems
Date	2/19/26
Validity	167 Facelift (GLE) with the following:  - Model Year 2024 and later (Option code 804, 805, etc...)  - Option Code 491 (Steel Spring Variant)  - Option Code 235 (PARKTRONIC with Active Parking Assist)
Reason for change	Op No/DC added

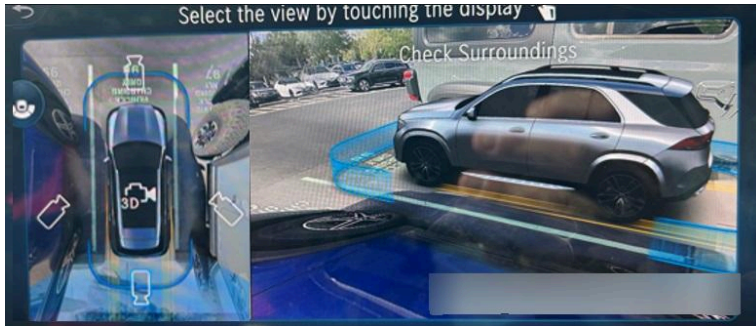
View PRIOR to SCN Coding:

**IMPORTANT:** After both control units have been SCN coded, the "Movable 3D View" feature in the head unit will no longer be available. With this change there will be two distinct differences:

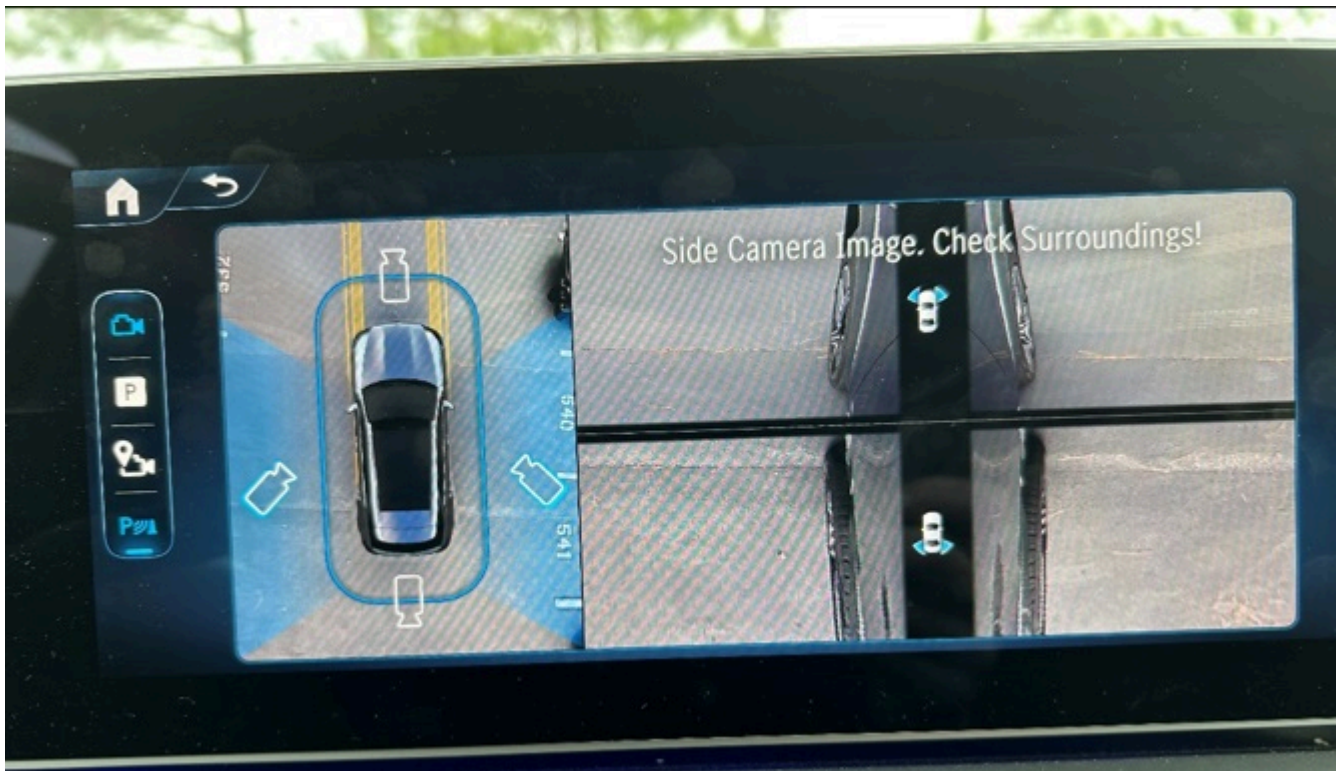
View AFTER SCN Coding:

- 1) The "3D" icon when in the top down vehicle view, will no longer be present on the head unit.
- 2) The digital rendering of the vehicle with the ability to spatially move around the vehicle is no longer possible. This view is replaced with 2D static images of the left and right sides.

- Rear camera flap when calibrating after a key cycle bus sleep will stay open to 29 MPH and then close. Will re-open, when calibrating, at 9 MPH.
- The head unit screens mentioned above appear the same as "View AFTER SCN Coding" as shown in the attachment.
