Rearview Camera Noise Optimization

| Topic number | LI54.71-P-080180 |
| Function group | 54.71 - Camera and radar-assisted assistance systems |
| Validity | 167 Facelift (GLE) with the following: - Model Year 2024 and later (Option code 804, 805, etc...) - Option Code 491 (Steel Spring Variant) - Option Code 235 (PARKTRONIC with Active Parking Assist) |

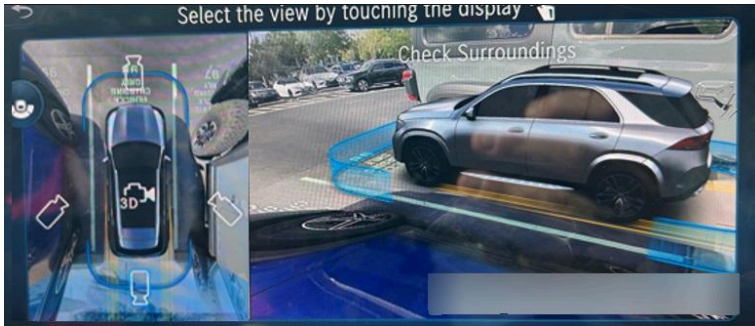
View PRIOR to SCN Coding:

IMPORTANT: After both control units have been SCN coded, the "Movable 3D View" feature in the head unit will no longer be available. With this change there will be two distinct differences:

- 1) The "3D" icon when in the top down vehicle view, will no longer be present on the head unit.
- 2) The digital rendering of the vehicle with the ability to spatially move around the vehicle is no longer possible. This view is replaced with 2D static images of the left and right sides.

Update both control units and perform on SCN coding:

- A26/17 (Head Unit)
- N62/* (PARK Control Unit)
