167 with M177 and 48V System - Yellow "Coolant" message in IC and DTC P2B2A7A The speed of the 'Coolant pump' component part is too high. A leak or defective seal was detected stored in PTCU

Topic number	LI20.00-P-080222
Version	1
Function group	20.00 - General
Date	2/23/26
Validity	Model series 167 with M177LS2 48 V prior to model year 2024
Reason for change	General revision of remedy and cause. Check of installed pumps omitted

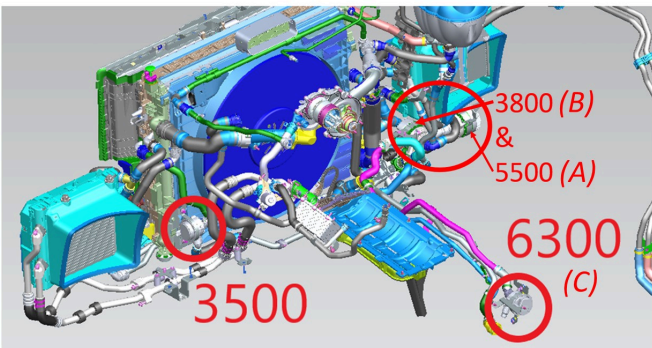
Figure 1

The fault code concerns the right rear 15 W pump on the side of the transmission (Figure 1, position C).

The fault code concerning the speed that is too high is set because of air in the system (emergency dry run function)

Air in the low-temperature coolant circuit

Check the installation position of the pumps at the front right of the low-temperature circuit (Fig. 1). Below are the correct specified part numbers at each location:

- Outer: A 000 500 5500 (Fig. 1, position A)
- Inner: A 000 500 3800 (Fig. 1; position B)
- If installation position is NOK, continue to step 4
- If installation position is OK, skip to step 7

- **NOTE:** The cooling system of the low-temperature circuit is vented in various stages. To start with, the pumps at front right are actuated at approx. 30%, then 50% and finally at 100%. At 100% actuation, the valve of the coolant circulating the pump at the side of the transmission is opened (Fig. 1; position C).

Replace the affected pump(s) (where the installed part number differs from the specified part number, see specified part number in step 3).

Vent the cooling system of the low-temperature circuit using XENTRY.
