Front Seat Ventilation Does Not Function: Observe Specified Procedure (66/25)

Model Line: **Taycan (Y1A / Y1B / Y1C)**

Model Year: **As of 2020**

Equipment: Front seat ventilation **(M-No. 4D3)**
Front seat ventilation / massage seats **(M-No. 4D5)**

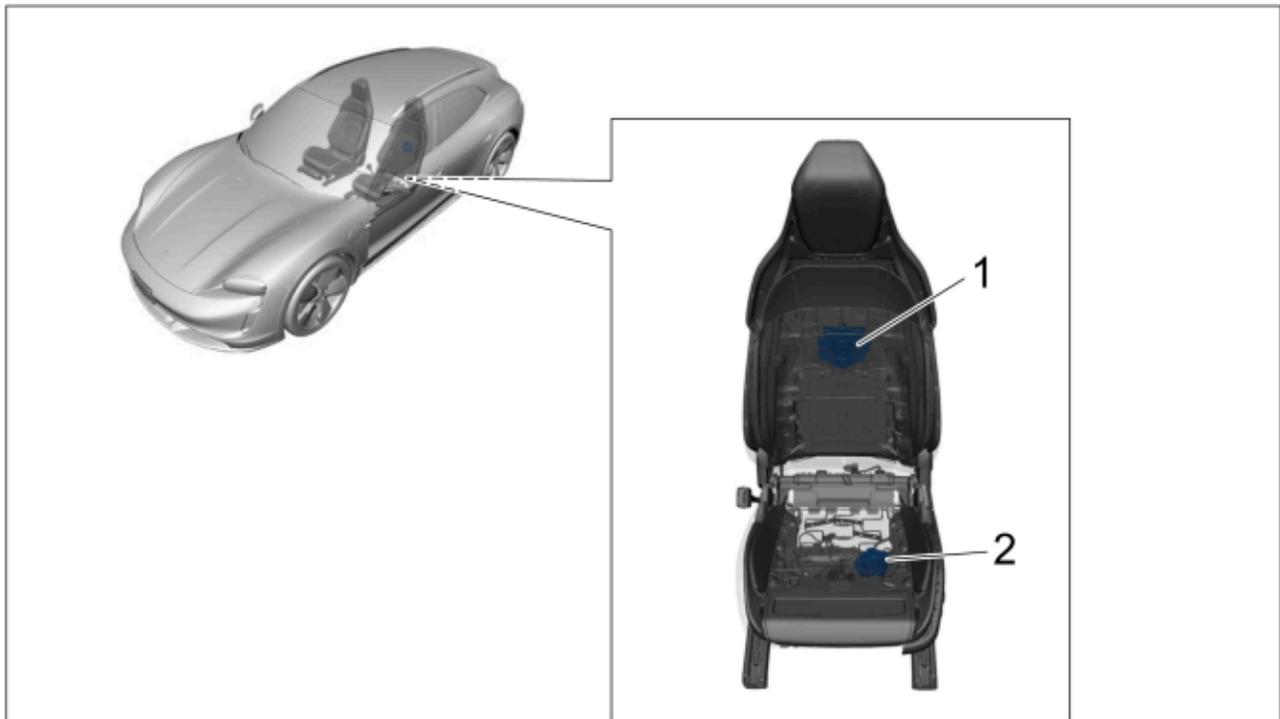
Installation location for backrest surface seat fan for and front seat surface seat fan

- 1 – Front backrest surface seat fan
- 2 – Front seat surface seat fan

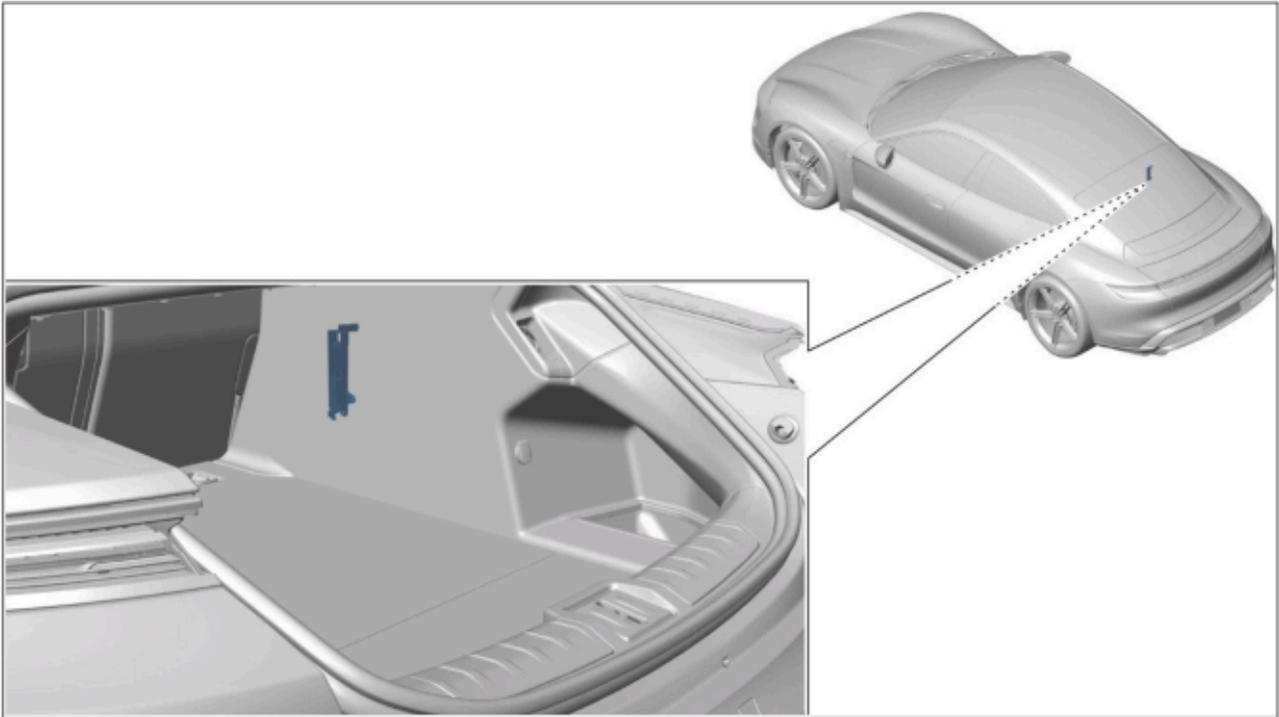
Fuse holder M

The potentially affected fuses (a total of 2 units; for front left seat ventilation and front right seat ventilation) **are located on fuse holder M, fuse position 1 (front left seat ventilation) or 2 (front right seat ventilation).**

- 1 Replace affected seat fan.
For procedure, see:
⇒ *Workshop Manual '741619A2 Removing and installing backrest surface suction fan'*
or
⇒ *Workshop Manual '740919A4 Removing and installing front seat surface suction fan'*
- 2 Check fuse for affected front seat ventilation (left **or** right) for damage and replace if necessary.

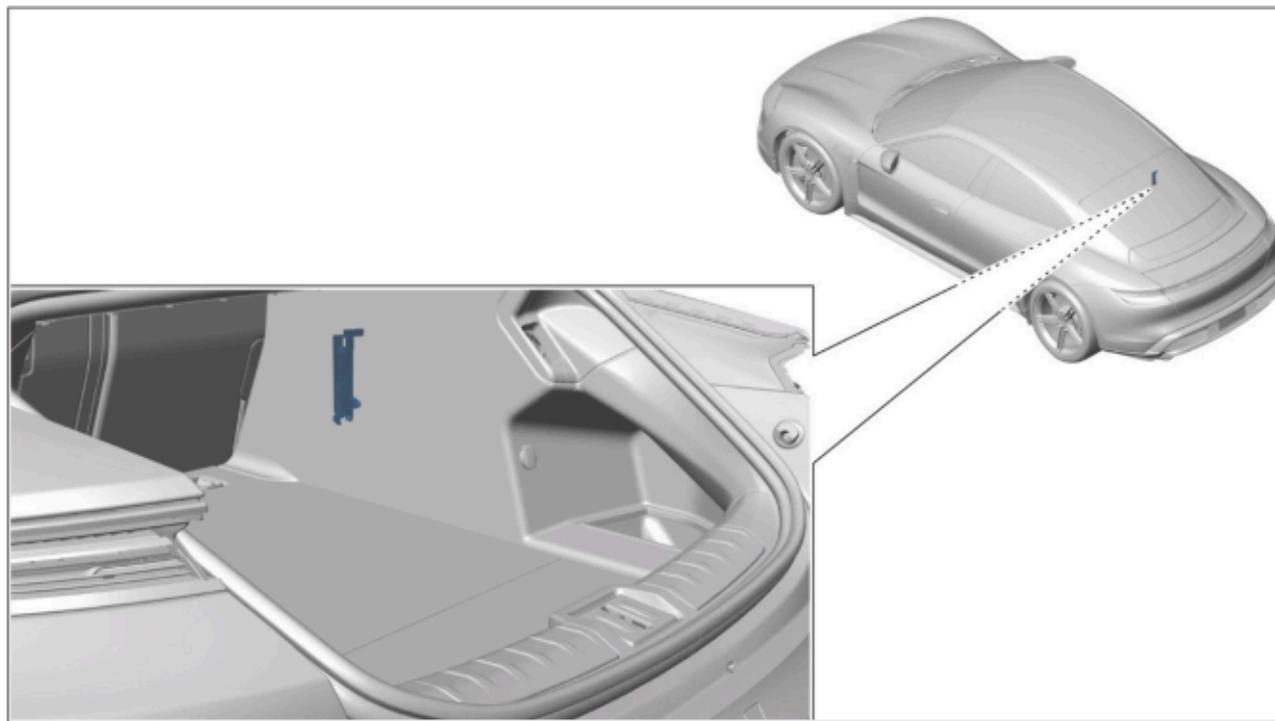
Fuse holder M

The potentially affected fuses (a total of 2 units; for front left seat ventilation and front right seat ventilation) are located on fuse holder M, fuse position 1 (front left seat ventilation), or 2 (front right seat ventilation).

- Work Procedure:
- 1 Check fuse for affected front seat ventilation (left **or** right) for damage and replace if necessary.
 - 2 Check the function of the affected seat ventilation again.
