WST8 – Reworking Rear Lid (Workshop Campaign)

Vehicle Type: **911 GT3 (992)**

Model Year: **As of 2025 up to 2026**

Concerns: **Screws on rear lid**

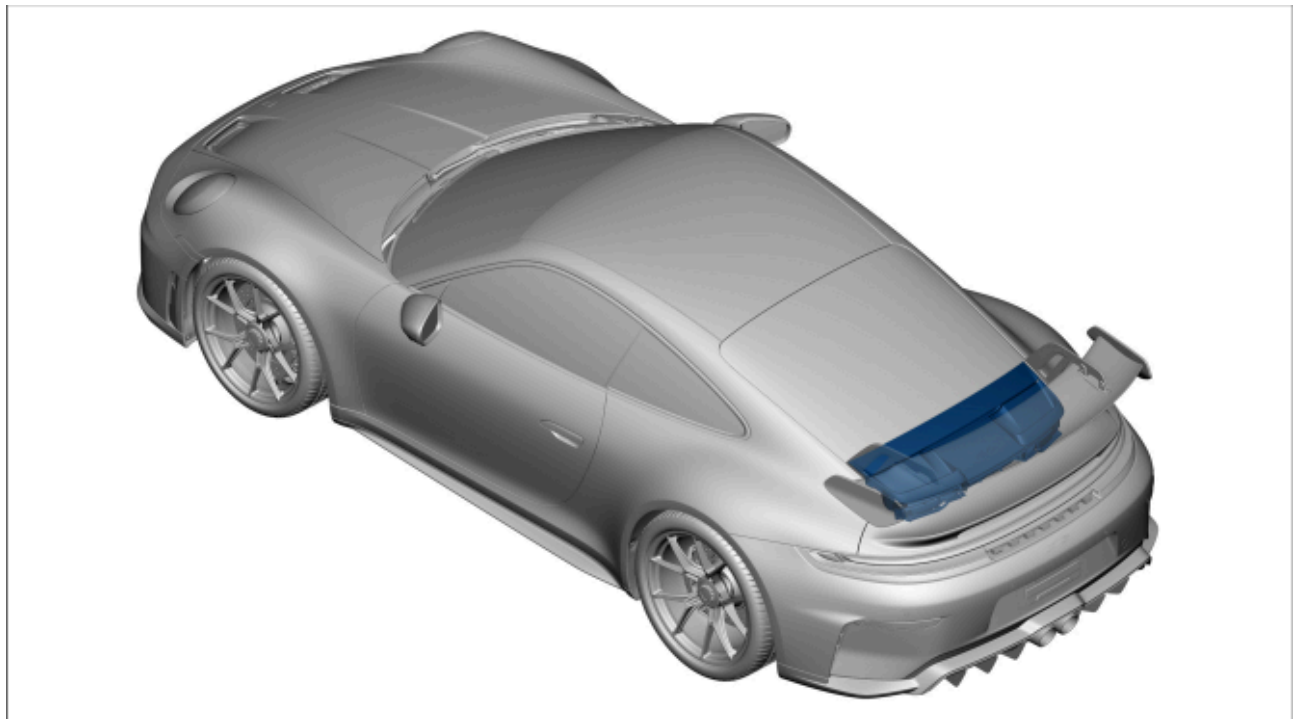
Rear lid

Cause: **There is a possibility that the fastening nuts on the rear lid on the affected vehicles have not been tightened to the specified tightening torque.**

If this is the case, this can cause noises with the rear lid while driving.

Action: Reworking rear lid screw connection
