Oil Leak Around the Oil-Filter Housing: Observe Work Procedure (173/22)

Model Line: **Cayenne (9YA)/Cayenne Coupé (9YB)**
Macan (95B)
Panamera (971)

Model Year: **As of 2017 up to 2021**

Concerns: **Oil leaks around the oil-filter housing – improved seal for the oil-filter housing available.**

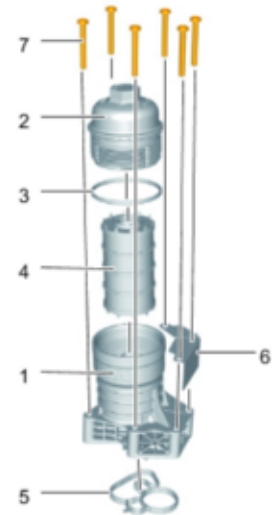
Cause: **We have discovered that the leak point is not clearly identified in some cases when the complaint “Oil leak at the oil-filter housing” is received. As a result, the oil-filter housing ⇒ Oil-filter housing (shown as an example) -1- is often replaced unnecessarily although, in most cases, it is sufficient to replace the seal ⇒ Oil-filter housing (shown as an example) -5-.**

- 1** – Oil filter housing
- 2** – Oil filter cover
- 3** – O-ring
- 4** – Oil filter
- 5** – **Seal**
- 6** – Heat shield
- 7** – Screws

If a leak is found in the oil-filter housing area, replace the seal with the improved type and check the oil-filter housing for damage.
