**WST1 - Checking Front Left Level Sensor With Linkage and Replacing if Necessary (Workshop Campaign)**

Vehicle Type: **Taycan (Y1A, Y1B, Y1C)**

Model Year: **As of 2020 up to 2022**

Concerns: **Front left level sensor**

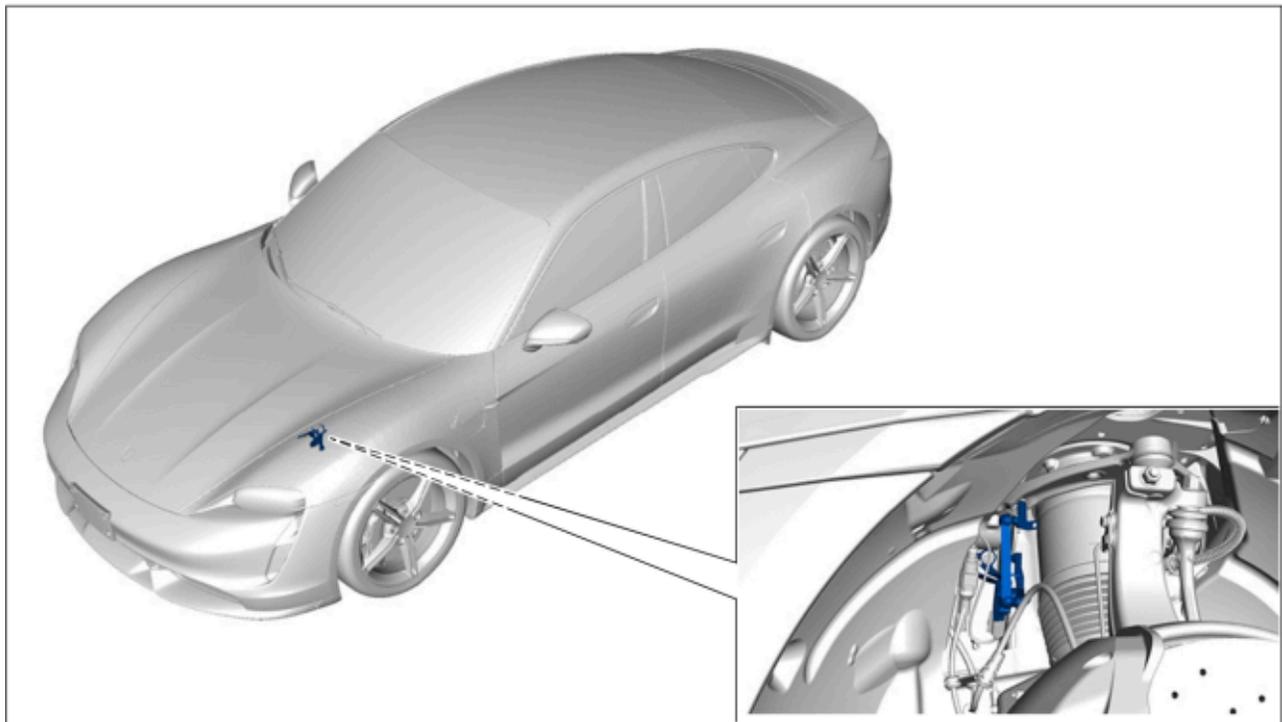
*Installation position of front left level sensor*

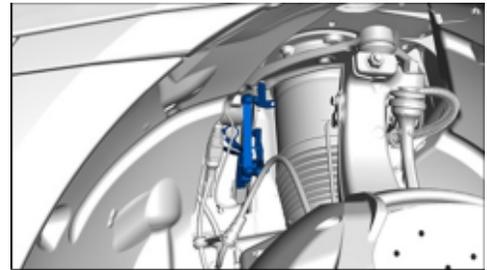
*Level sensor with front left linkage*

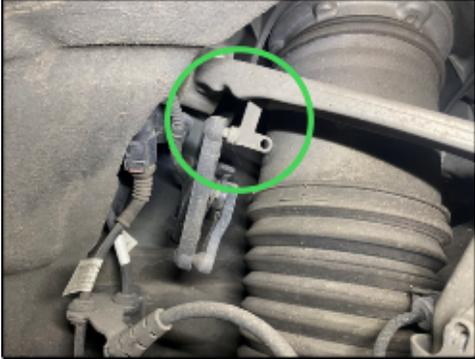
Assessment		Action
(✓)	<p>Level sensor holder has <b>no corrosion</b>.</p>

<p><b>End of action.</b></p> <p>Invoicing for <b>Scope 1</b>.</p> <p>Continue with Step 5.⇒</p>
(x)	<p>Level sensor holder has <b>corrosion</b>.</p>
