Lack of Cooling Power or Failure of Air-Conditioning System - Warning Message "High-Voltage Battery Cooling Malfunctioning" in Instrument Cluster (SY 119/25)

Vehicle Type: **911 GTS (992)**
911 4 GTS (992)

Model Year: **As of 2025 up to 2026**

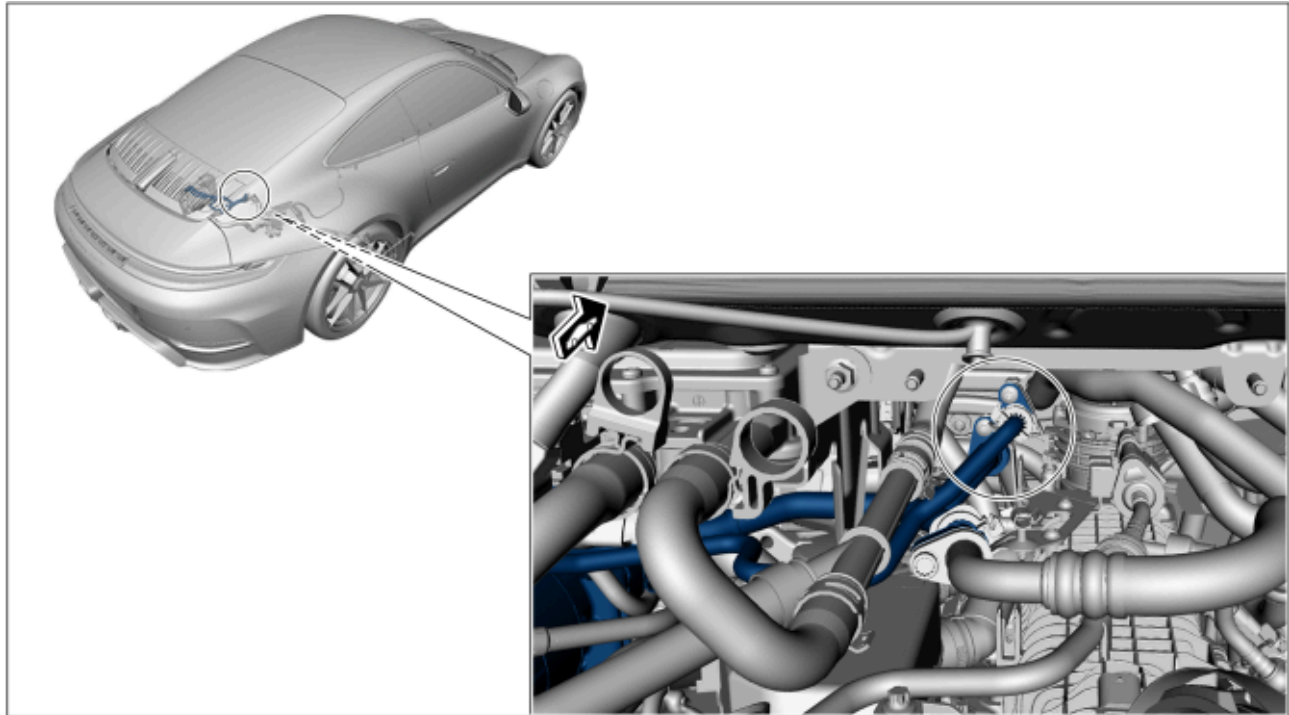
Cause: A damaged round seal at the engine compartment connection point of the refrigerant line from the air-conditioning compressor - evaporator (section from air-conditioning compressor to engine compartment connection point) and/or the refrigerant line from the air-conditioning compressor - condenser (section from air-conditioning compressor to engine compartment connection point) can cause a leak in the air-conditioning system.

Refrigerant line connection point in engine compartment

Remedial Action: Check the air-conditioning system in accordance with the Workshop Manual using a leak detector in the area of the refrigerant line connection points in the engine compartment for leaks.
If a leak is detected in the area of the connection points, replace the affected round seal.

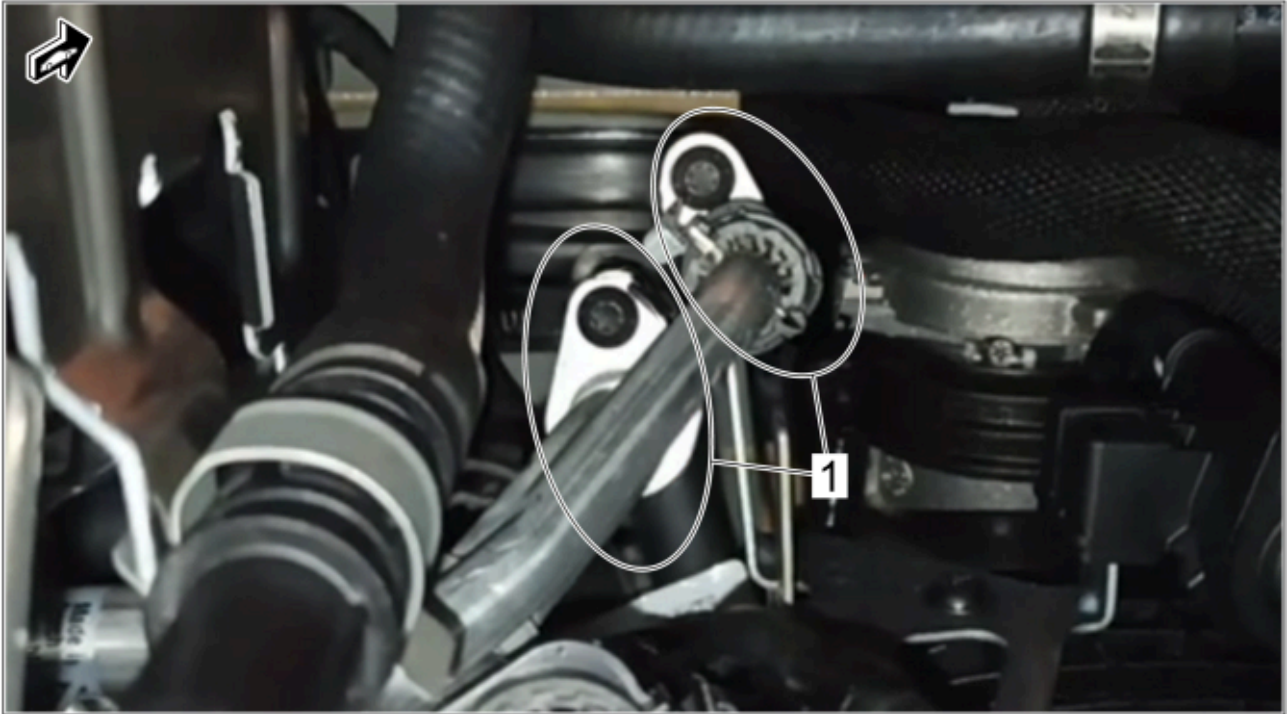
Test areas for refrigerant line connection points in engine compartment

Assessment		Action
(✓)	Both refrigerant line connection points in the engine compartment have no leaks.	Round seals on the refrigerant lines are OK. Continue troubleshooting in some other way. Continue with Step ⇒ 5.
(x)	One or both refrigerant line connection points in the engine compartment have leaks.	The round seal on one or both refrigerant lines is not OK. Continue with Step ⇒ 4.

- 4 Replace round seal of the affected refrigerant line at the refrigerant line connection point in the engine compartment.
