G2.II Panamera - Exclusive Design Taillight Faulty

Vehicles Affected

Models	Model Year	Model Type	VIN Range	Vehicle-Specific Equipment
Panamera	As of 2021 up to 2024	971	All	8VQ - Exclusive Design Taillight

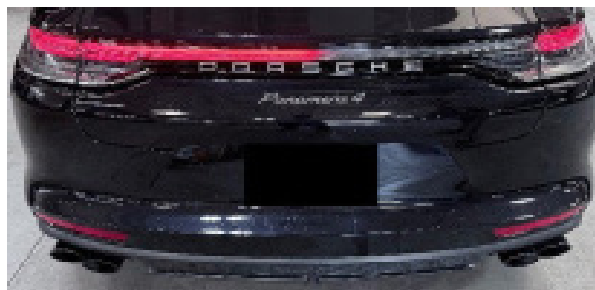
Figure 1

The customer states the taillights exhibit limited function in part (Figure 1) or in full (Figure 2), accompanied by an instrument cluster message pertaining to , "Tail light faulty".

If the condition described above is found in vehicles equipped with the Exclusive Design Taillight (I-Number 8VQ), it will be necessary to retrofit the standard taillight, as the design and shape correspond to the Exclusive Design Taillight.

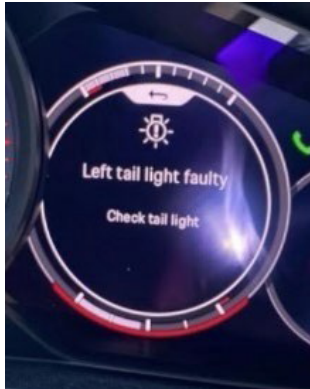
Vehicles exhibiting this condition typically display a message, "tail light faulty" as shown in Figure 3 or Figure 4. In cases where there are functionality issues in multiple tail lights, a "several rear lights faulty" display message may also be present (Figure 5).

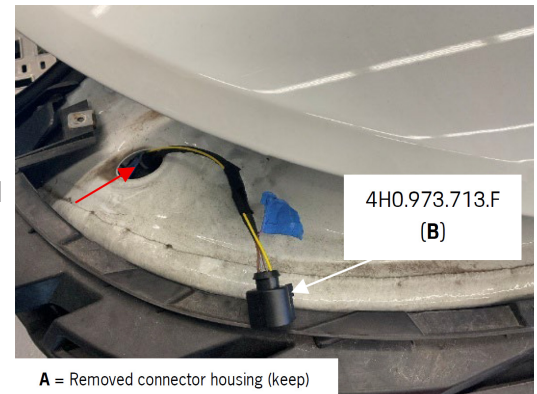
Figure 8. Passenger Taillight Area

A = Removed connector housing (keep)

1. Carefully loosen the grommet on the wire harness and slide it towards the taillight connector.
2. Carefully feed overlay wire with single-wire seal through the grommet and guide it to the taillight connector.
3. Remove pin 3 (LIN) and insulate pin using insulating tape.
4. Replace the connector housing (A) with a new connector housing B (4H0.973.713.F), keeping all pins in their original location apart from the removed LIN line. Keep A for a future step.
5. Insert overlay wire into pin location 6.
6. Move rubber plug from pin 6 to pin 3.
7. Install grommet in the body. Check that the grommet is seated correctly in body, as seen in Figure 8.

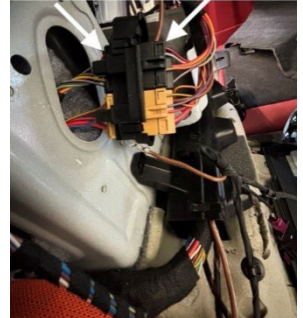
Figure 14. Driver-side C-Pillar Connector

Insert into pin location 13 on female and male connectors

1. Route overlay wire with pin contact along the wire harness to the connection point at the C-pillar.
2. Remove the black, 17-pin connector socket from the holder.
3. Insert overlay wire with pin contact into pin 13 of the black connector.
4. Continue overlay on the mating connector – Pin 13 of the black connector.
5. Lock male and female connector socket and reinstall.
