Technical Journal

Tailgate Opens While Parked

REF NO: TJ 37246.5.0	ISSUING DEPARTMENT: Technical Service	CAR MARKET: United States and Canada	
PARTNER: 3 US 7515 Polestar		ISSUE DATE: 2026-01-15	STATUS DATE: 2026-02-06
FUNC GROUP: 8327	FUNC DESC: Door operation, electrical	Page 1 of 3

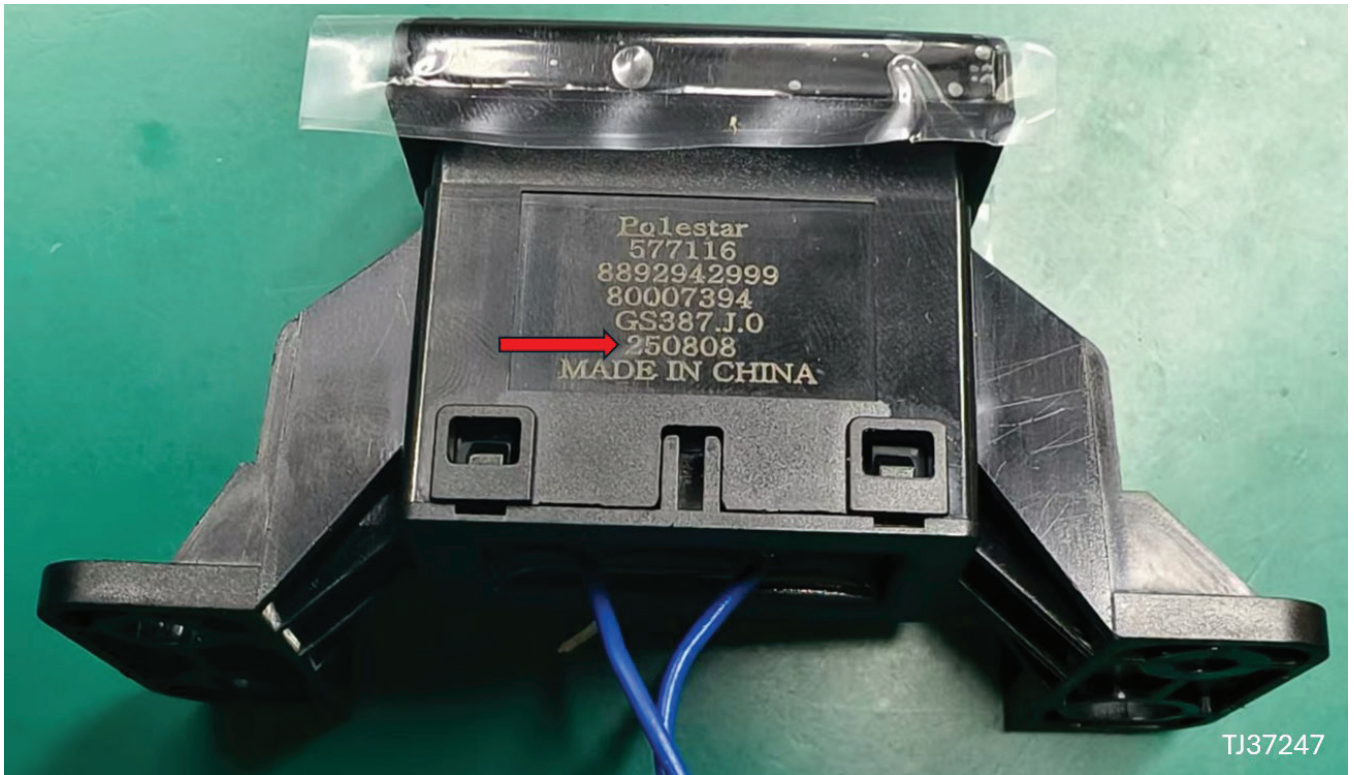
File Name	File Size
TJ37246_1.jpg	0.1557 MB

If the tailgate opens by itself while parked, follow advise under Service.

1. Follow VIDA instructions on how to dismantle the tailgate lamp (VCC-527817-1).
2. Check the wiring. If the cable is damaged or the tailgate switch batch number is earlier than 250808 (see reference TJ37247_1.jpg), replace the part.
