**Service Action SP1080: PS3 Tailgate Leakage
Model Year 2025 Polestar 3**

GROUP: 83	NO: SP1080	ISSUING DEPARTMENT: Product, Safety and Compliance	CAR MARKET: United States	
REVISIONS:			ISSUE DATE: 2026-02-13	STATUS DATE: 2026-02-18
Page 1 of 6

Title	Tailgate/trunk lid panel	Page	1 (3)
Action	Adjustment	Operation number:	99924-2

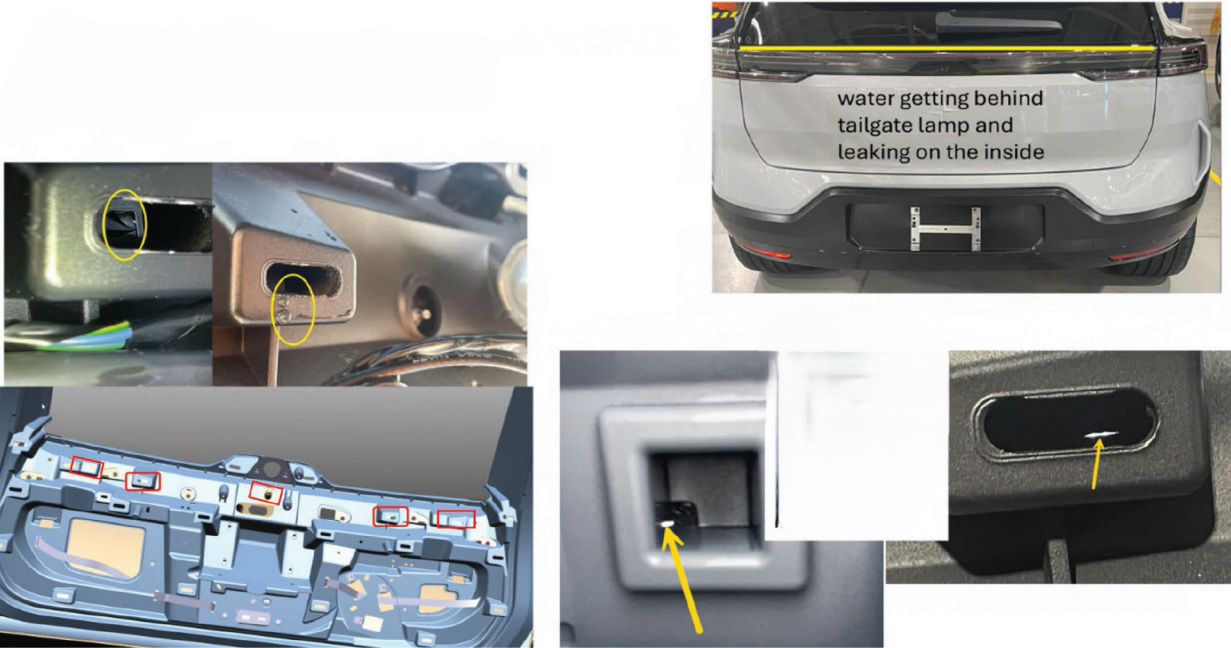
The concern with the tailgate is that 5 holes are drilled and not resealed which may cause water intrusion into the tailgate.

In the instruction inside of the cavity where it is marked for sealing, there you will see 1 drilled hole around 6mm in diameter that needs to be covered.

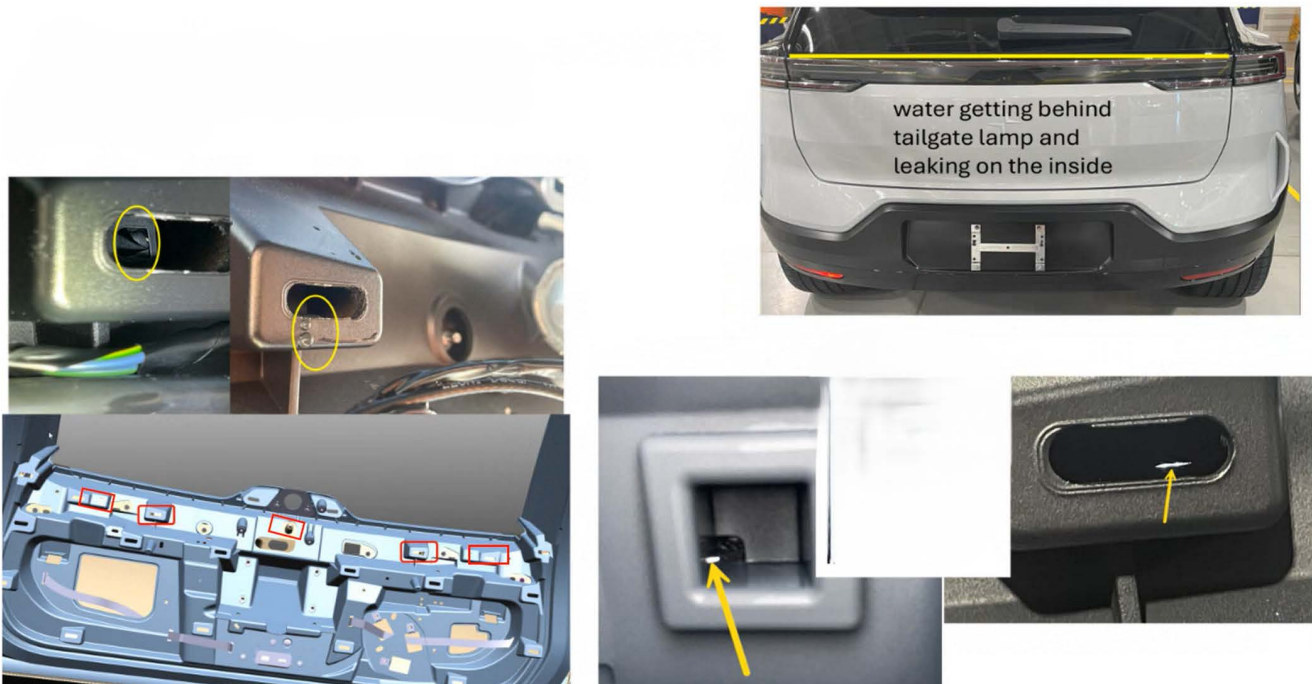
In the instruction inside of the cavity where it is marked for sealing, there you will see 1 drilled hole around 6mm in diameter that needs to be covered.
Example photos below:
