WINNEBAGO			Revel / Ekko Alternator Retrofit		
Classification		Issue Date		Number	
Technical Service Bulletin		2/19/2026		7SB002-26-01A	
Models Affected:					
Revel/Ekko with Balmar Alternators

This Technical Service Bulletin provides guidance for replacing or retrofitting the alternator on certain Winnebago Revel and Ekko motorhomes equipped with Balmar alternators. Due to higher-than-normal alternator failure rates, some owners may request a proactive retrofit. This bulletin outlines the recommended steps to support a smooth, efficient, and customer-focused service experience.

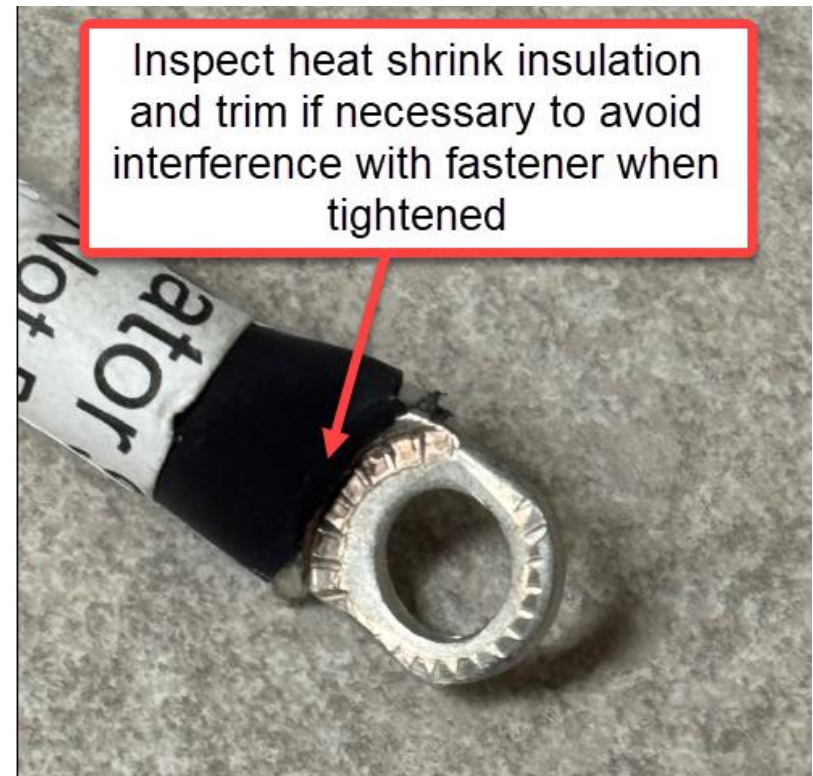
Temp sensor eyelet review.

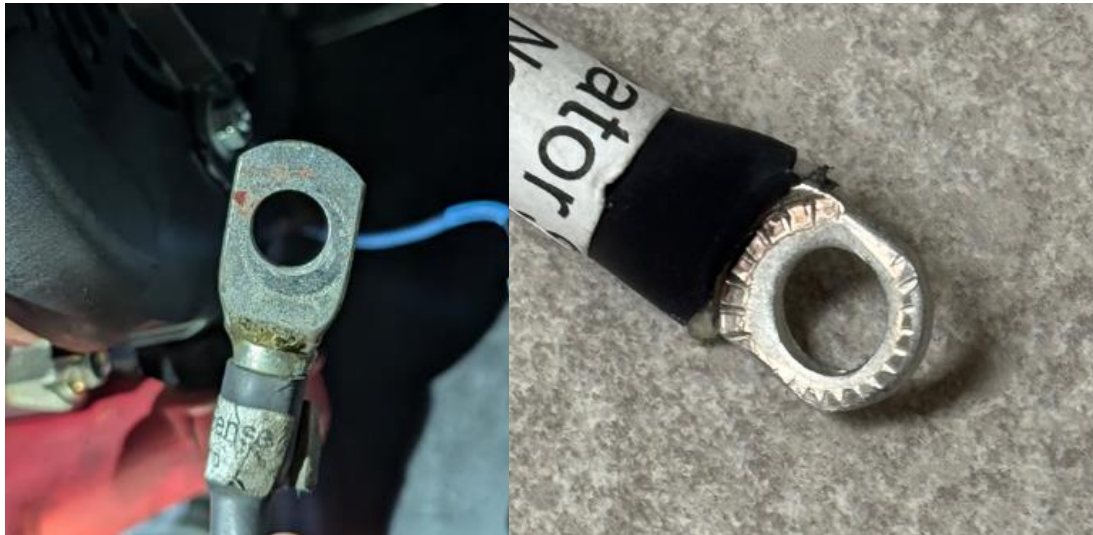
Temp Sensor Installation-Larger Eyelet

Early vendor harness the sensor is hardwired to the main harness. Left photo is larger eyelet.

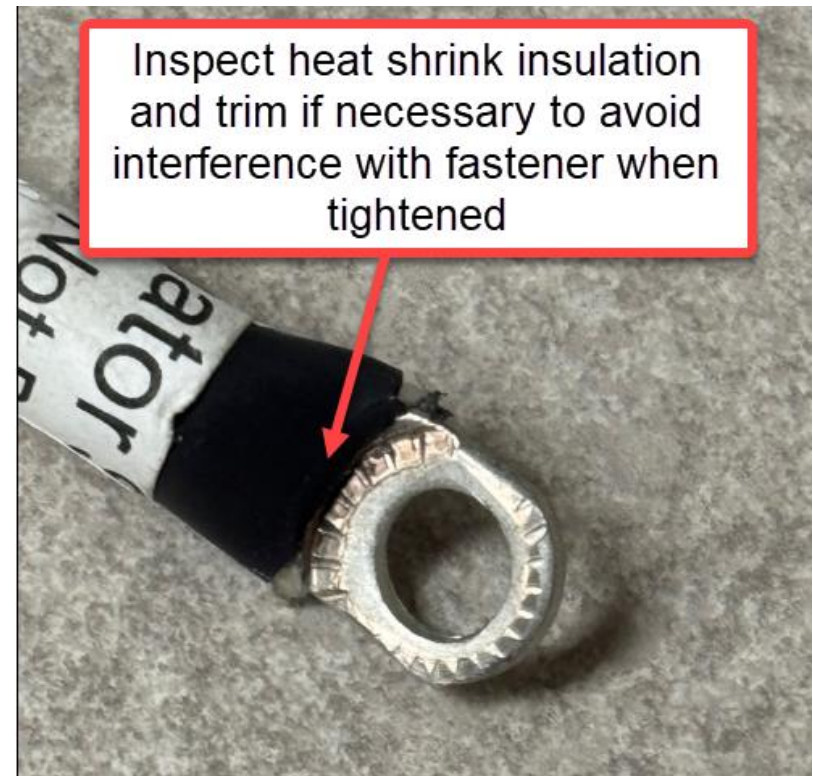
Temp sensor eyelet review.

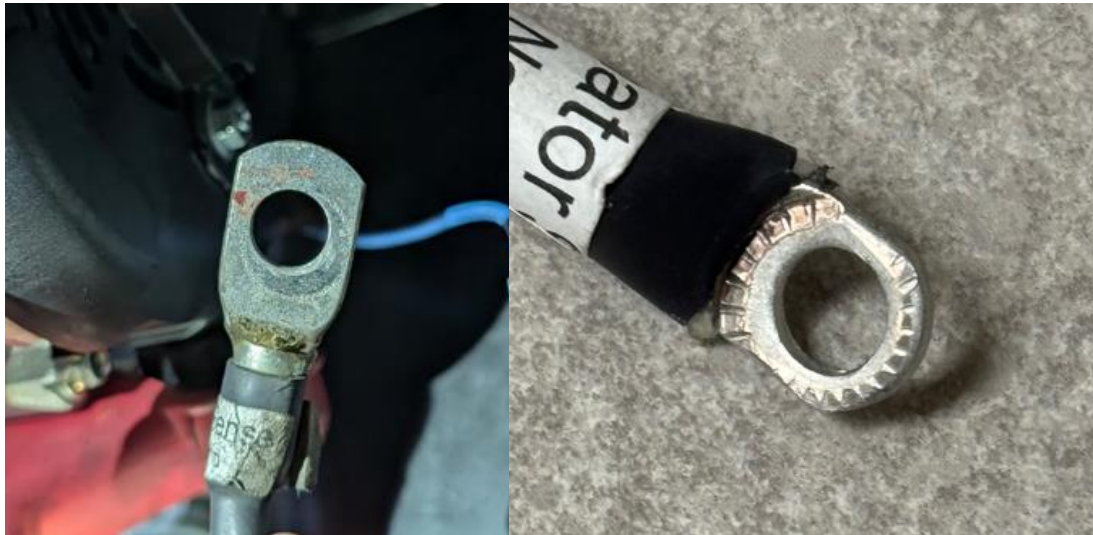
Temp Sensor Installation-Larger Eyelet

Early vendor harness the sensor is hardwired to the main harness. Left photo is larger eyelet.

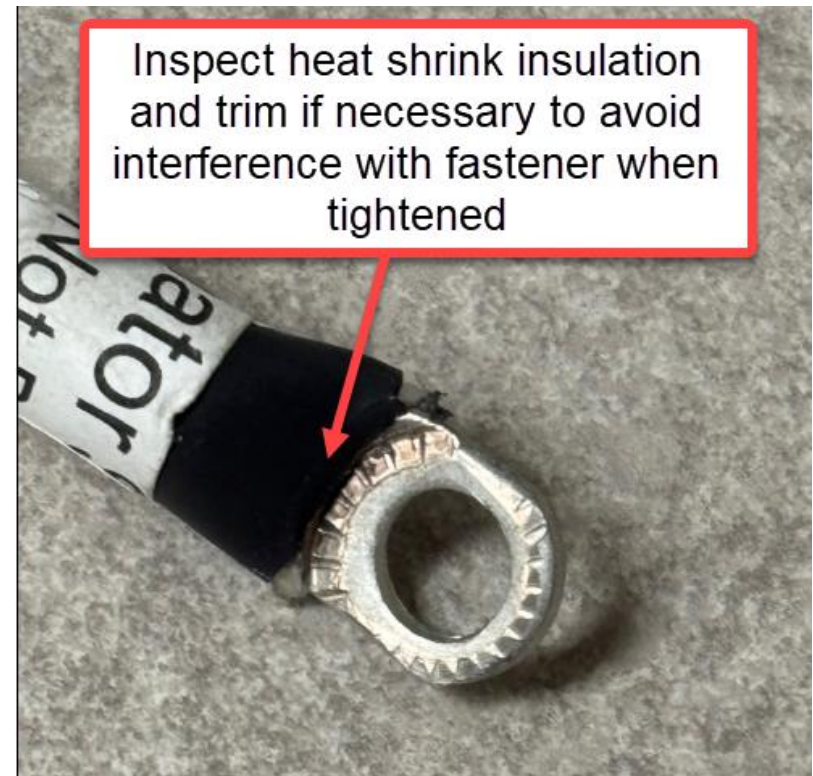
Temp sensor eyelet review.

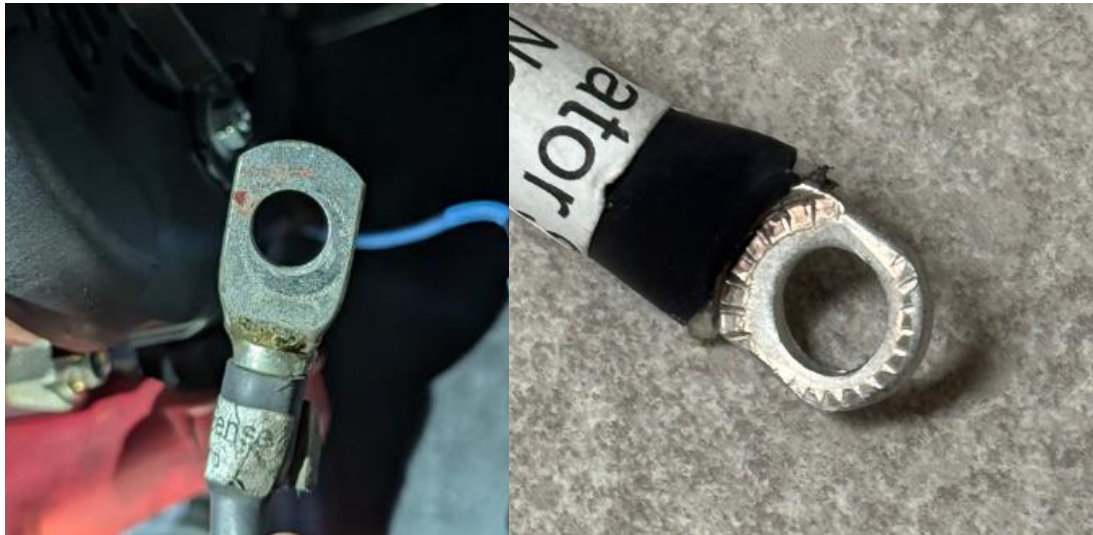
Temp Sensor Installation-Larger Eyelet

Early vendor harness the sensor is hardwired to the main harness. Left photo is larger eyelet.
