Technical Service Bulletin

Subject: GREEN RESIDUE ON OUTER SURFACE OF COOLANT RESERVE TANK	Bulletin No.: 01-005/26
	Last Issued : 02/25/2026

2024-2026 CX-90 (All)

2025-2026 CX-70 (All)

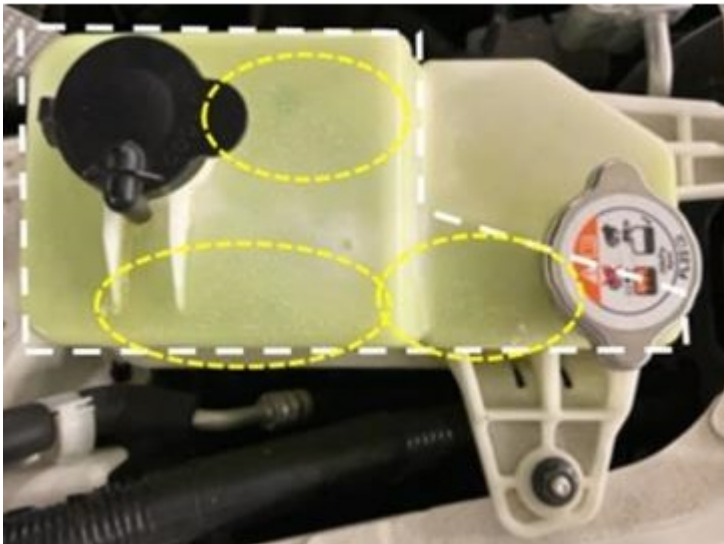
Some vehicles may exhibit green residue (yellow circle) on the outer surface of the coolant reserve tank, which appears to be coolant blowback.

This is caused by coolant seeping out and appearing as leakage from small pores (slight gaps) formed due to the deterioration of the coolant reserve tank (sub) material. To eliminate this concern, the material of the coolant reserve tank (sub) will be modified.

1. Verify the customer concern.
2. Replace the coolant reserve tank with a modified one according to the instructions in MGSS.
