Technical Service Bulletin

Mazda North American Operations
Irvine, CA 92618-2922

Subject: EXTERIOR LIGHT WARNING WITH DTC B10A3:86	Bulletin No.: 09-011/26
	Last Issued : 02/25/2026

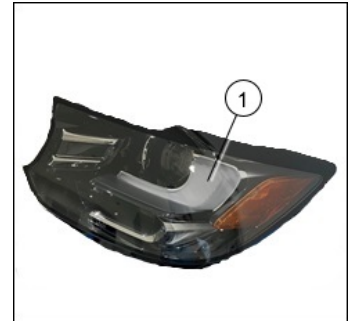
Exterior light warning light

Some vehicles equipped with the Adaptive Front lighting System (AFS) may exhibit the exterior light warning light/ exterior light warning indication on while driving or when the ignition is turned on and DTC B10A3:86 (Error signal received from swivel actuator (LH)) stored in memory.

Combination light with AFS
(1): Parking light/daytime running light (DRL)

NOTE: The combination light with AFS can be distinguished if it is equipped with the parking light/daytime running light (DRL) that illuminates while the ignition is turned on.

This may be caused by the AFS Control Module detecting a false headlight malfunction. This concern will likely occur when the light returns to the center position after swiveling. To eliminate this concern, the control software of the AFS

control module has been further modified. Customers having this concern should have their vehicle repaired using the following repair procedure.

2. Reprogram the **AFS** with the Mazda Modular Diagnostic System (M-MDS), using Mazda Diagnostic And Repair Software (MDARS). Refer to MDARS ECU Reprogramming Procedure.
