Service Bulletin

Bulletin No.: PIP6095C

Subject: 6T40 Harsh Shift into Drive

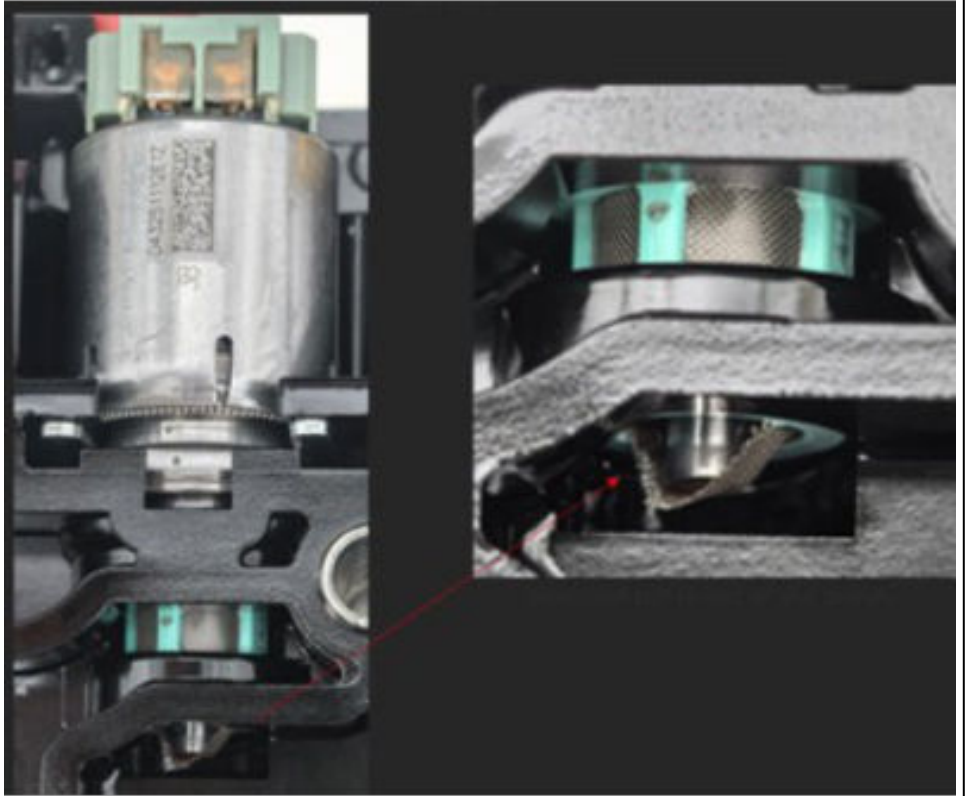
7046070

Involved Region or Country	GMNA, South Korea, China, Japan
Condition	Some customers may complain of harsh shift into drive.
Cause	<p>There may be an issue with the normally high solenoids in the control solenoid valve and transmission control module assembly (TEHCM) having a valve over travel and contact or rupture the solenoid screen as shown below.</p>

6. If the solenoid valve is found to be touching or pushing through the screen, replace the control solenoid valve and transmission control module assembly (TEHCM) and the control valve body per SI instructions.

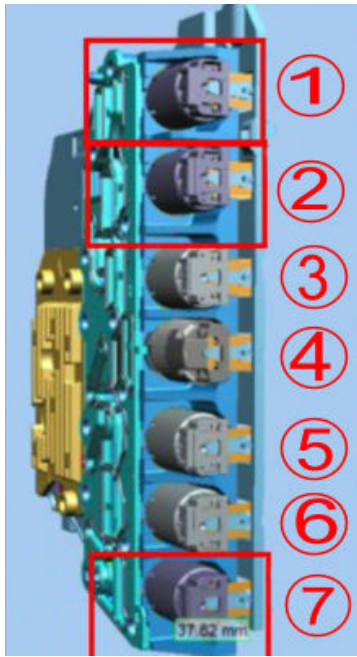
7046068

1. Verify your vehicle was built after 5/1/25. If so, your vehicle is within the suspect window.
2. Test drive to verify the customer concern.
3. If any applicable DTCs are set, root cause per SI diagnostics for your specific DTCs before moving to the following steps.
4. If no DTCs are set, start by removing the control solenoid valve and transmission control module assembly (TEHCM) from the transmission.
5. Check the below locations for the solenoid valve touching the screen as shown in the cause section.
