Service Bulletin

Bulletin No.: PIC6645

Subject: Amplifier Inoperative Due to Water Intrusion

Brand:	Model:	Model Year:		VIN:		Engine:	Transmission:
		from	to	from	to		
Cadillac	OPTIQ	2025 - 2026		SOP	October 2025	All	All

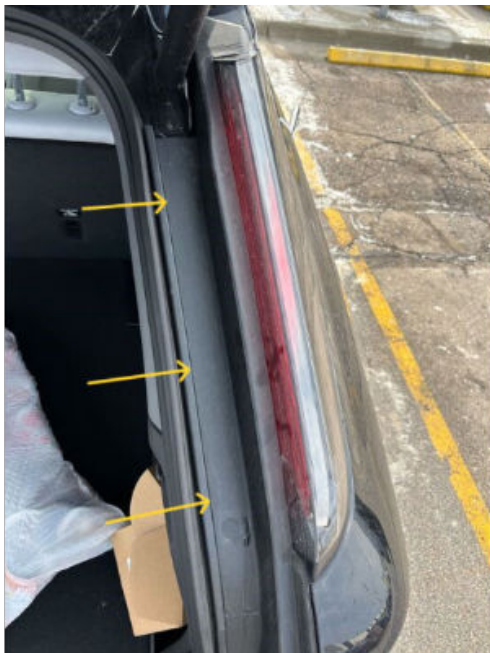
7085621

Remove trim to access body seam.

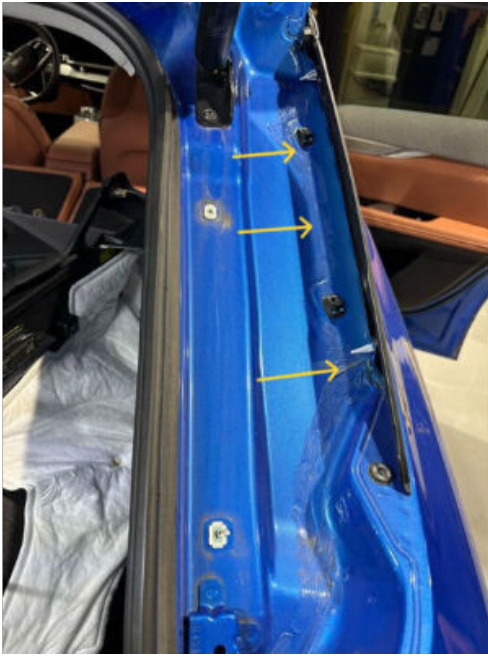
7085620

Inspect for holes or voids in the seam sealer, and bumps that do not allow the rubber locators for the taillight to sit flat.
