# Service Bulletin

Bulletin No.: PIP5927D

**Subject: Diagnostic Tips: Possible DTC P0237 P0101 P1101 P0234 or P0299 Reduced Engine Power**

Brand:	Model:	Model Year:		VIN:		Engine:	Transmission:
		from	to	from	to		
Chevrolet	Equinox	2023 - 2026		All	All	1.5 LSD	All
GMC	Terrain	2023 - 2026		All	All	1.5 LSD	All

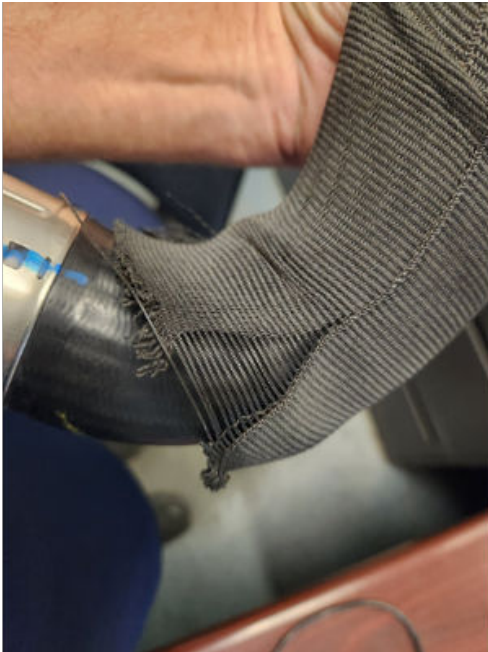
#1

Inspect the Charge Air Inlet Pipe at the Turbocharger to see if the anti-abrasion sleeve shows signs of being shredded or split.

This type of damage would allow the hose to swell under pressure damaging the abrasion sleeve and altering the readings within the boost control system or create a potential air leak.

Pictures below show damage to abrasion sleeve on Charge Air Inlet Hose.

Replace Charge Air Inlet Pipe assembly using latest parts listed in EPC.

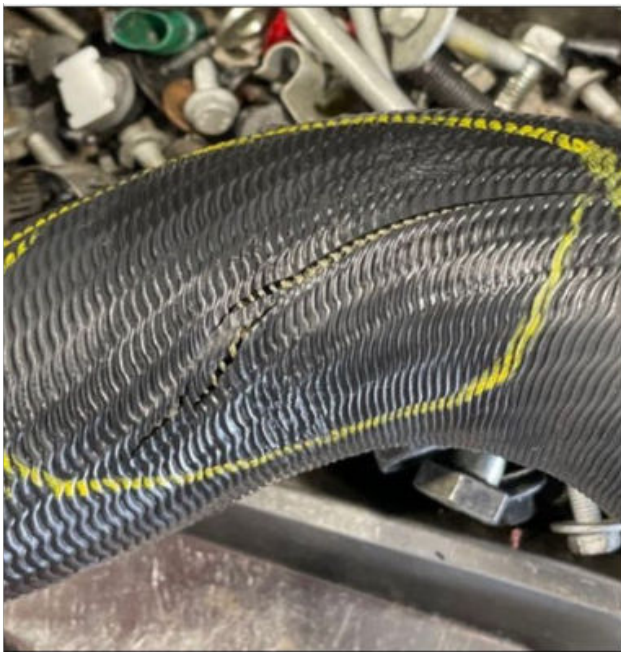
If this type of damage has been identified remove the Charge Air Inlet Hose assembly and inspect the Charge Air hose beneath the abrasion sleeve for signs of being split.

#3 Picture below inside the circled area shows damage to inner hose beneath abrasion sleeve
