**PRODUCT CAMPAIGN BULLETIN**

| <b>APPLICABILITY:</b> | 2026MY Forester | <b>NUMBER:</b> | <b>WRG-25R</b> |
| <b>SUBJECT:</b> | Safety Recall and Stop Sale: Rear Gate Stay Bracket | <b>REVISED:</b> | <b>02/24/26</b> |

Subaru of America, Inc. (Subaru) has initiated a safety recall for certain 2026 model year Forester Vehicles to replace the rear gate stay and bracket.

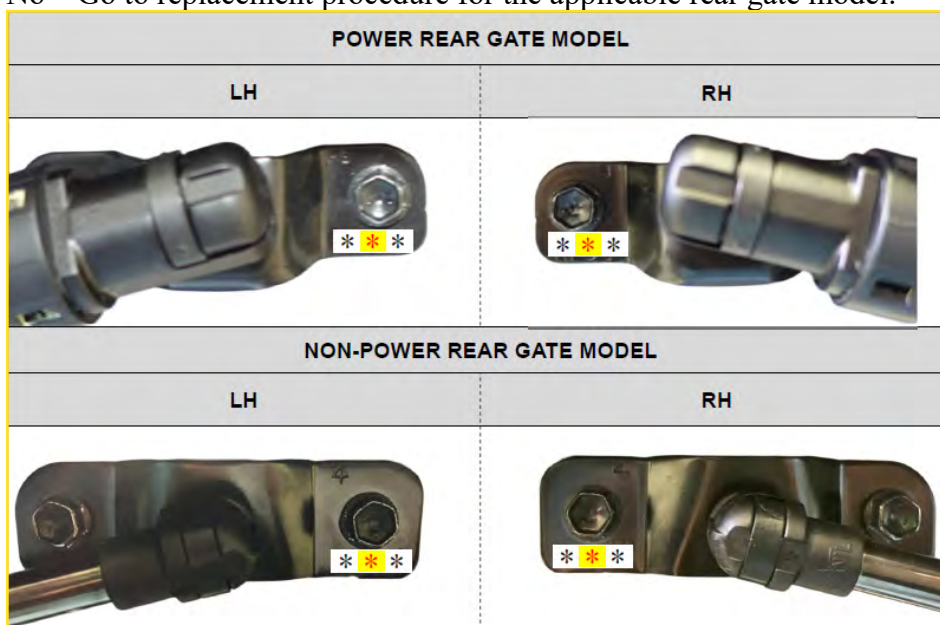
**Step 3)** Inspect rear gate stay bracket identification mark to ensure it is correct for rear gate model.

Check the middle digit of the identification mark:

The middle digit will be either P or N. P brackets are for power rear gates, and N brackets are for non-power rear gates.

No – Go to replacement procedure for the applicable rear gate model.
