ID # CBR-439

Volvo Chassis - Water leaking Around The Windshield - Model Year 2018 and Newer

Vehicles with the 2018 body update may experience water leaks around the windshield.

Volvo Chassis - VN

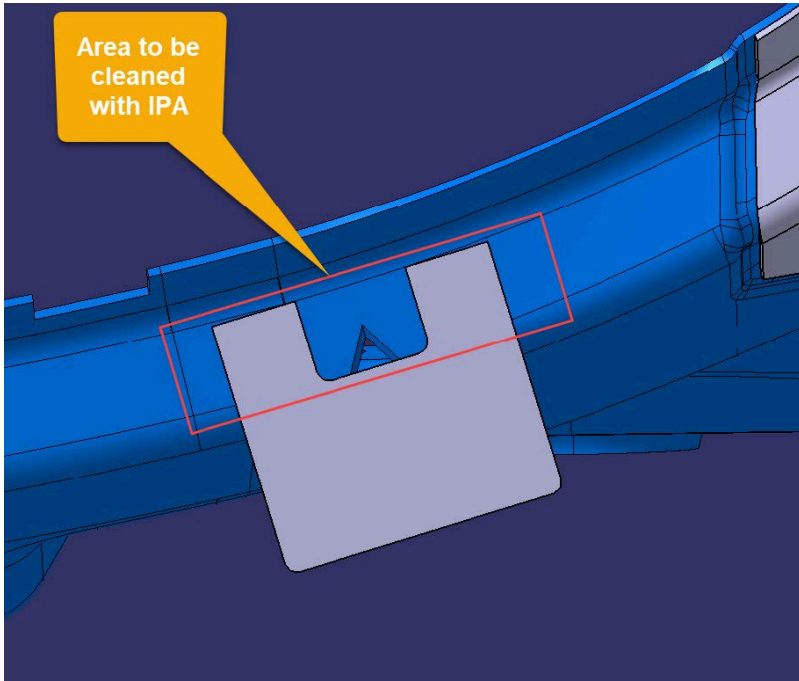
It has been found that the hood may not properly deflect water away from the "bird-beak" openings around the windshield opening.

Two flaps (**PN 78565353**) are required per vehicle, and they are to be positioned at the bird-beak drain features at the lower corners of the windshield opening. The bonding area on the BIW is to be cleaned with isopropyl alcohol prior to attaching the flaps.
