## Technical Service Bulletin

### 91X4 UPDATE

### MMI Software Update – (pre-requisite to Compliance Recall 90TV)

**Applies to ALL vehicles with recall 90TV showing open in ELSA/Elsa2Go, regardless of warranty status.**

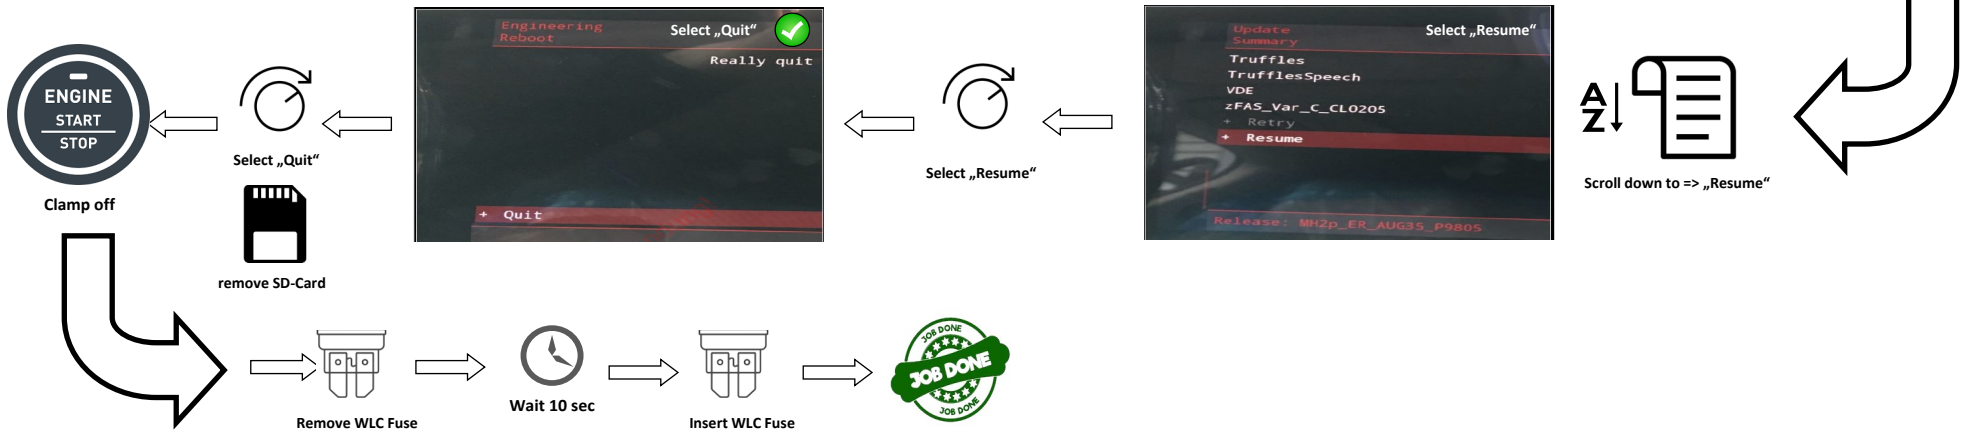
Error 33: AMP\_BAO\_D5

**Error 33: AMP\_BAO\_D5**

remove fuse of the Wireless Charger "recharger 1 for mobile end device" ---  
 > Repair Instruction --> circuit diagram --> fuse point of installation

In case of the A8 it is also necessary to remove the rear Wireless Charger fuse "recharger 2 for mobile end device". The fuse is located at the rear left trunk position --> Repair Instruction --> circuit diagram --> fuse point of installation

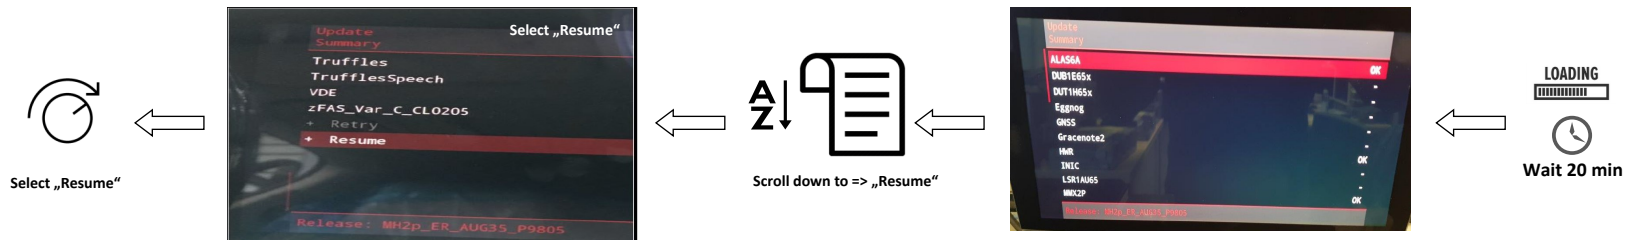
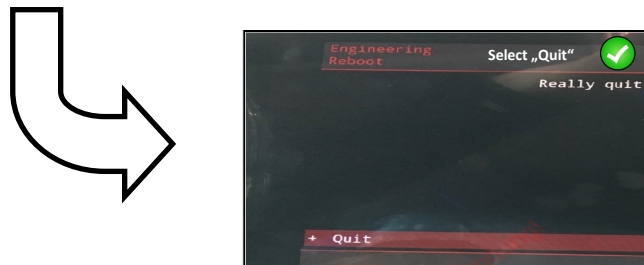
Error 33: PChargeF or PChargeR

Error Case 33 "PChargeF" = wireless charger front  
 Error Case 33 "PChargeR" = wireless charger rear

remove fuse of the Wireless Charger "recharger 1 for mobile end device" ---

In case of the A8 it is also necessary to remove the rear Wireless Charger fuse "recharger 2 for mobile end device". The fuse is located at the rear left trunk position --> Repair Instruction --> circuit diagram --> fuse point of installation

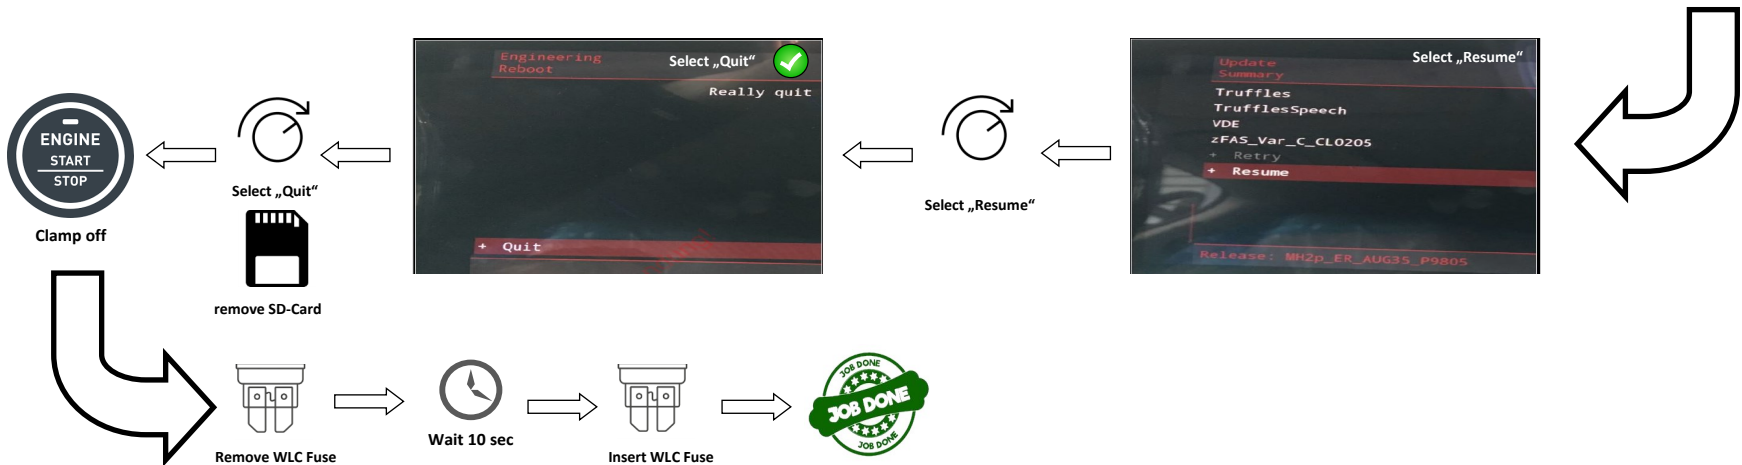
Error 128: zFAS\_Var\_C\_CL0205...

Note: This step is only necessary if Error 128 on Block 41 occurs!

remove fuse of the Wireless Charger "recharger 1 for mobile end device" ---

In case of the A8 it is also necessary to remove the rear Wireless Charger fuse "recharger 2 for mobile end device". The fuse is located at the rear left trunk position --> Repair Instruction --> circuit diagram --> fuse point of installation

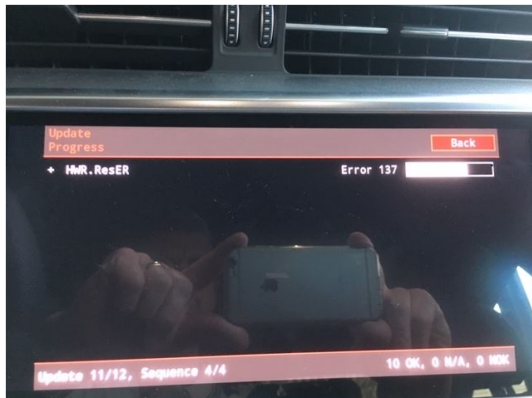
Error Case 137: HwR.ResER

The update medium has not been completely copied and / or there is a functional defect within the SD card!

Repair: Please generate or order a new SD card (max. 32 gb) include the software and continue the update with the new Sd card.
