## Technical Service Bulletin

Transaction No.: **2070110/7**

93 e-tron Mandatory work steps when replacing charging socket UX4/UX5 e-tron - NTC  
to PT1000 Charging socket e-tron OBC

Release date: Feb 27, 2026

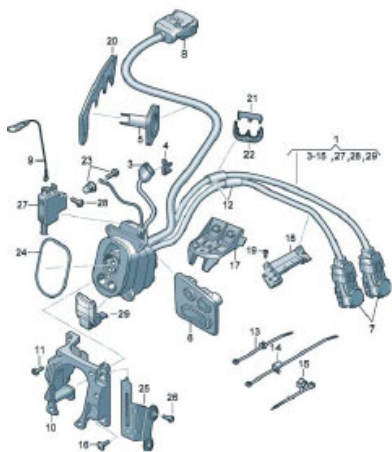
**Figure 1.** High-voltage wiring harness for charging socket.

The High Voltage Wiring Harness for the charging socket UX4 or UX5 is replaced as part of any repair work (Figure 1).

It is essential to check the part number of the removed original high-voltage wiring harness and of the new replacement high-voltage wiring harness.

If the high-voltage wiring harness for the charging socket is replaced as listed in Table 1.2, an SVM code will need to be performed, *and a replacement test plan performed.*
