Condition

Model(s)	Year(s)	VIN Range	Vehicle Specific Equipment
A6 Sportback e-tron, S6 Sportback e-tron, Q6 e-tron, Q6 Sportback e-tron, SQ6 e-tron, and SQ6 Sportback e-tron	2025	All	Not applicable

The electric charging flap does not open or cannot be closed.

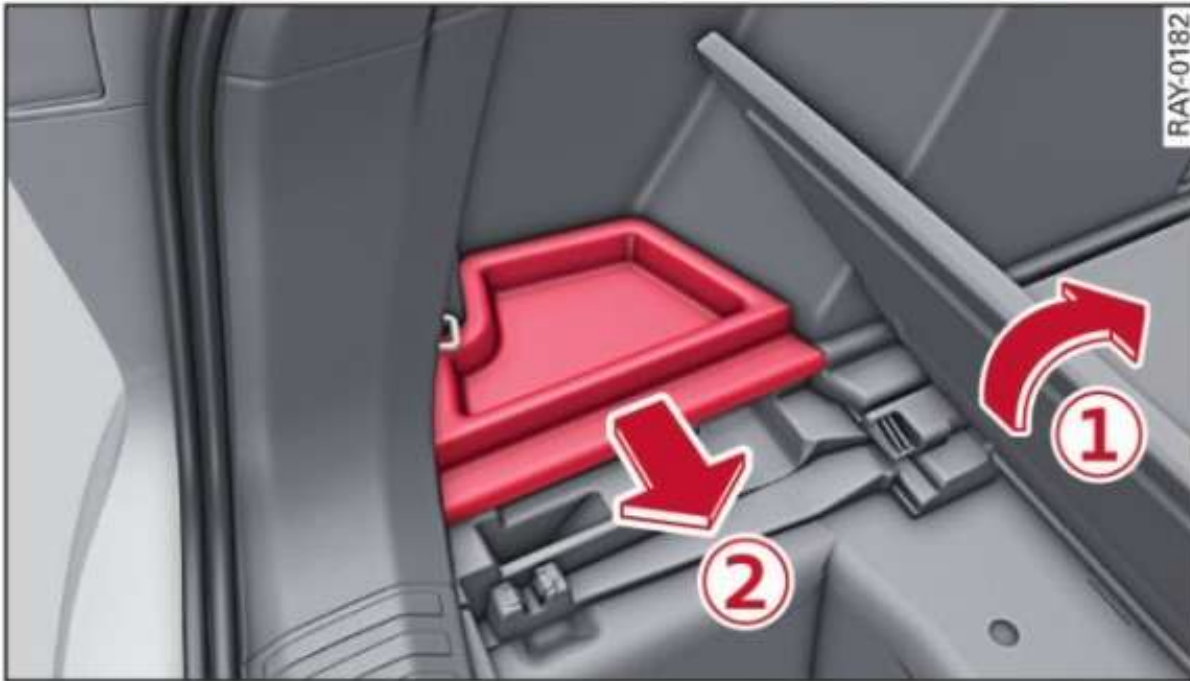
Figure 1: Fuse carrier cover.

- If the charging flaps are not in the closed position, push them carefully into the end position.
- Open the cover on the left in the luggage compartment to access the fuse carrier (see Figure 1).
- Remove the charging flap fuses (39, 43) for about 10 seconds (see Figure 2).
- Refit the fuses and close the fuse holder cover.
- Check whether the charging flap works.

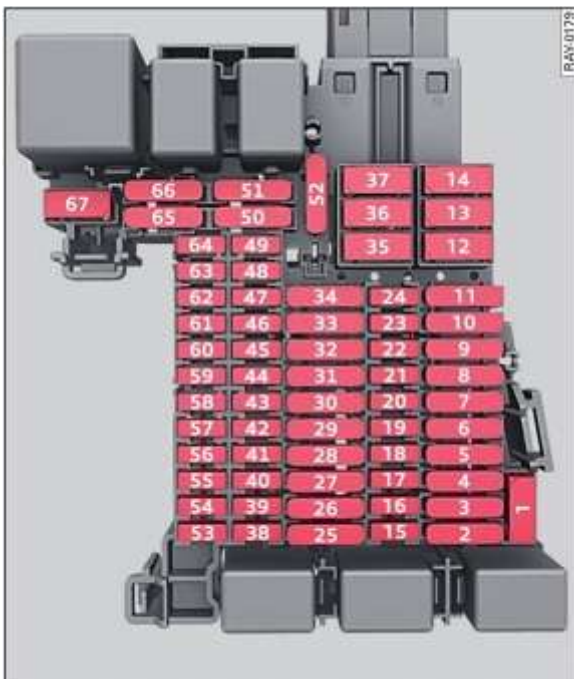
Figure 2: Fuse carrier.

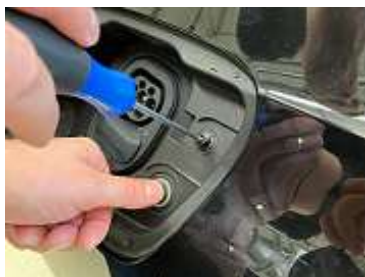
Improper use may cause the actuator to be locked even though the charging flap is not closed. In this case, it can be released using the following procedure (see Figure 3 and attached video):

Figure 3: Releasing actuator.

- Use a screwdriver to carefully push in the actuator signal pin as far as it goes.
- Then press the button on the button module for approx. 2 seconds and release the button again.
- The actuator will be unlocked.
- Remove the screwdriver.
- Carefully push the charging flap into the end position.
- Check whether the charging flap works.
