Model(s)	Year(s)	VIN Range	Vehicle Specific Equipment
A5, S5 (FU), A6 Sportback e-tron, S6 Sportback e-tron, Q5 Sportback, SQ5 Sportback (GU)	2025	All	Not applicable

The rear lid does not close and opens again.

<b>Claim Comment:</b>	As per TSB 2080959/1

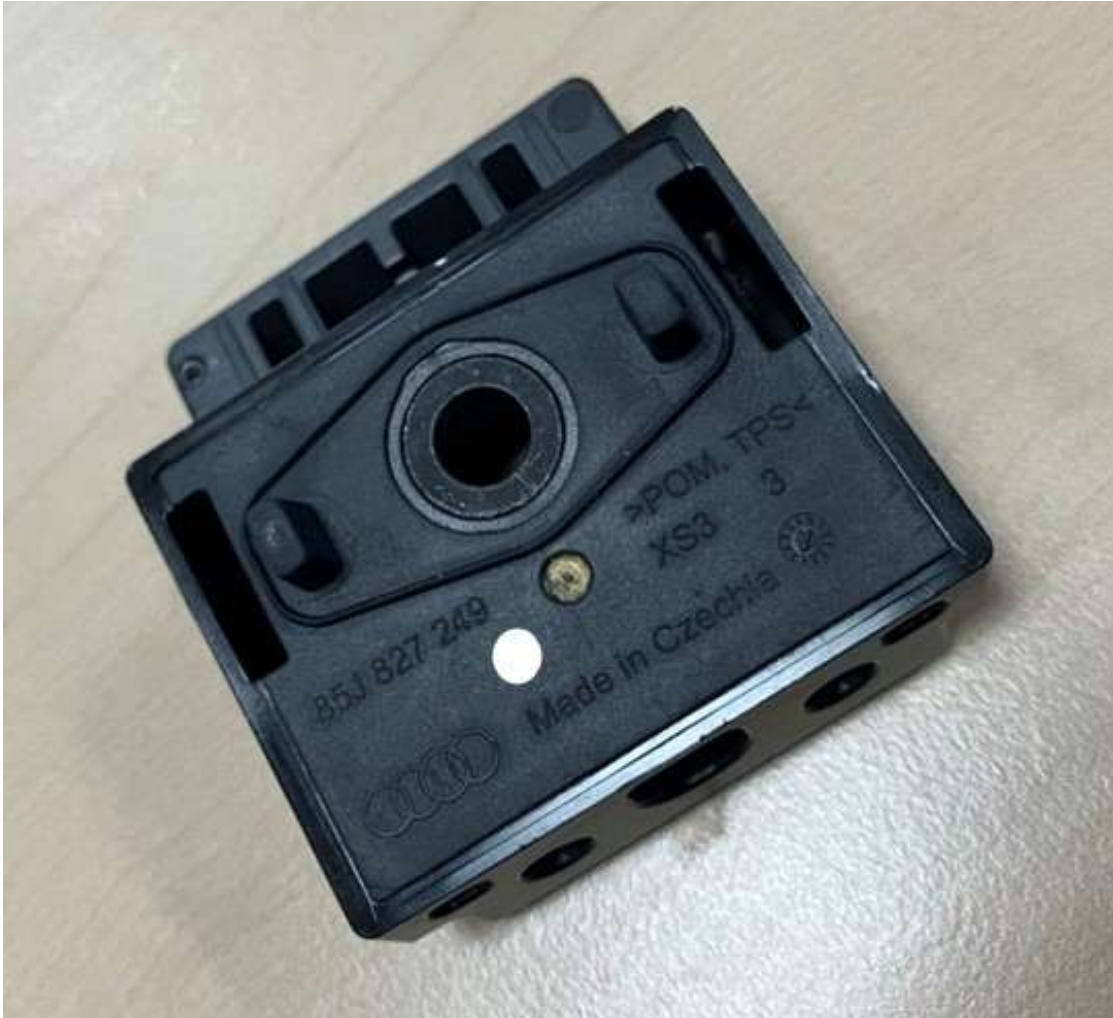
The control unit detects excessive force at the bump stops.

Make sure the new side bump stop (see Figure 1) with part number 85J 827 249 A is fitted on the vehicle. The spring preload is reduced on this part. If the old bump stop 85J 827 249 is fitted on the vehicle, replace it with the new bump stop with index A.

In autumn 2025, optimized buffers were already installed in vehicles that did not yet carry an index A. This buffer can be identified by a white dot on the back. These buffers can also remain fitted in the vehicle.

**Figure 1.** Example of an acoustic buffer with optimized spring without index A marked by a white dot.

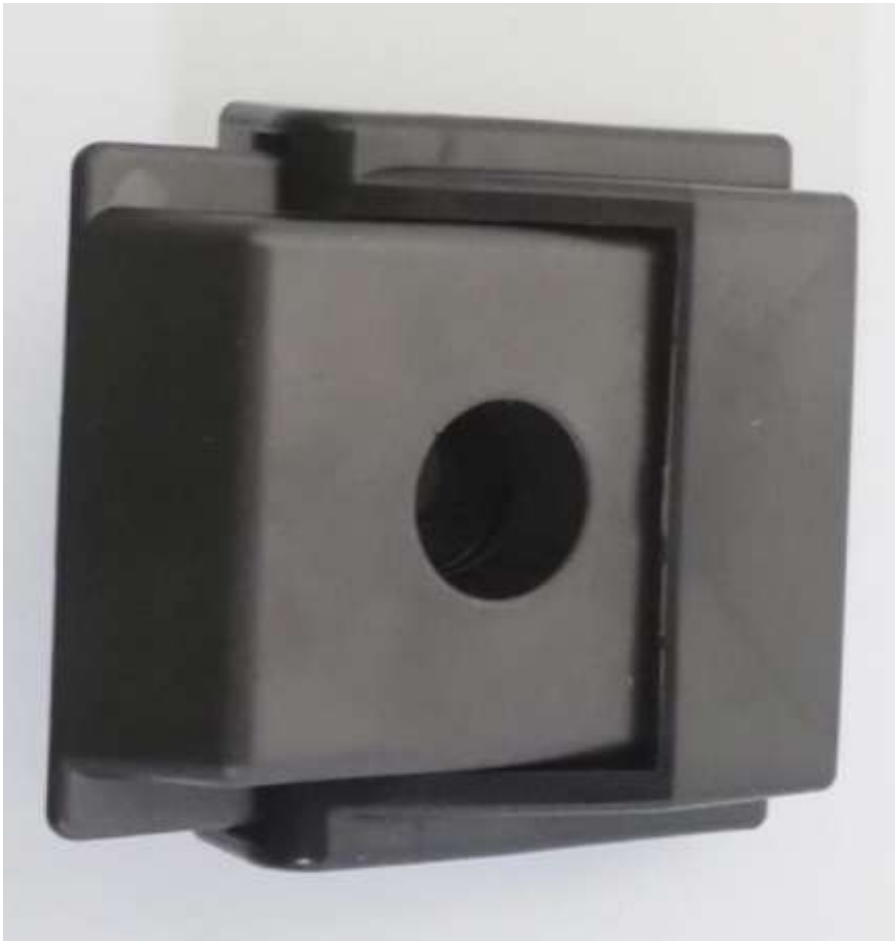
**Figure 2.** Pre-tensioned bump stop.

- Remove the side bump stops (pre-tensioned spring buffers, see image 2). Using the Workshop Manual, spring force gauge VAS 895 035 and measurement film VAS 895 037, adjust the buffer forces of the rear lid bump stops to between 40 N and 60 N and then refit the bump stops. Alternatively, you can leave the side bump stop installed and set the buffer forces to the lower limit of 40 N. Please also observe the Special Technical Service Training video on the spring force gauge VAS 895 035 in the Audi Knowledge Tank (AKT). In addition, make sure that the striker is positioned correctly and enters the lock in the center. Incorrect positioning can also cause the rear lid to reverse direction. **NOTE:** If your vehicle is not equipped with side bump stops (see image 2), please start from the point: “**Adjusting buffer forces using spring force gauge VAS 895 035**”.
