ID # CBR-2514

Lost Communication to Alternator Message - DTC C103508

This procedure provides a temporary corrective action for the “Lost Communication to Alternator” message and Vehicle Master Control Unit (VMCU) DTC C103508 caused by a software issue.

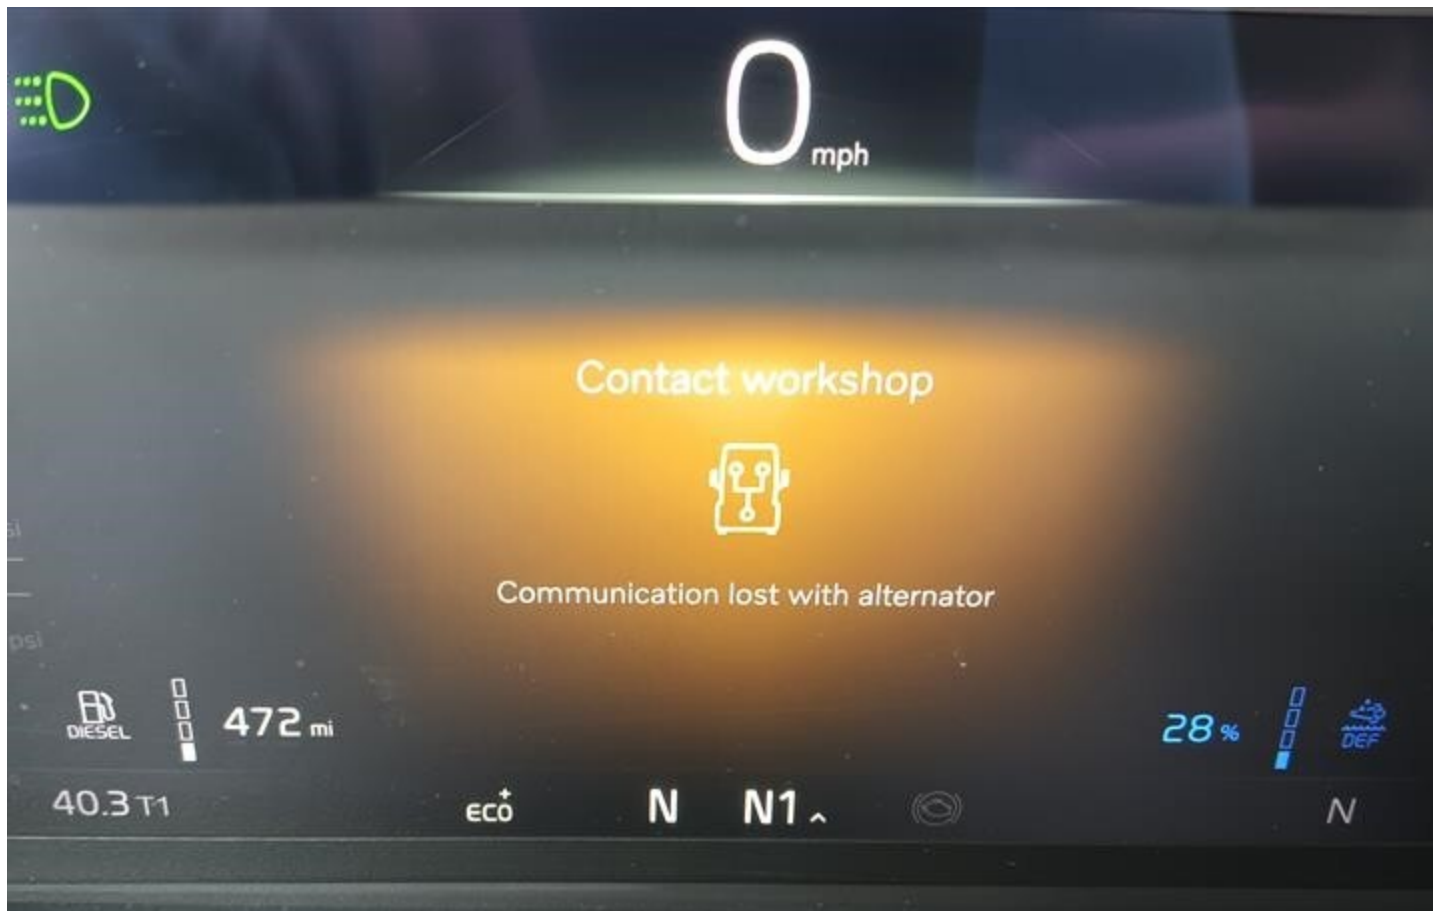
A “**Lost Communication to Alternator**” message may be displayed, and **VMCU DTC C103508** may be active. This condition is caused by a **software issue** in the VMCU.
