**Document ID:** IK1201505

**Title:** S13 Integrated Powertrain Known Leak Diagnostics

**Applies To:** S13 Integrated Powertrain

This article is to walk through and assist the technician in diagnosing and repairing some of the known leaks around the **S13 Integrated Powertrain**.

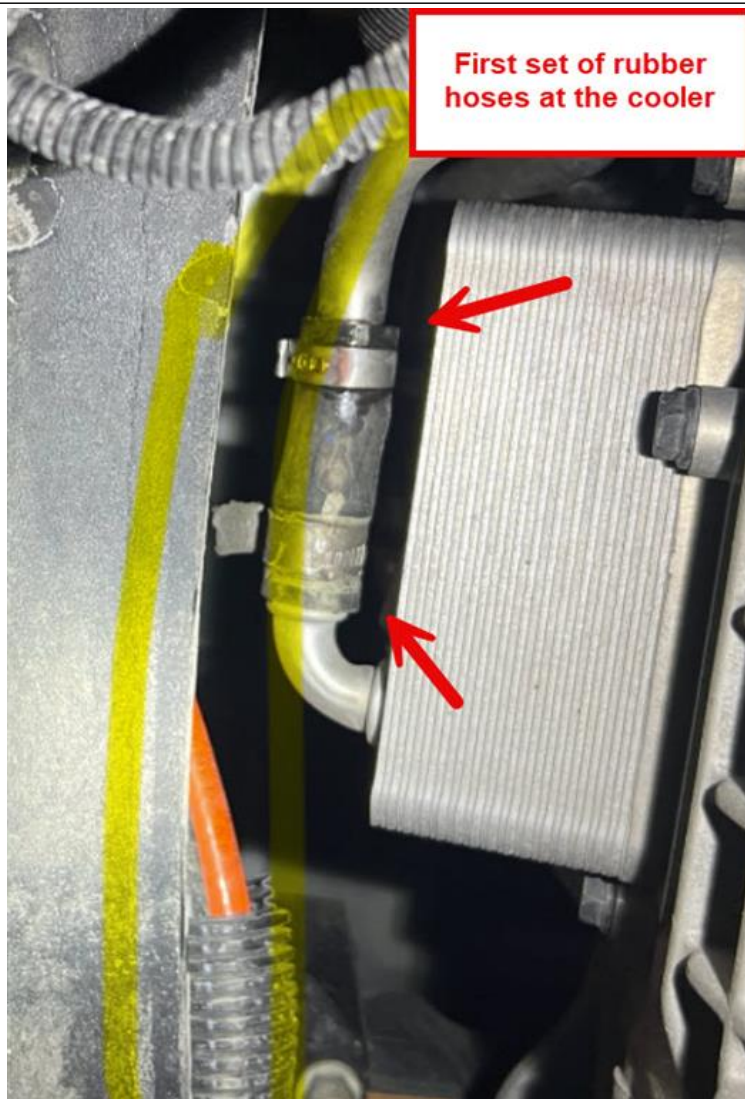
**Figure 3 - Transmission Cooler Hose Leak**

| Step | Passenger Side Transmission | Decision |
|---|---|---|
| #3 | Inspect for coolant on the passenger side of the transmission. Coolant can be seen seeping through the joints of rubber coolant hoses and at the hard lines near the transmission cooler area. There are two sections of rubber hose on | Yes. |

the supply side of the cooler and two sections of rubber hose on the return side of the cooler. See [Figure #3](#), [Figure #4](#), and [Figure #5](#) for examples:

Reference [IK1300194](#) for repair instructions.

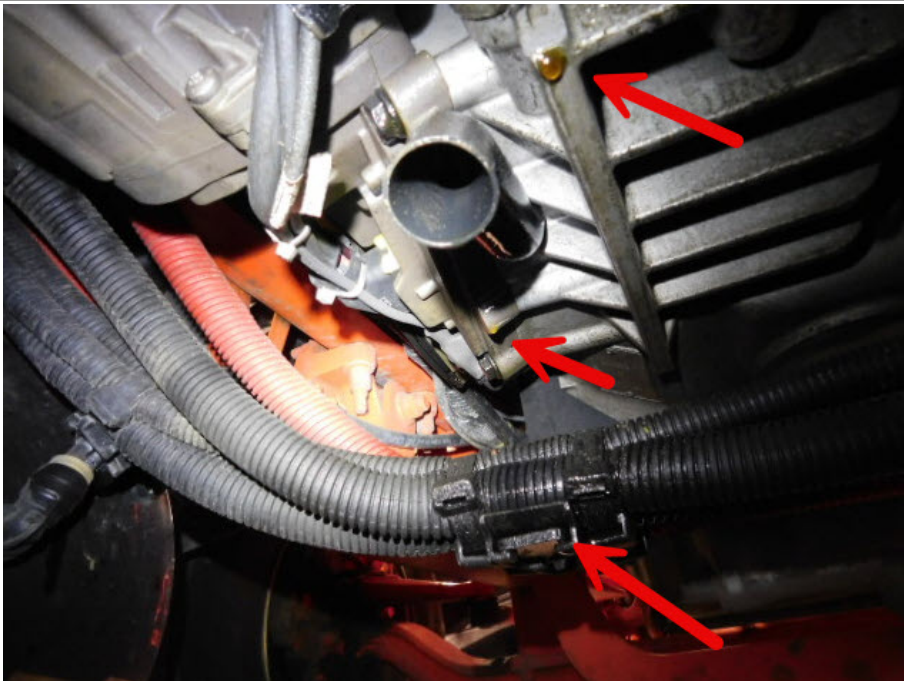
**Figure 6 - Oil Leak at the ECA**

| Step | Driver Side & Under The ECA | Decision |
|---|---|---|
| #4 | <p>Inspect under the transmission on the driver's side. Inspect for oil leaking down the ECA (Electronic Clutch Actuator) and collecting at the bottom of the transmission. See <a href="#">Figure #6</a> and <a href="#">Figure #7</a> for examples:</p> <p>Was an oil leak discovered?</p> | <p><b>Yes.</b></p> <p>Proceed to step 5 for further inspection and repair steps.</p> |

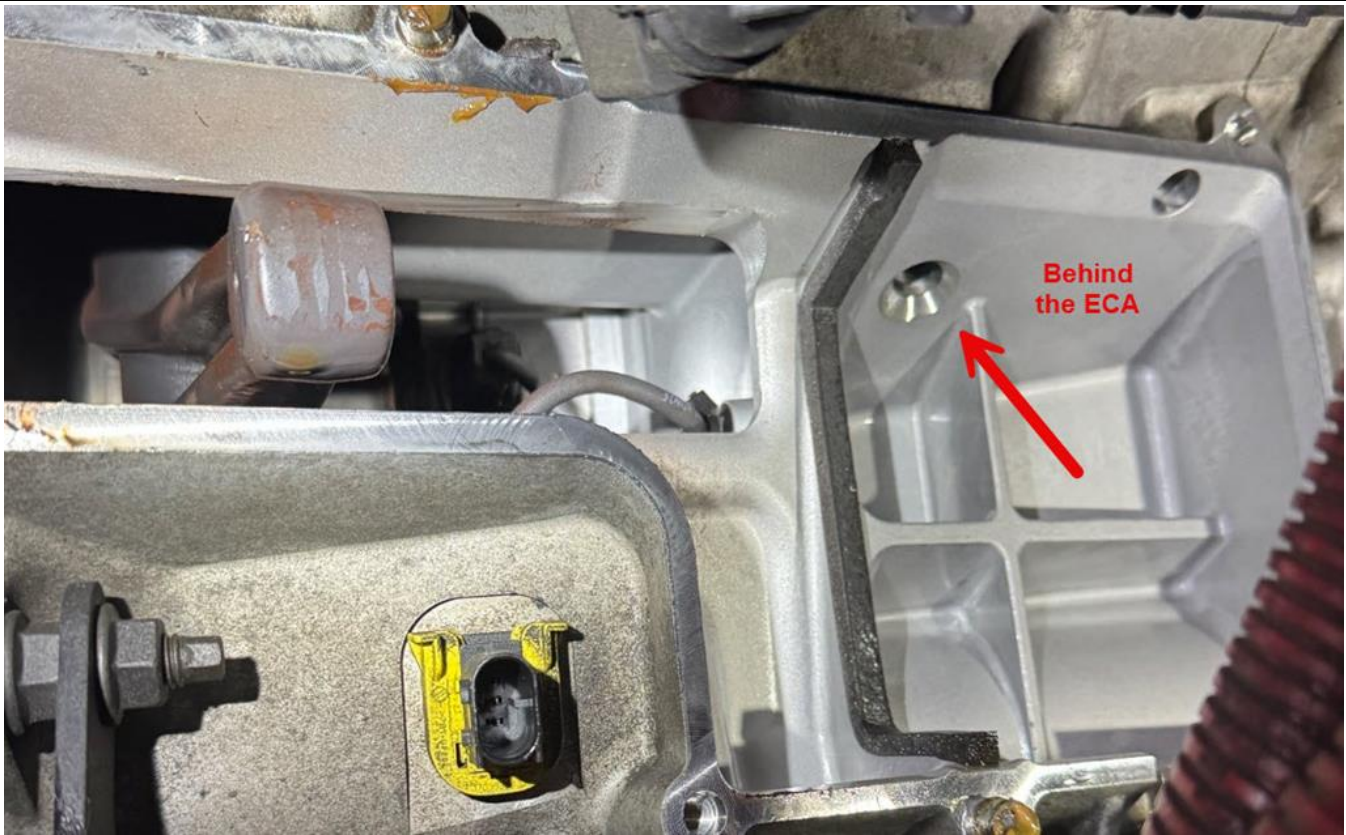
**Figure 8 - ECA Removed**

| Step | ECA Inspection/Repair | Decision |
|---|---|---|
| #5 | <p>Inspection:</p> <ul style="list-style-type: none"> <li>Remove the ECA and inspect for wetness at the pointed galley from <a href="#">Figure #8</a>.</li> <li>If wetness is observed, remove the main valve body assembly, inspect the condition of the green O-Ring as called out in <a href="#">Figure #9</a>.</li> <li>If the O-Ring is in good condition, inspect the 3 air ports at the top for wetness as shown in <a href="#">Figure #10</a>.</li> </ul> <p><b>NOTE:</b> There will be oil present in the housing behind the main valve body assembly; this is normal. The system is designed for shift rails to pass a slight amount of oil so they self-lubricate, oil that collects in the housing then flows back into the sump through one of the drilled passages. The galley with the green o-ring called out in <a href="#">Figure #9</a> is the same galley behind the ECA as</p> | <p>Repairs:</p> <p>Green O-Ring from <a href="#">Figure #9</a> - 104229N1</p> <p>Black O-Ring in shift actuators that position sensors sit in - 105465N1</p> <p>Green O-Ring on the position sensor harness connector that sits in the housing - 104440N1</p> |

called out in [Figure #8](#). If the green o-ring is left out, not installed properly, or gets pinched due to slippage during the installation process, the collected oil will run down into the ECA area, and this will result in an external transmission leak.

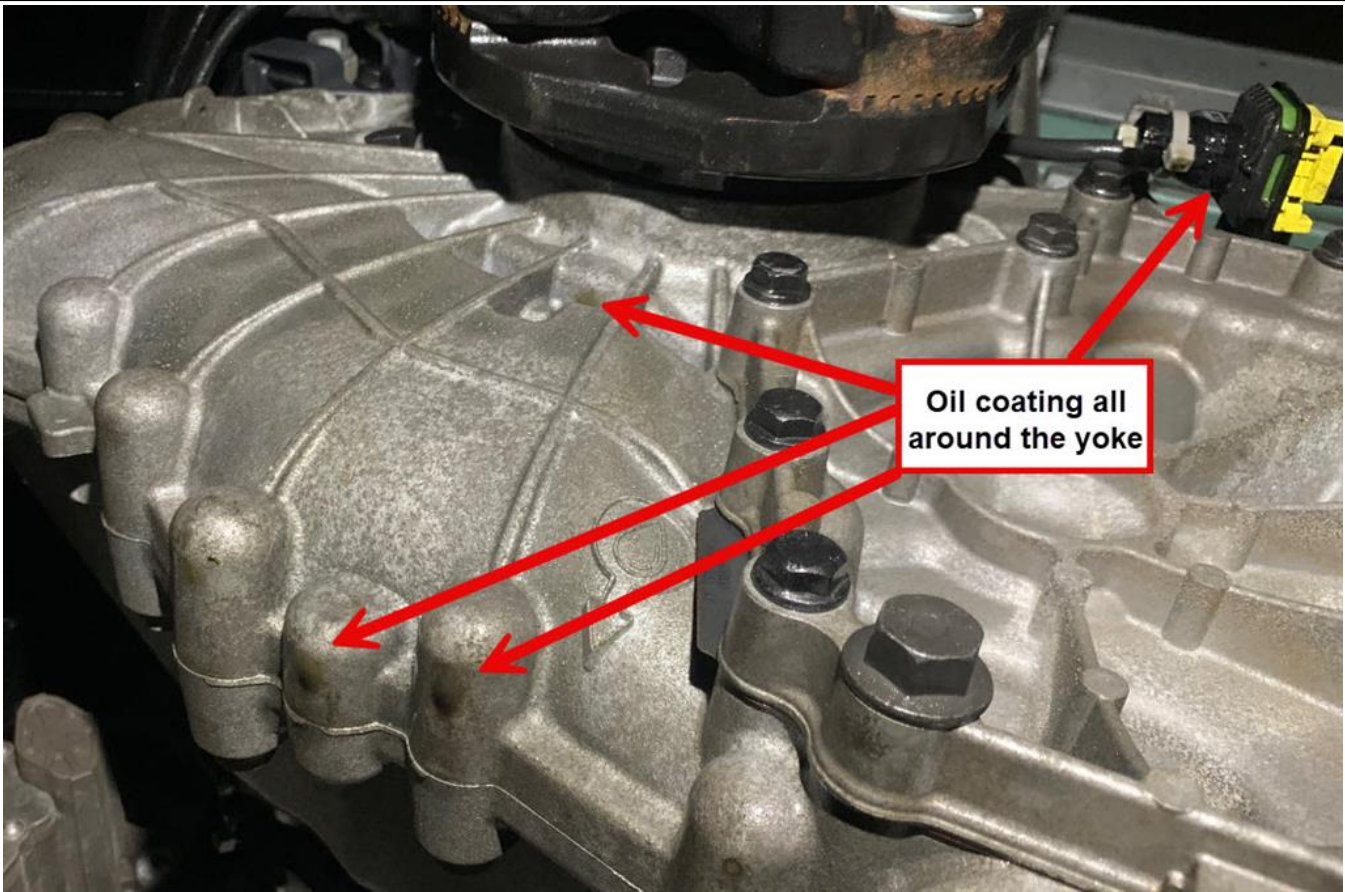
Figure 11 - Rear Output Yoke Leak

| #6 | <p>Inspect the rear of the transmission for signs of oil leaking/coating. See Figure #11 and Figure #12 for examples. Check the output shaft for excessive play:</p> <p>Was an oil leak discovered with SPN 191 FMI 2 present?</p> <p><b>NOTE:</b> This symptom may be associated with a fault code. If the vehicle has logged SPN 191 FMI 2, check the output yoke for play, pull the output speed sensor for inspection and check if there is any metal noticed on the tip of the sensor. See Figure #13 for an example.</p> | <p>Yes, a leak is present with no fault present.</p> <p>Replace the output flange seal. Reference the S13 Integrated Powertrain Technician Manual - "Output Flange and Output Flange Seal Removal"</p> |

| | | <p>Yes, a leak, fault code, excessive play on the output, and metal on the sensor is present.</p> <p>Capture images of the damage found and then open a technical support case file for direction. See <a href="#">Best Practices</a> section for case opening requirements.</p> |

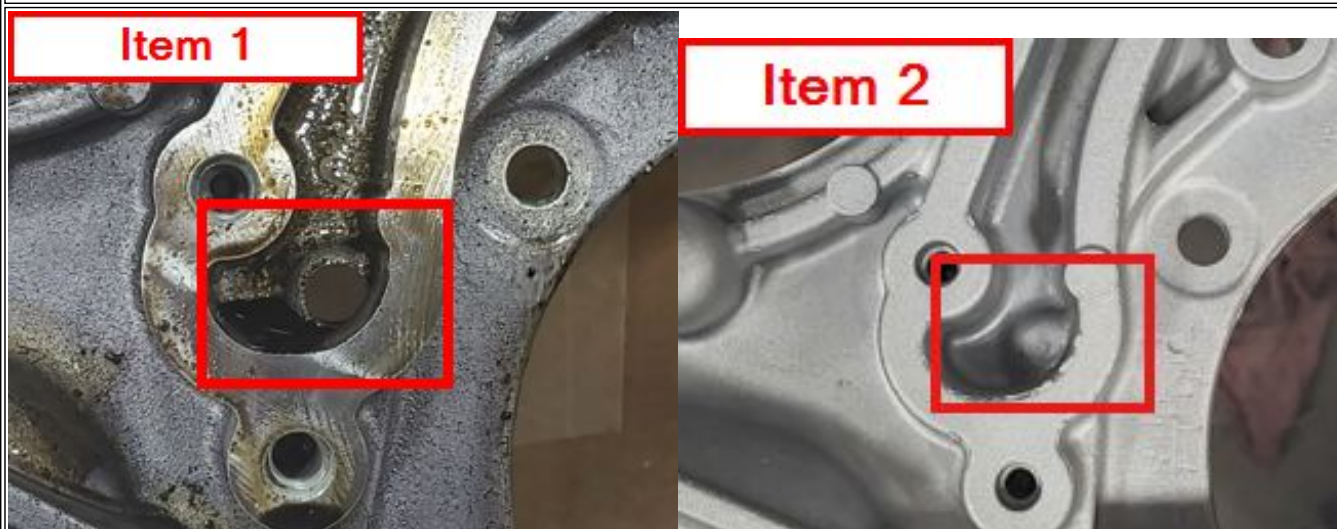
**Figure 1**

- The inner gear housing has been updated to remove the upper oil feed dowel-pin bore. This is not required, and the updated parts can be used without issue. See Figure #1 below for an example.

Item 1: Old-style housing with a dowel hole drilled.  
Item 2: New-style housing with no dowel hole drilled.
