Subject: OIL LEAKING AT REAR OF ENGINE FROM POSSIBLE TURBO RETURN TUBE GASKET (H3T INLINE 6)	Service Alert No.: SA-007/26
	Last Issued : 02/04/2026

2025 CX-70 (H3T inline 6)

2024-2025 CX-90 (H3T inline 6)

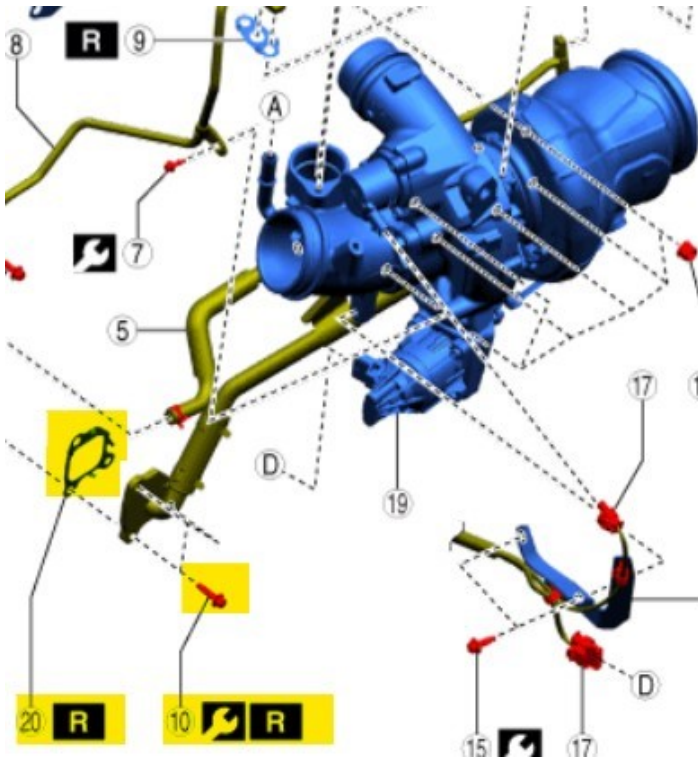
On some vehicles, an engine oil leak from the rear of the engine at the turbocharger drain back tube could be be confused as an oil leak from behind the bell housing. The bolt holes for the drain back tube to the block are drilled through to the inside of the engine and thread sealer was not properly applied to the bolts threads, causing oil to leak past the threads.

2: Replace the bolts and gasket.

- Bolt holes and gasket surface must be cleaned from residual oil and sealer before reassembly.
- Bolts have thread sealer and must be replaced.
- Catalytic converter removal is required to access the turbocharger drain back tube. Refer to Catalytic converter removal/installation H3T

Tightening torque: 95 in-lbs (11 Nm, (97kg-cm)
