# Service Alert

<b>Subject:</b>  THIRD ROW SEAT BACK CONCERNS AND/OR ISSUES WHEN LIFTING FROM THE LOWERED POSITION	<b>Service Alert No.:</b> SA-010/26
	<b>Last Issued :</b> 02/24/2026

2024-2026 CX-90

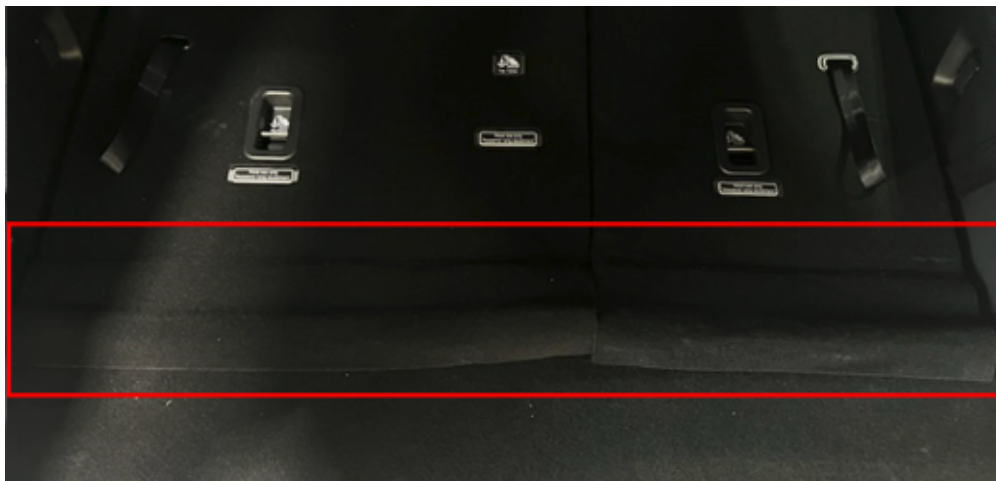
Customers may report issues with third-row seats, loose or damaged trim, not folding down, binding when folding up, and other concerns. The technician may notice the cargo floor is out of place and may attempt to replace parts as defective. This is due to the cargo floor being uneven and/or foreign objects stuck between the third-row seats and cargo floor.
