HYUNDAI Technical Service Bulletin

GROUP CAMPAIGN	NUMBER 26-01-020H
DATE FEBRUARY 2026	MODEL(S) IONIQ 9 (ME1A EV)

SUBJECT: RATCHETING NOISE - SLIDING CENTER CONSOLE
(LIMITED COVERAGE CAMPAIGN LA4)

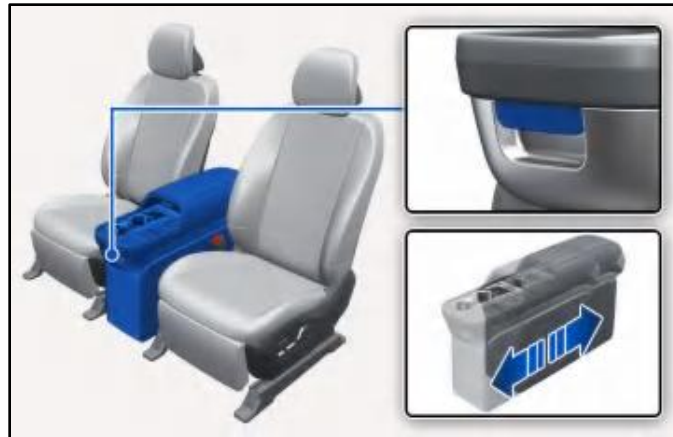
Description: Certain IONIQ 9 (ME1A EV) vehicles may have a sliding center console (rear floor console) that makes a ratcheting noise while being moved forward or backward. This bulletin provides instructions to remove and replace the affected sliding center console.
