HYUNDAI

Technical Service Bulletin

GROUP CAMPAIGN	NUMBER 26-01-026H
DATE FEBRUARY 2026	MODEL(S) PALISADE (LX3) PALISADE HYBRID (LX3 HEV)

SUBJECT: ACTIVE AIR FLAP WIRING ASSEMBLY INSPECTION & REPLACEMENT (LIMITED COVERAGE CAMPAIGN LA13)

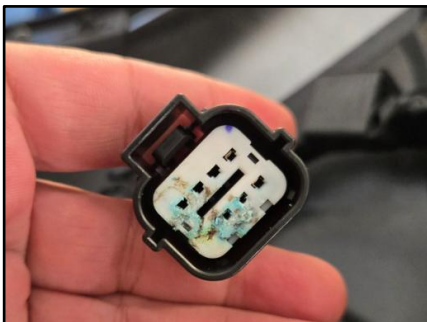
AAF Front Bumper Wiring Connector

Description: Certain Palisade (LX3) and Palisade Hybrid (LX3 HEV) vehicles may exhibit a “Check Active Air Flap System” warning message, check engine light on, and/or “Low Engine Oil” warning message, due to improper operation of the Active Air Flap (AAF) system. DTCs include, but are not limited to: P05AE00, P05B100, P05B200 P05B400, P05FE00, P15A200, P15A500, P2C7400, U028500, U028B00, and/or U100800. This condition may be caused by water ingress and corrosion at the wiring connections for the lower AAF actuators and/or sensors. This bulletin contains instructions to inspect the front bumper wiring connectors, AAF actuators, and sensors for water ingress and corrosion, and to replace them if necessary.

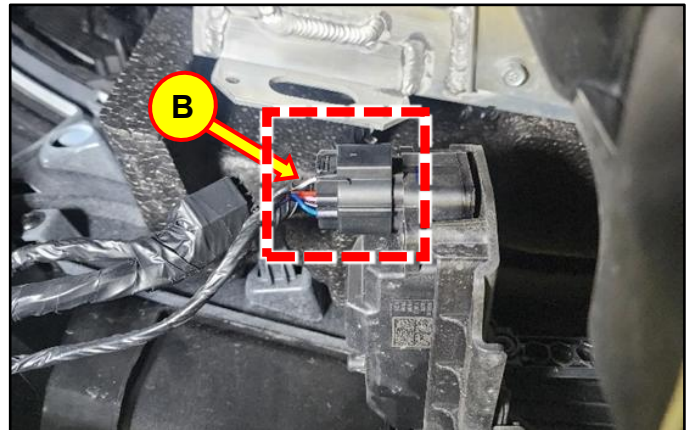
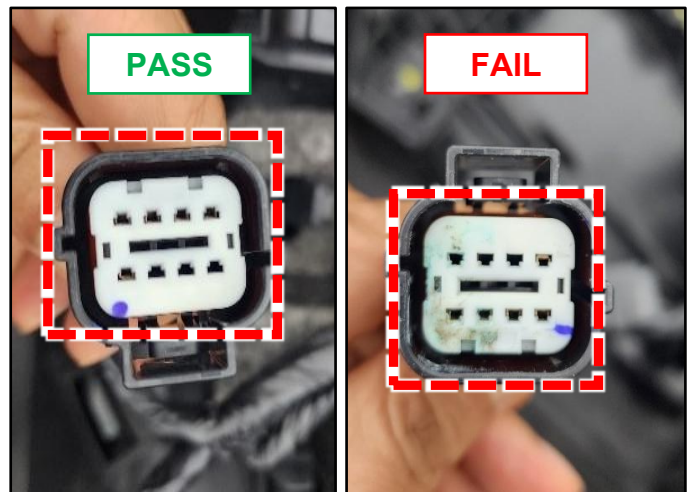
Visually inspect both the LH and RH front bumper wiring connectors for water ingress or corrosion.

At right are examples of good (**PASS**) and damaged (**FAIL**) wiring connectors.

- **PASS**: If damage is **NOT** found on either LH or RH connectors:
 - Proceed to **step 4**.
- **FAIL**: If damage is found,
 - On **ONE** side **ONLY**: Proceed to **step 4**.
 - On **BOTH** sides: Proceed to the **Front Bumper Removal** procedure.

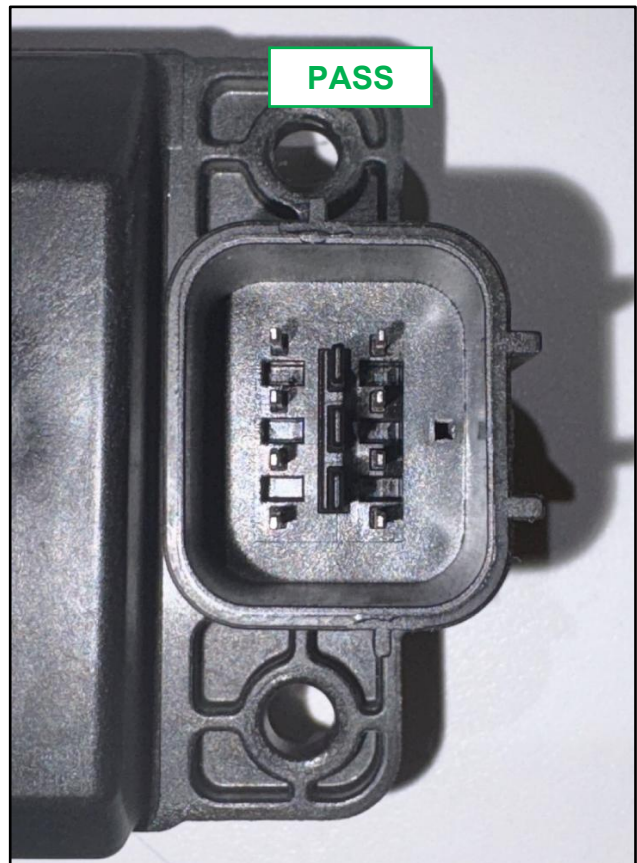
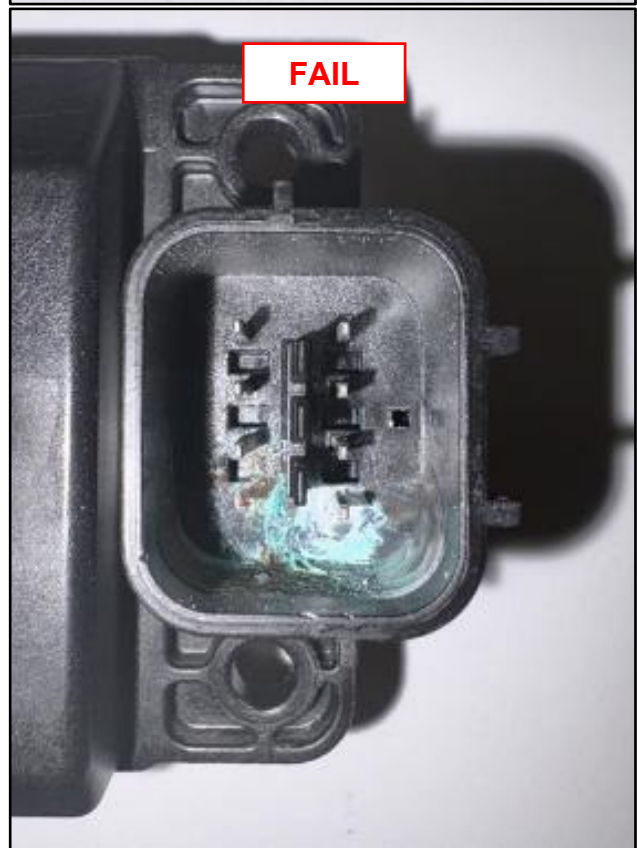
4. On the side(s) that received a **PASS** in **step 3**, use a small mirror and flashlight to inspect the AAF actuator pins for water ingress or corrosion to ensure no damage is missed.

At right are examples of good (**PASS**) and damaged (**FAIL**) actuator pins.

- **PASS:** If damage is **NOT** found in **BOTH** inspections (**steps 3 and 4**), proceed to **step 5**.
- **FAIL:** If damage is found in either inspection (**step 3 or 4**), proceed to the **Front Bumper Removal** procedure.

If **ANY** corrosion or water ingress evidence is found, even if it is minor, the inspection is still a **FAIL**.

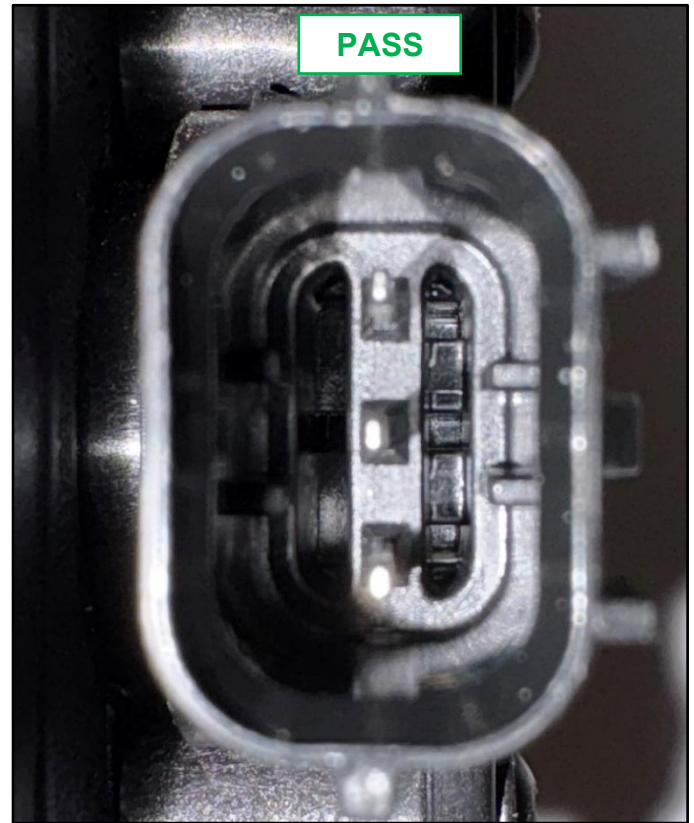
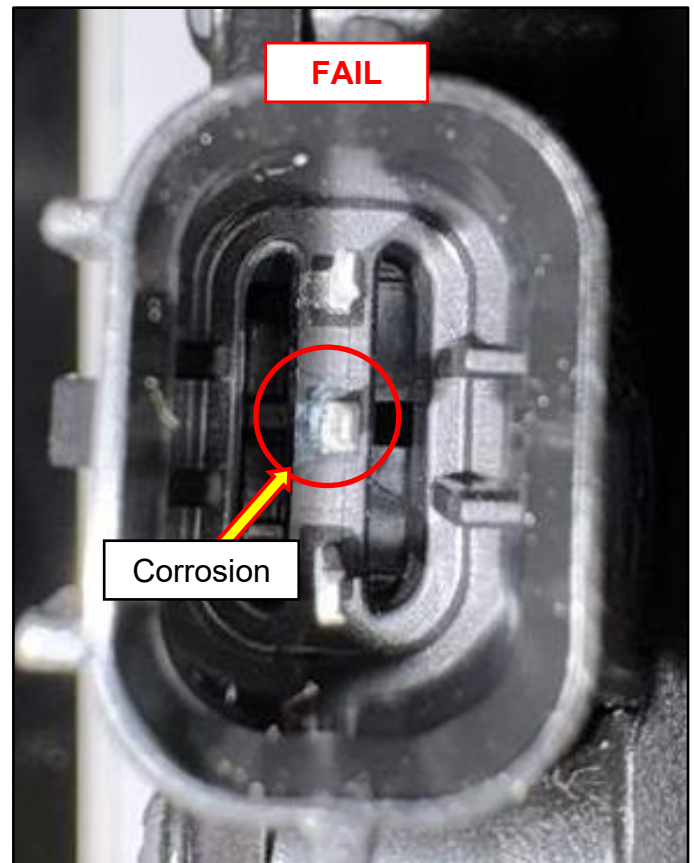
2. Visually check LH/RH sensor connections for water/corrosion ingress.

If the RH side **PASSED** the **Front Bumper Wiring & AAF Actuator Pin Inspection** procedure, but RH **sensor** is found to have corrosion/water ingress, then proceed to replace **BOTH** LH and RH parts as stated in **step 3** of the **Replacement of Front Bumper Harness, AAF Actuator(s), and AAF Sensor(s)** procedure.
