TECHNICAL SERVICE BULLETIN

Media Bin Not Opening Consistently

26-2013

Ford 2025 Explorer

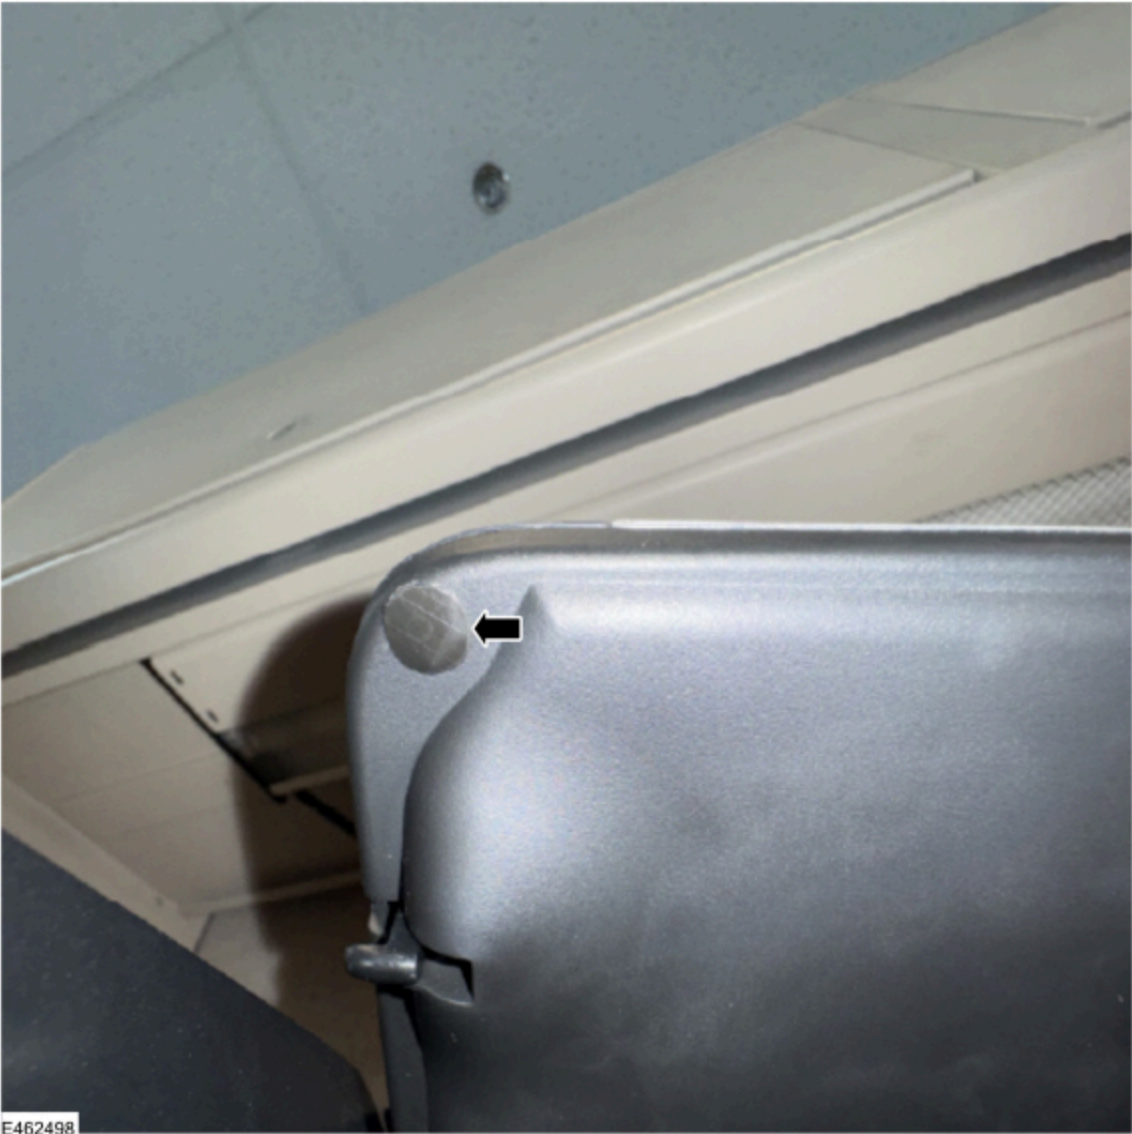
Figure 1

Issue: Some of the vehicles listed in the Model statement above may exhibit a media bin that will not open consistently. This may be due to lack of tension between the media bin door and media pads.

1. Clean the underside corners of the media bin door using a lint-free wipe and isopropyl alcohol to prepare the surface. Allow the area to fully dry before installing the round self-adhesive pads.
2. Open the media bin door. Install the new round self-adhesive pads on the underside corners of the media bin door lid, aligned with the existing lower pad location. (Figures 1-2)
