# RSB-64-26-001-1: Gap at Front of Wireless Charging Mat

Rivian is launching a technical service bulletin for some model year 2025-2026 R1T and R1S vehicles. These vehicles may have been built with a visible gap at the front of the wireless charging mat, resulting in a perceived quality issue. Upon customer complaint of a gap at the front of the wireless charging mat, Rivian will modify or replace components as necessary.

<b>Document Type</b>	Technical Service Bulletin
<b>Date</b>	February 18, 2026
<b>Affected Region(s)</b>	USA, Canada
<b>Affected Model(s)</b>	R1T, R1S
<b>Model Year(s)</b>	2025-2026
<b>Approximate Build Dates</b>	May 2024-December 2025

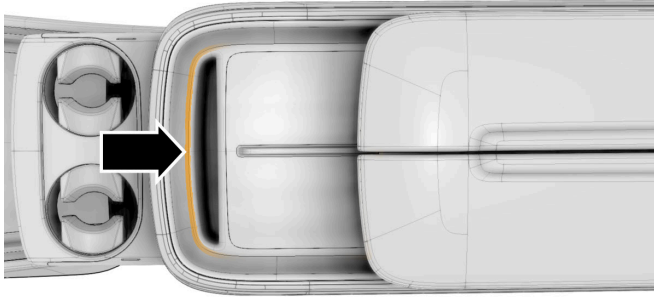
1. Inspect for a gap in the highlighted area.

If a gap is present: Continue to the next step.

If no gap is present: This bulletin is not applicable. Discontinue this procedure.

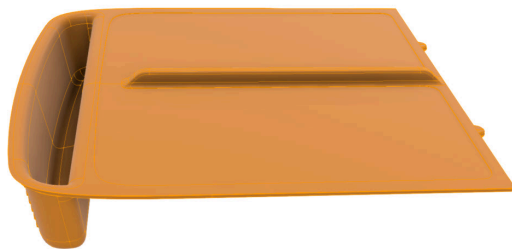
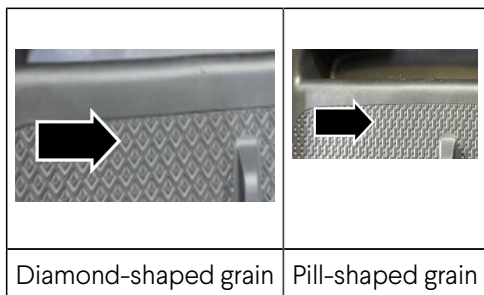
7. Inspect:

If the grain on the component is diamond-shaped: Replace the component(s). Continue to the next step.

If the grain on the component is pill-shaped: Reuse the existing component.

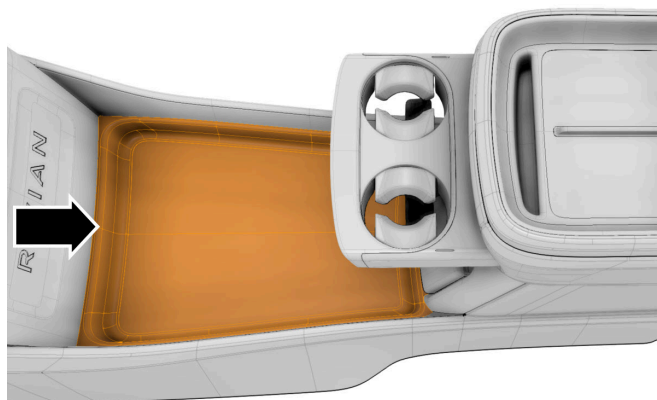
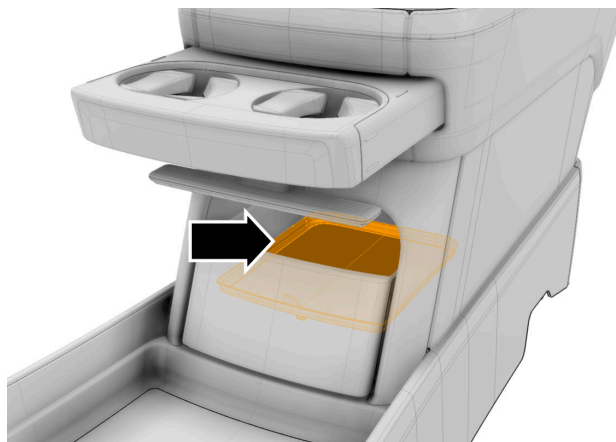
8. If the component was replaced in the previous step: Inspect and replace the highlighted components using the same criteria as the previous step.
