RATTLE TYPE NOISE FROM LOWER STEERING COLUMN AREA

Range Rover

- 22MY-On Range Rover (L460)
- 23MY-On RR Sport

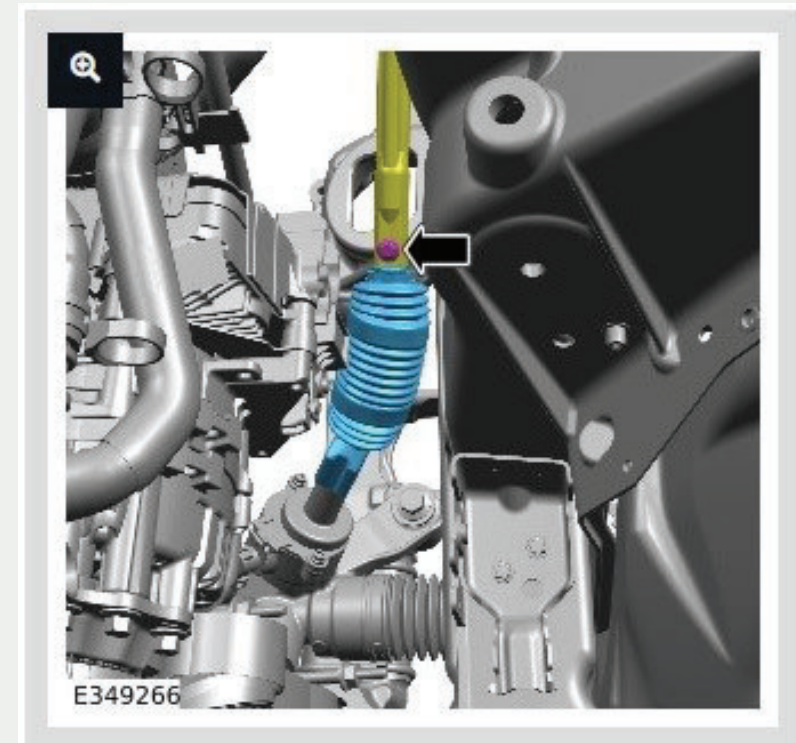
- “There is a rattle noise turning slightly over uneven road surfaces.”

- This may be caused by the steering column flexible coupling.

- Engineering are currently investigating this concern.
- SSM000020 has been published to provide repair guidance.
- Please do not replace any parts unless instructed to do so following the repair instructions.
- Please report repair details via EPQR for actions correcting the concern as requested in the SSM.
