<b>Topic</b>	ODIS Error Message – Best Practice When Performing Baseline (BiL) Updates
<b>Market area</b>	Bentley: worldwide (2WBE),China 796 VW Import Comp. Ltd (Vico), Beijing (6796)
<b>Brand</b>	Bentley
<b>Transaction No.</b>	2078962/3
<b>Level</b>	EH
<b>Status</b>	Released for publication
<b>Release date</b>	Feb 2, 2026

Transaction No.: 2078962/3

ODIS Error Message – Best Practice When Performing Baseline (BiL) Updates

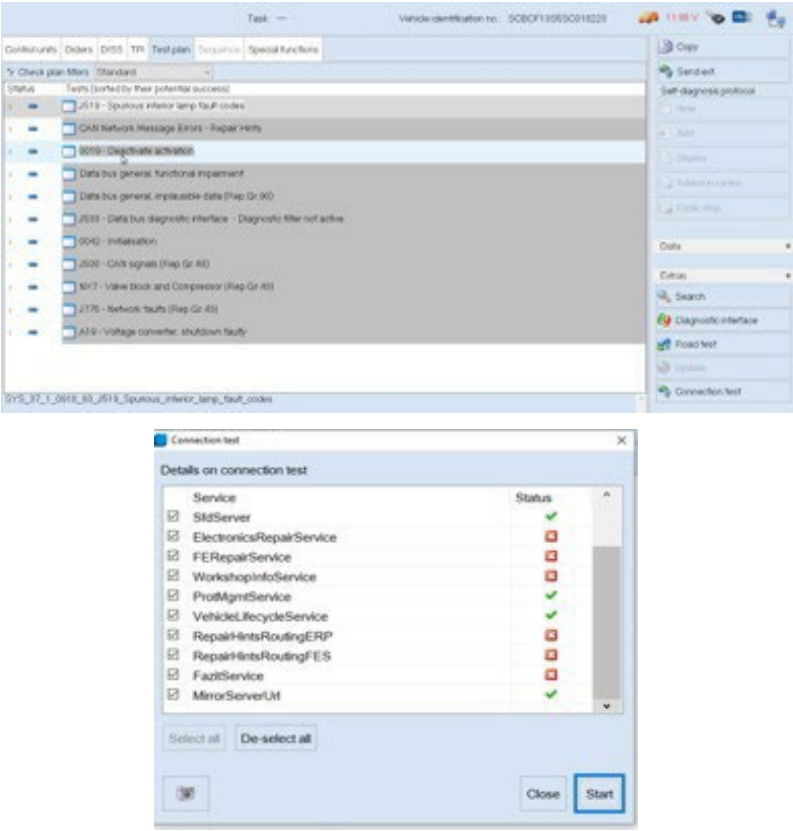
Step	Action	Images
<p>Check that the D3 Edge Box is connected</p>	<ul style="list-style-type: none"> <li>• Perform the 'connection test' within the extra menu                             <ul style="list-style-type: none"> <li>– Navigate to "Extras" -&gt; "Connection Test" -&gt; Select "Bentley" (If Multi Brand) -&gt; "Select ALL -&gt; Start</li> <li>– If the Mirror Server does not return a green ✓ -&gt; Check your D3 setup and IP settings as per the next step.</li> </ul> </li> </ul>

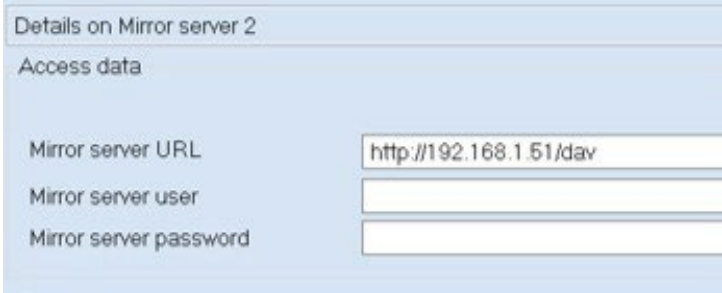
<p>Mirror Server Settings</p>	<ul style="list-style-type: none"> <li>• Check that the URL in the Mirror Server 2 is correct for the new D3 edge box.                             <ul style="list-style-type: none"> <li>– Refer to "Operating Modes" -&gt; "Admin" -&gt; "Connections" -&gt; "Mirror Server 2;;</li> </ul> </li> <li>• Ensure that the URL is http://.. And NOT https://</li> <li>• Enter the mirror server URL into a web browser, and ensure that the flash files are visible on the server.</li> </ul>

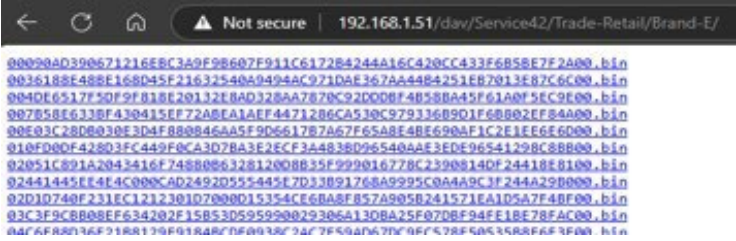
<ul style="list-style-type: none"> <li>- Copy &amp; paste the Mirror server address into a web browser e.g Microsoft edge) -&gt; Navigate to the flash files location: XXX.XXX.XX/DAV/Service42/Trade-Retail/Brand-E/</li> </ul>

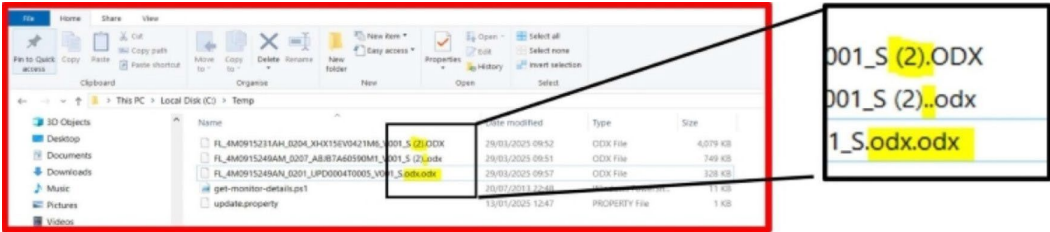
<p>Type of Flash Container</p>	<p>Best Fixes</p>
<p>Local Flash Containers (Using files from c:/temp)</p>	<ul style="list-style-type: none"> <li>If a flash file is being used locally, eg ED40, ED42 download from atheer – this means that the flash container is extracted directly form the C:/temp folder on the users ODIS tester.</li> <li>If the flash files are downloaded incorrectly, or not extracted from the ZIP folders correctly, this means ODIS cannot identify the correct flash file.</li> </ul> <p>Example of Bad file structure / naming:</p>

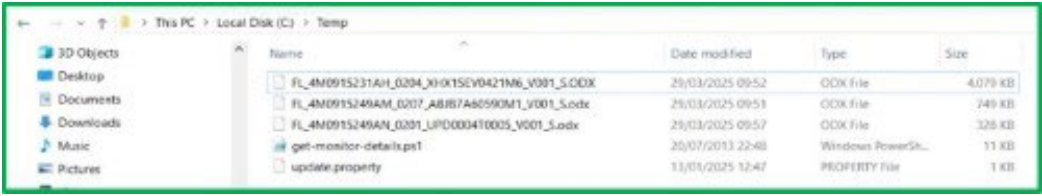
<ul style="list-style-type: none"> <li>Duplicated Download Suffix</li> <li>Multiple or incorrect file extension types</li> </ul>

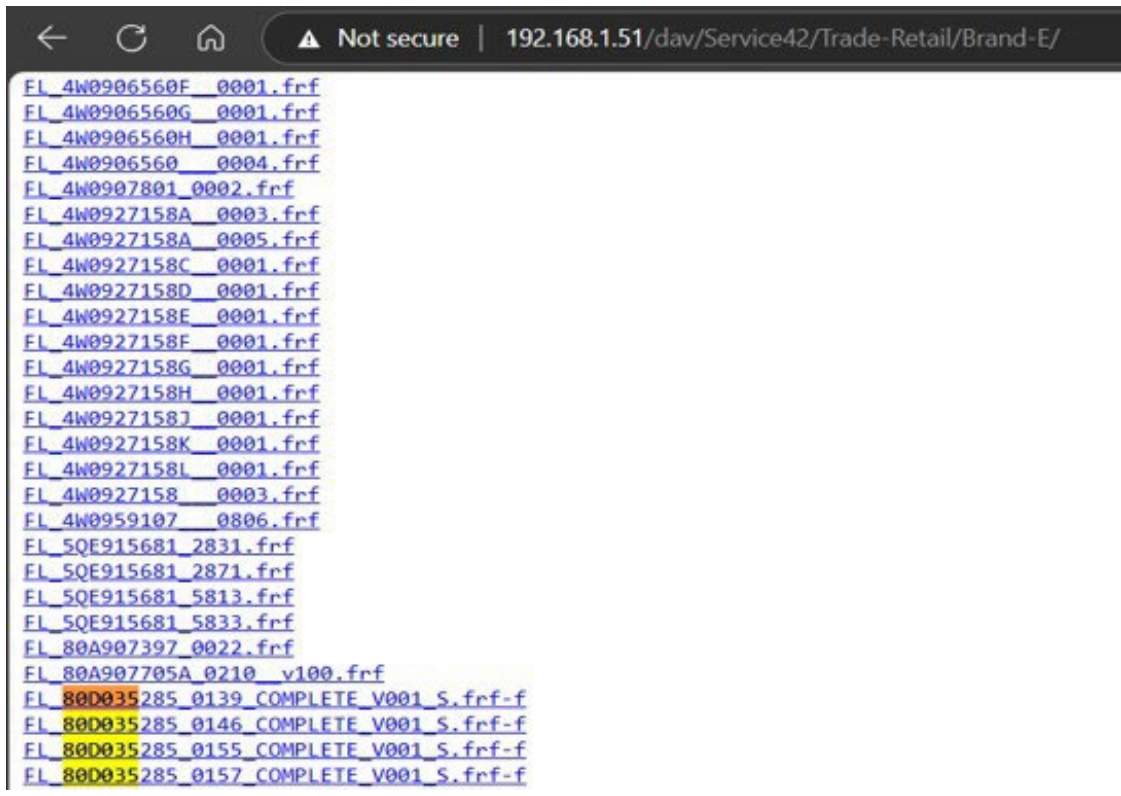
- When an ECU requires a software update through SVM, ODIS will pull the file from the mirror server/ D3 edge box.
- If the Flash Container can not to be linked, check if the files is present on the mirror server
- To do this:
  - Enter the mirror server URL into a web browser, and ensure that flash files are visible on the server.
  - Copy & paste the mirror server address into a web browser (eg Microsoft edge) -> Navigate to the flash files location: XXX.XXX.X.XX/dav/Service42/Trade-Retail/Brand-E/
- Then press 'ctrl' + 'f' and search the Mirror Server for that flash container.
- In this example, the FRF file is available to be flashed with ODIS:
