Technical Service Bulletin

| Topic | 58-Way Transmission Control Module (TCM) Connector - Terminal Replacement |
| Brand | Bentley |
| Transaction No. | 2080753/1 |

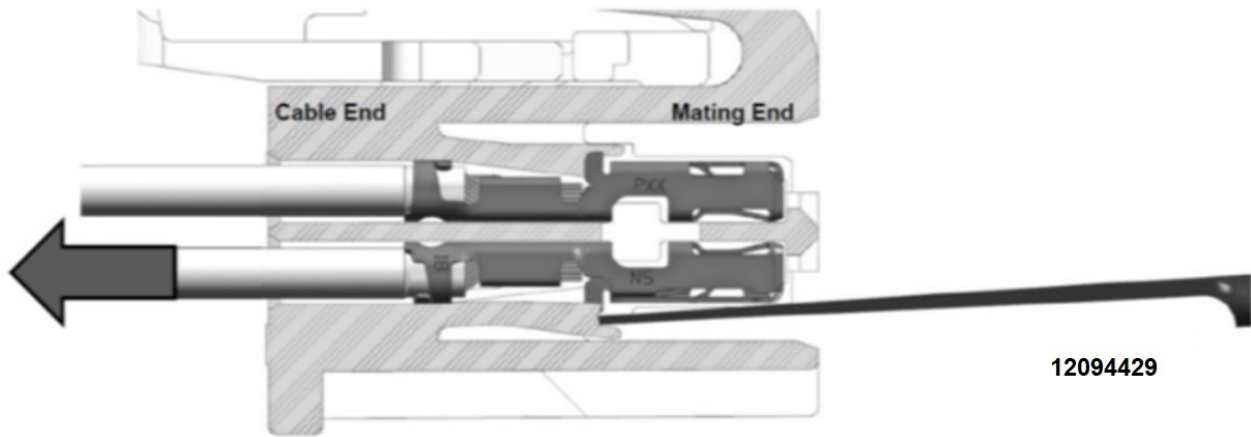
Figure 1. *Terminal removal*

- Various DTCs stored in 02 – Transmission Control Module.
- DTC root cause linked to loose, opened, or damaged female terminals in the 58way Transmission Control Module connector.
- Evidence of poor terminal tension when conducting a drag test.

Over an extended period of service, the female terminals within the 58-way TCM connector may exhibit minor changes in fit. This condition can contribute to:

8. To remove a defective contact terminal, follow the steps below and see the diagram in figure 1:
 - a. Locate the flex lock at the front end of the cavity.
 - b. Insert Tool **12094429** straight into the cavity.
 - c. Deflect the flex lock to unseat the terminal.
 - d. Gently pull on the cable to remove the female terminal from the receptacle.
