# Service Alert

<b>Subject:</b> CHECK ENGINE LIGHT ON WITH DTC P061B, LIGHT INCREASE IN ENGINE RPMS DURING ACCELERATION, TRANSMISSION WON'T SHIFT PAST 4TH GEAR, VARIOUS U CODES SET	<b>Service Alert No.:</b> SA-011/26
	<b>Last Issued :</b> 02/25/2026

2018-2025 CX-5

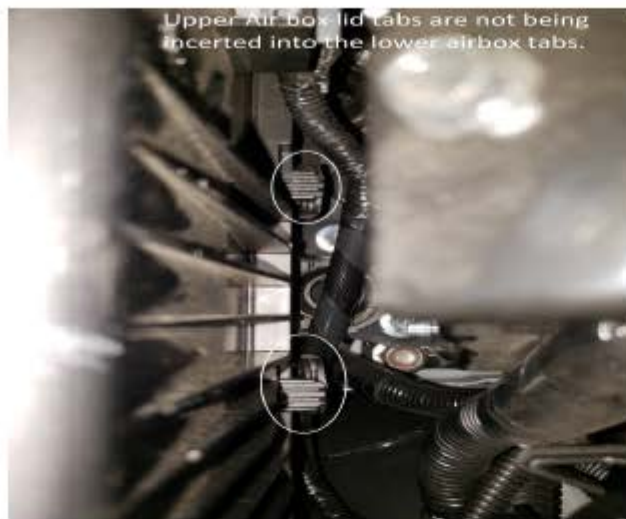
Upper air box tabs are not inserted into the lower air box tabs. Turbulent air is entering the air box, affecting the MAF.

1. Open the hood.
2. Grasp the air cleaner assembly by hand and gently pull it toward the front of the vehicle.
  - If the air cleaner assembly moves, inspect the three (3) tabs at the lower rear area of the air cleaner assembly. Ensure that all three (3) tabs are properly attached to the lower air cleaner assembly.
  - If the air cleaner assembly is properly attached, inspect that the air filter is properly sealing the upper and lower air filter box and not letting turbulent air to leak past the mating surfaces. If OK, perform a normal diagnosis according to the instructions on MGSS online.

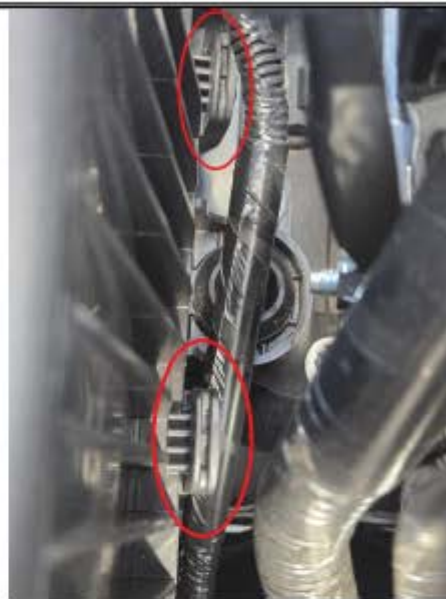
Properly inserted upper and lower tabs. The air box is sealed from the turbulent underhood air.
