Technical Service Bulletin

Topic	Side Mirror - Loud Noise During Folding Operation
Market area	Bentley: worldwide (2WBE),China 796 VW Import Comp. Ltd (Vico), Beijing (6796)
Brand	Bentley
Transaction No.	2080808/1
Level	EH
Status	Released for publishing
Release date	Feb 4, 2026

Continental GT/GTC

Flying Spur

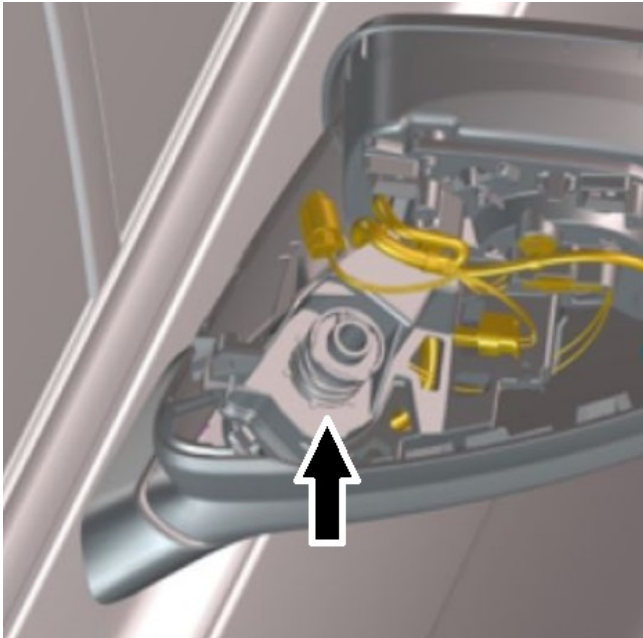
Figure 1. Side mirror pivot area

Customers may report a loud or abnormal noise from one side mirror during the automatic folding or unfolding operation.

The noise may be caused by insufficient lubrication at the side mirror base pivot point and associated rubber interfaces. During the folding movement, increased friction between the pivoting components and seals can generate a loud creaking or grinding noise.

4. Identify the side mirror base pivot area between the mirror base and mirror housing.

To access the base pivot area for lubrication, it may be necessary to partially disassemble the side mirror. Refer to ElsaPro Repair group 66 'Side mirror – To dismantle and assemble'.

6. Apply a small, even amount of Krytox lubricant to:

The pivoting surfaces.
