Technical Service Bulletin

Continental GT/GTC and Flying Spur Series

2062257/7

Keyless door entry does not work - Front Outside Door Handle(s) - Touch Sensor DTC B147613 and/or B147713 are present

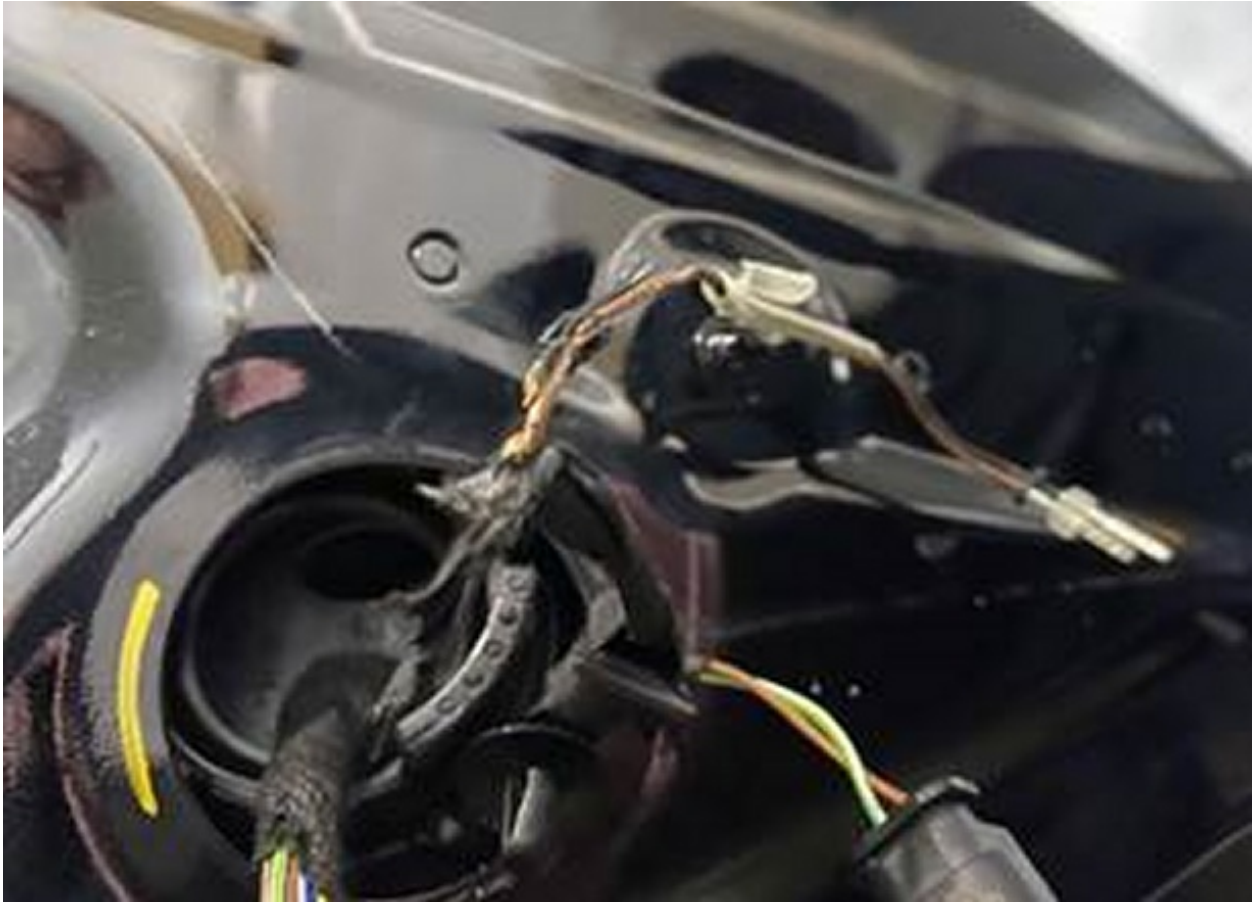
Figure 1

- Referring to Figures 1 and 2 - Perform a check of the wiring that is routed through the exterior door handle (from the convenience control module), including the wiring inside the clear heat shrink and/or insulation tape
- In the event that any wires show damage or signs of chaffing/breaks continue with the suggested repair as detailed in Step 3

3) Repair the broken or damaged wires as per Rep.Gr 97

TIP: Where possible, extend the length of the wires by 10mm

- Ensure the wiring does not clash with and components in particular the window mechanism
