STAR ONLINE PUBLICATION

Case Number: S1923000010 Rev. A

Symptom/Vehicle Issue: Floor Console Center Storage Bin Door Inoperable And Or Stuck Closed.

Models Affected: 2019-2026 Ram 1500 (DT), 2500 (DJ), 3500 (D2 DD)

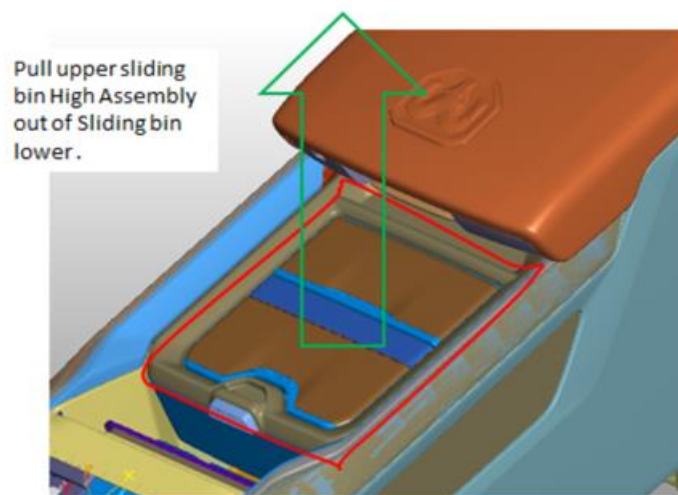
Figure 1

Discussion: A floor console storage bin door that will not open can be caused by foreign material lodged on the backside of door (which you cannot see) - typically a straw, writing utensil, or wrappers. Follow the below to repair the condition.

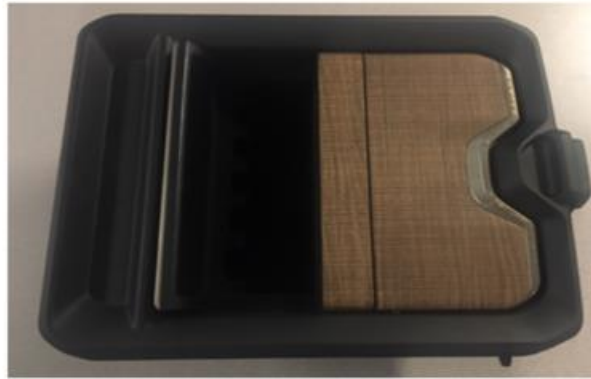
Figure 2

Sliding bin high with lodged contaminate now out of vehicle
