L74X-  
A.05.26

To: After Sales Official Network  
Object: BL MY24 Update PN\_47B990100C\_Rev\_0141\_0142  
Date: 19/02/2026  
Pages: 12

BL MY24 Up-  
date\_PN\_47B990100C\_Rev\_0141\_0142

Revuelto

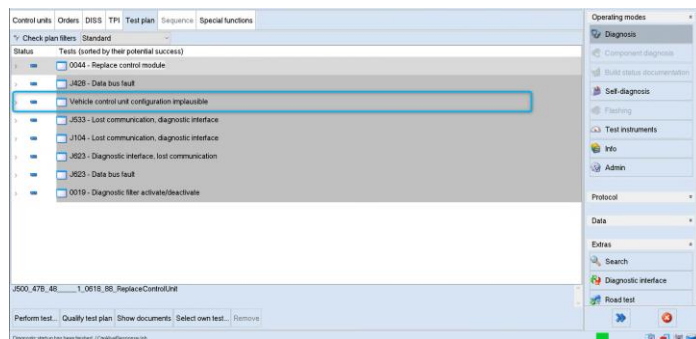
22. Check the DTCs from the ECU 0019: If the DTC “**C12A5F0: Vehicle electrical system configuration implausible**” is present and is in “active” status, please perform the GFF “**Vehicle configuration implausible**” from the Test Plan, as shown below:

| Number: | C12A5F0: Vehicle electrical system configuration implausible |
| Error type 2: | active/static |

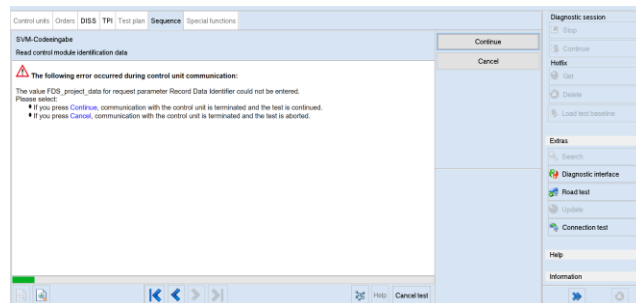
**29.** If the following error screen is displayed, the error does not indicate an issue, please press “Continue” and continue with the campaign.

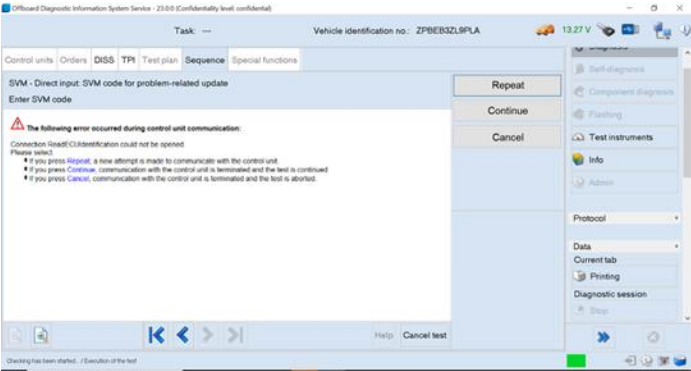
- A. If the following error screen is displayed, abort the guided function by clicking on “Cancel Test” and contact Technical Support.

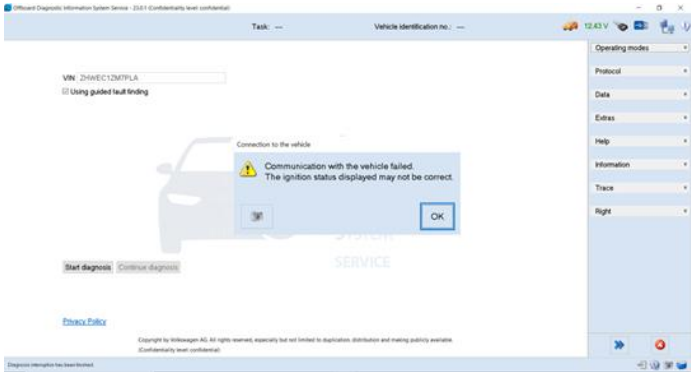
- B. If an error is displayed that regards the hardware interface, and the "connection to vehicle" and "key state" icons appear as shown in the figure below:
- Click “Cancel”.

- Repeat installation of the interface VAS6154/6154A/6154B for the instructions

in procedure (\*) “Checking the VAS 6154”, selecting the right-hand “Extras” menu in O.D.I.S. Service and clicking on the “Diagnostic interface” button.

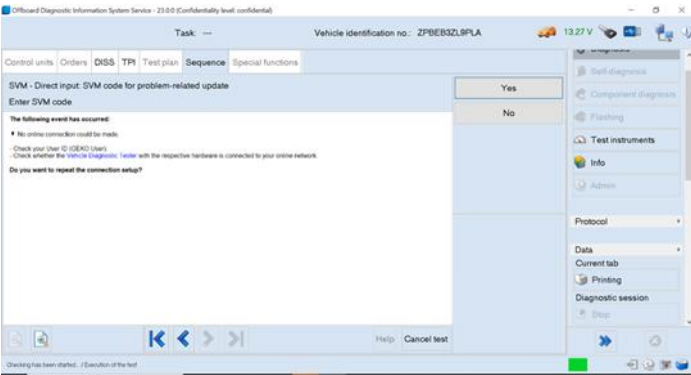
- C. If the following connection error is displayed like in the following example screenshots:
- It is not possible to connect to the central server; check that your laptop is correctly connected to the Internet and retry by clicking on “Yes” or “Done/continue”, as appropriate.
