L74X-  
A.08.26

**Campaign code:**  
L74X-A.08.26

**Campaign name:**  
BL MY25 Update PN\_47B990100D\_REV0110

**Model:**  
Revuelto

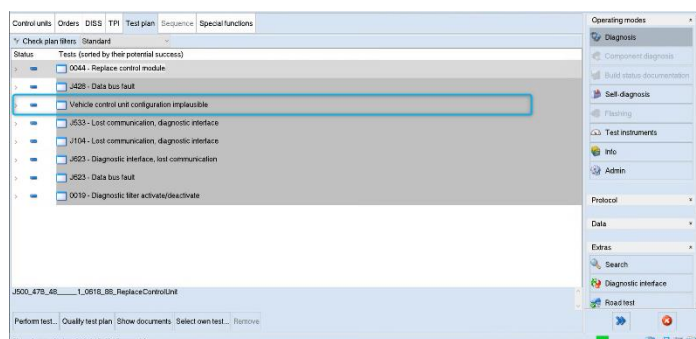
23. Check the DTCs from the ECU 0019: If the DTC “**C12A5F0: Vehicle electrical system configuration implausible**” is present and is in “active” status, please perform the GFF “**Vehicle configuration implausible**” from the Test Plan, as shown below:

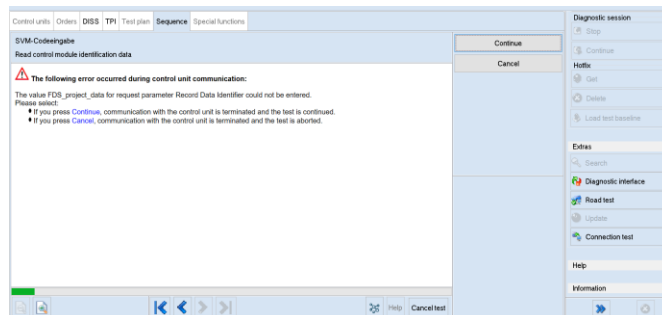
**30.** If the following error screen is displayed, the error does not indicate an issue, please press “Continue” and continue with the campaign.

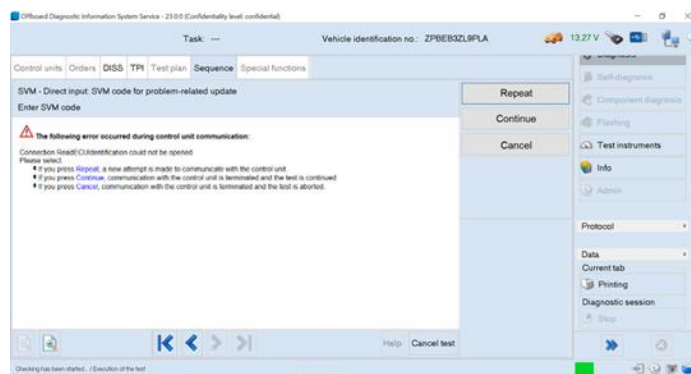
- A. If the following error screen is displayed, abort the guided function by clicking on “Cancel Test” and contact Technical Support.

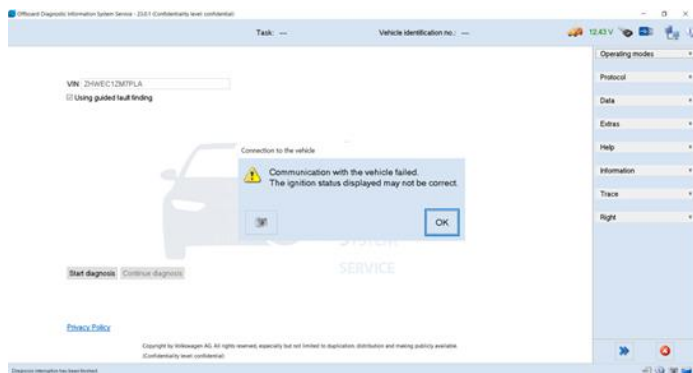
**B.** If an error is displayed that regards the hardware interface, and the "connection to vehicle" and "key state" icons appear as shown in the figure below:

- Click "Cancel";
- Repeat installation of the interface VAS6154/6154A/6154B for the instructions in procedure (\*) "Checking the VAS 6154", selecting the right-hand "Extras" menu in O.D.I.S. Service and clicking on the "Diagnostic interface" button.

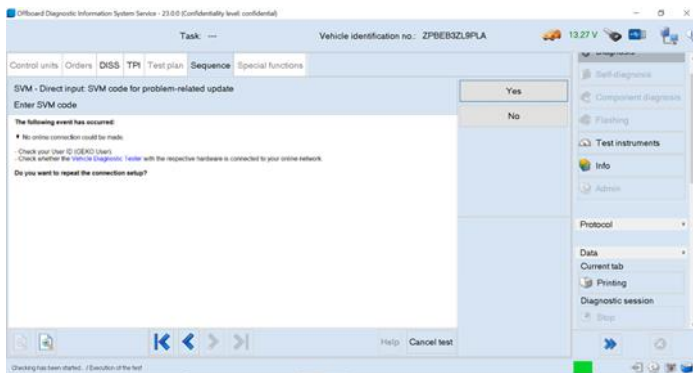
**C.** If the following connection error is displayed like in the following example screenshots:

- It is not possible to connect to the central server; check that your laptop is correctly connected to the Internet and retry by clicking on "Yes" or "Done/continue", as appropriate.

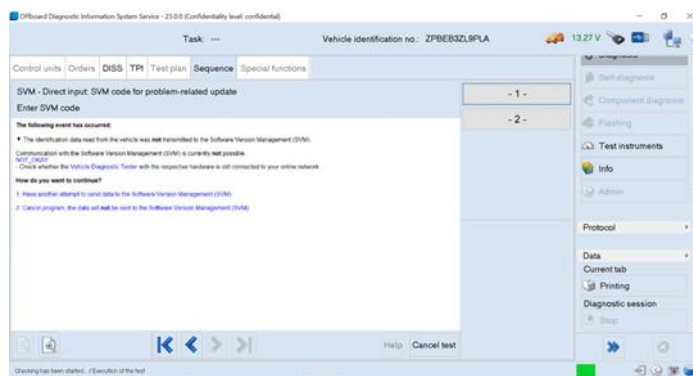
**D.** If the connection is dropped during the target/actual comparison during the SVM procedure:

- It is not possible to connect to the central server; check that your laptop is correctly connected to the Internet and retry by clicking on "I".
