Customer Satisfaction Program 25N10

**SUBJECT: Customer Satisfaction Program 25N10**  
Certain 2017-2025 F-450 – F-600 Super Duty Chassis Cab Upfitted with an Aerial Bucket  
Frame Rail Crack

## CERTAIN 2017-2025 F-450 - F-600 CHASSIS CAB UPFITTED WITH AN AERIAL BUCKET — FRAME RAIL CRACK

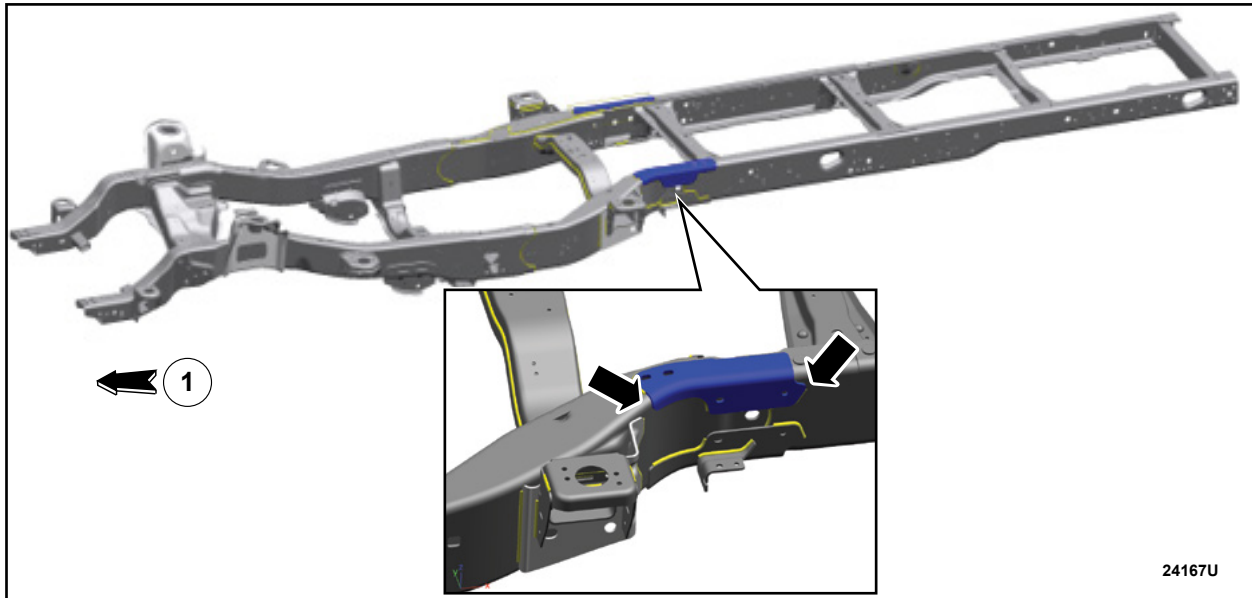
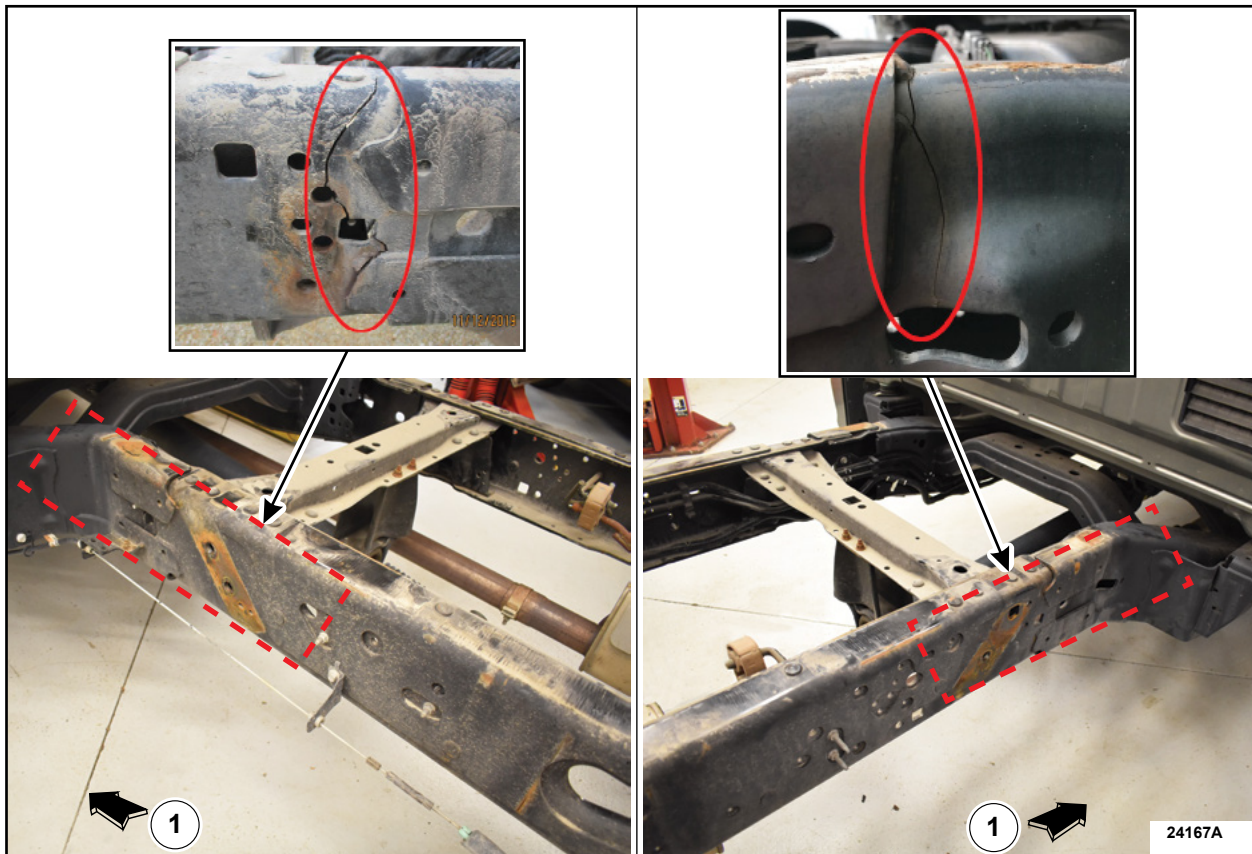
**LOCATION 1 - UPPER FRAME RAIL BEHIND CAB - See Figures 1 and 2.**

In some of the affected vehicles the Aerial Bucket Second Unit Body (SUB) upfits could cause stress points on the frame rail. Over time, this stress could cause a crack in the frame rail.

1. Identify and inspect the areas where the frame rail may exhibit signs of stress or a crack. See figures 1 through 6. Using compressed air, clear any debris that may be on the frame rails.

If an affected vehicle exhibits this condition, dealers are to replace the frame assembly at no charge to the vehicle owner. For new vehicle storage guidelines, refer to EFC13033, Storage Guidelines for New Vehicles.
