L634-
A.08.26

To: **After Sales Official Network**
Subject: **Rework on LH-RH door emergency release cover**
Date: **23/02/2026**
Pages **6**

Campaign name:
Rework on LH-RH door emergency release cover

Model:
Temerario (Only for vehicle with upholstery configuration)

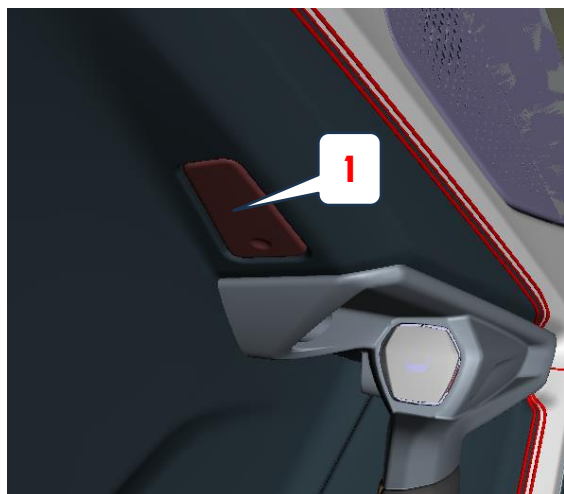
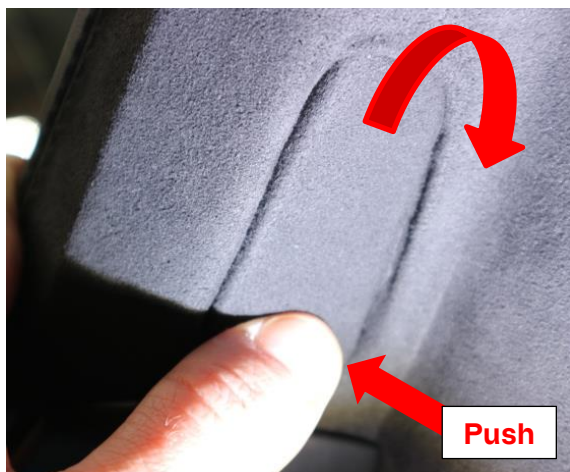
1. Check the door panel on the right and left sides.
2. Remove the emergency release cover (1) by pressing on the bottom corners and check that it detaches easily from the door panel.
3. If the emergency release cover (1) does not easily come off, perform **operation B**. If the emergency release cover (1) is removed smoothly, perform **operation C**.
4. When finished, check that the orange bowden cable strap is correctly secured to the cover and that the emergency release cover (1) is correctly positioned on the door panel.
